**EVALUATION OF ARCHAEOLOGICAL FEATURES AT
BREKKA AND DAÐASTAÐIR, NÚPASVEIT IN
ÖXAFJARÐARHREPPUR**

Evaluation report

FS286-05151

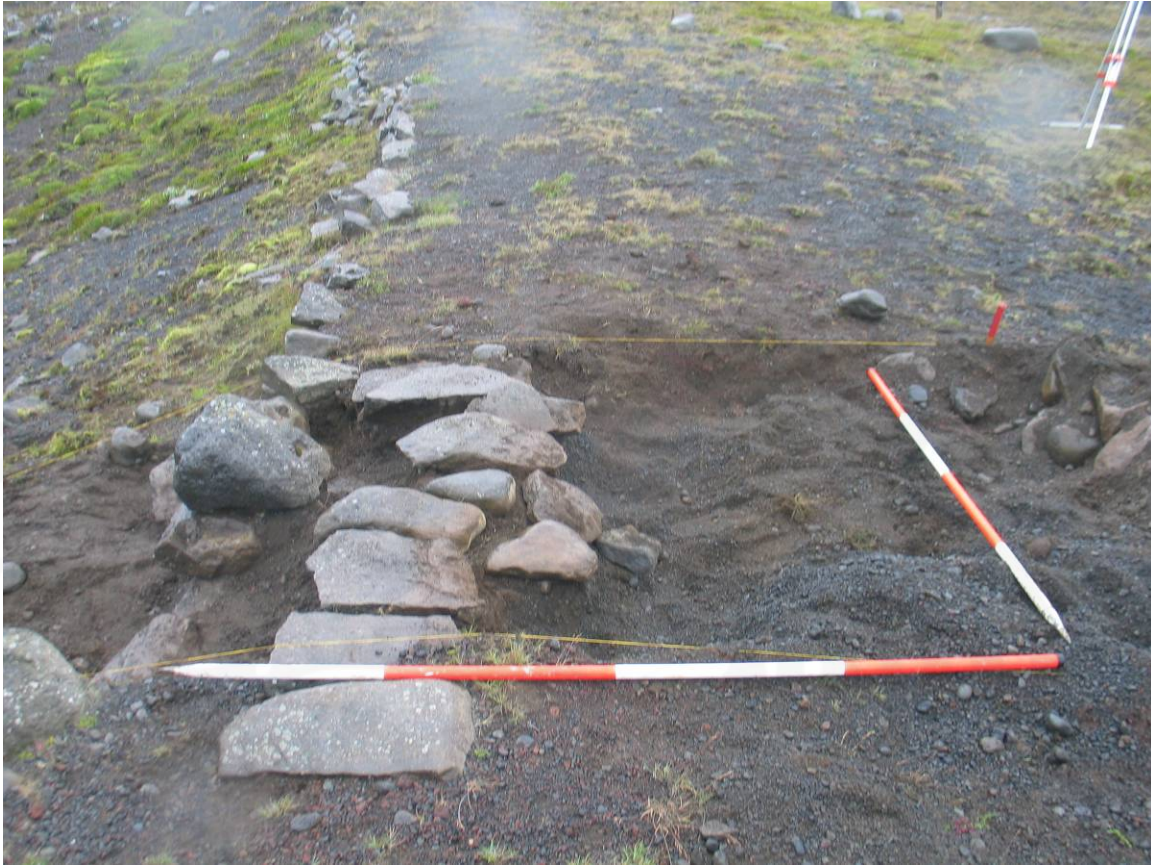
Figure 1 Looking north, the two stone revetment for the track.

The stone revetment was visible either side of the trench, and probably has a similar construction. Towards the south, as it approached the present road downslope, severe erosion and destruction has occurred. Otherwise near to the trench further upslope it was relatively well preserved on the surface.
