SURVEY POINTS AT HIGHLAND HOUSE, SEAVIEW, CODRINGTON AND RIVER IN BARBUDA

GARÐAR GUÐMUNDSSON

REYKJAVÍK 2011
FS458-11031

FORNLEIFASTOFNUN ÍSLANDS SES
INSTITUTE OF ARCHAEOLOGY, ICELAND

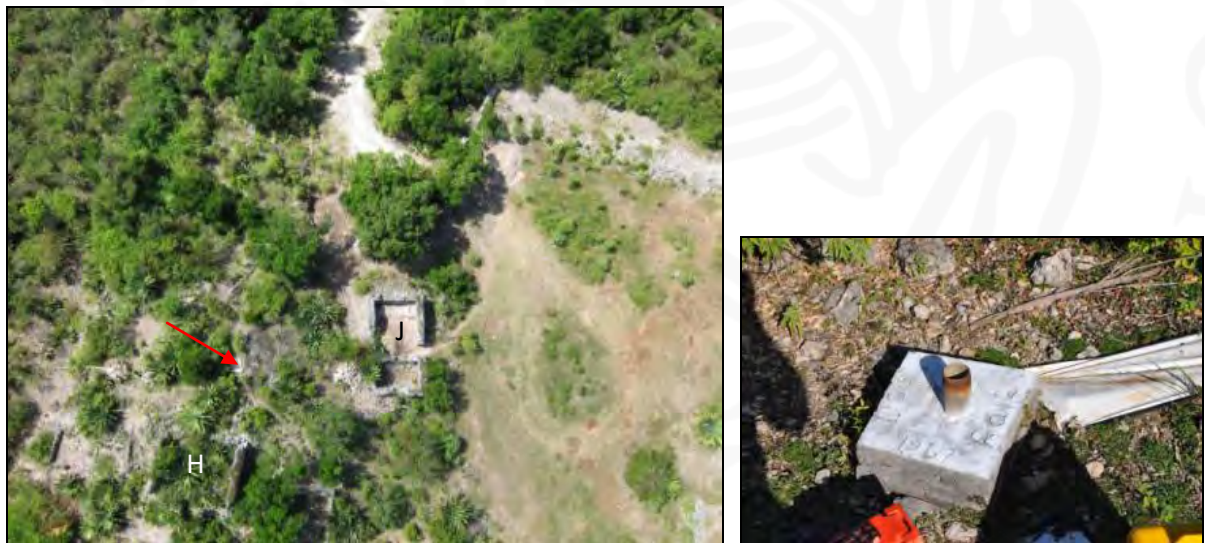
Figure 1. Station Ba12 at Highland House. A: Kite AP of Ba12 south east of house J. Arrow points at station and north. B: Close-up view of Ba12, looking east. (Photos FSI.)

The coordinates for the base point, Ba12, at Highland House were established from a 248 minute run of the DGPS base antenna over Ba12 (centre of the iron pipe), antenna height measured from the top of the pipe. Height of Ba12 was calculated with the base antenna at Ba12 and rover antenna at station C1 on the jetty in Codrington harbour using the height of C1, 0,76m, as established in a 2009 survey carried out in advance of a construction of a fishing factory by the harbour. Reference to Ba12 hereafter, unless otherwise stated, is with the following coordinates and height.

Name	Description/Remarks	E	N	Height
Ba12	Concrete block with vertical iron pipe. 12,1 m SSE of structure J and 6,2 m W of structure H (Watters '85 number 5 and 6 respectively). Centre and on top of pipe.	628.312,117	1.953.610,452	37,165

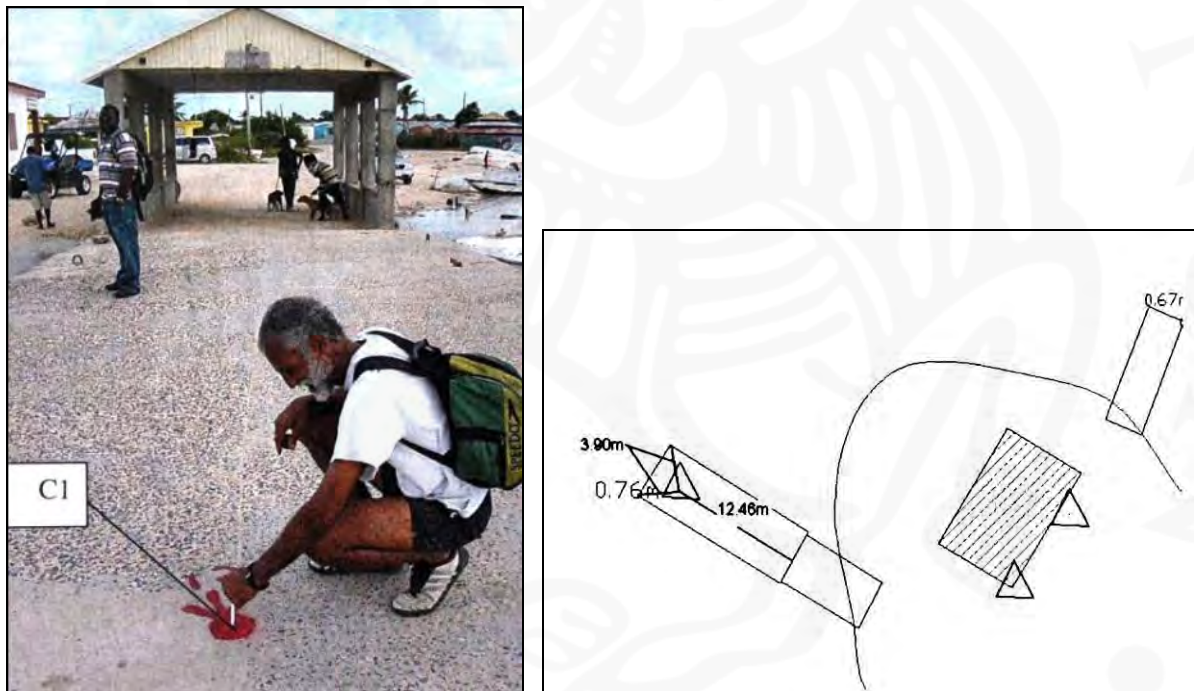
Figure 2. Station C1 on the jetty at Codrington harbour. (Figures from Survey at Project Site 2009.)

Coordinates for station C1, a point on the concrete jetty in Codrington harbour, was established with the rover antenna and the base antenna at Ba12. Height taken from survey conducted in 2009 in preparation of fish factory construction.

Name	Description/Remarks	E	N	Height
C1	SS Steel screw in concrete jetty at Codrington harbour. 12,46 m W from shed and 3,9 m from each outer W corners of jetty.	624.207,616	1.950.989,464	0,760

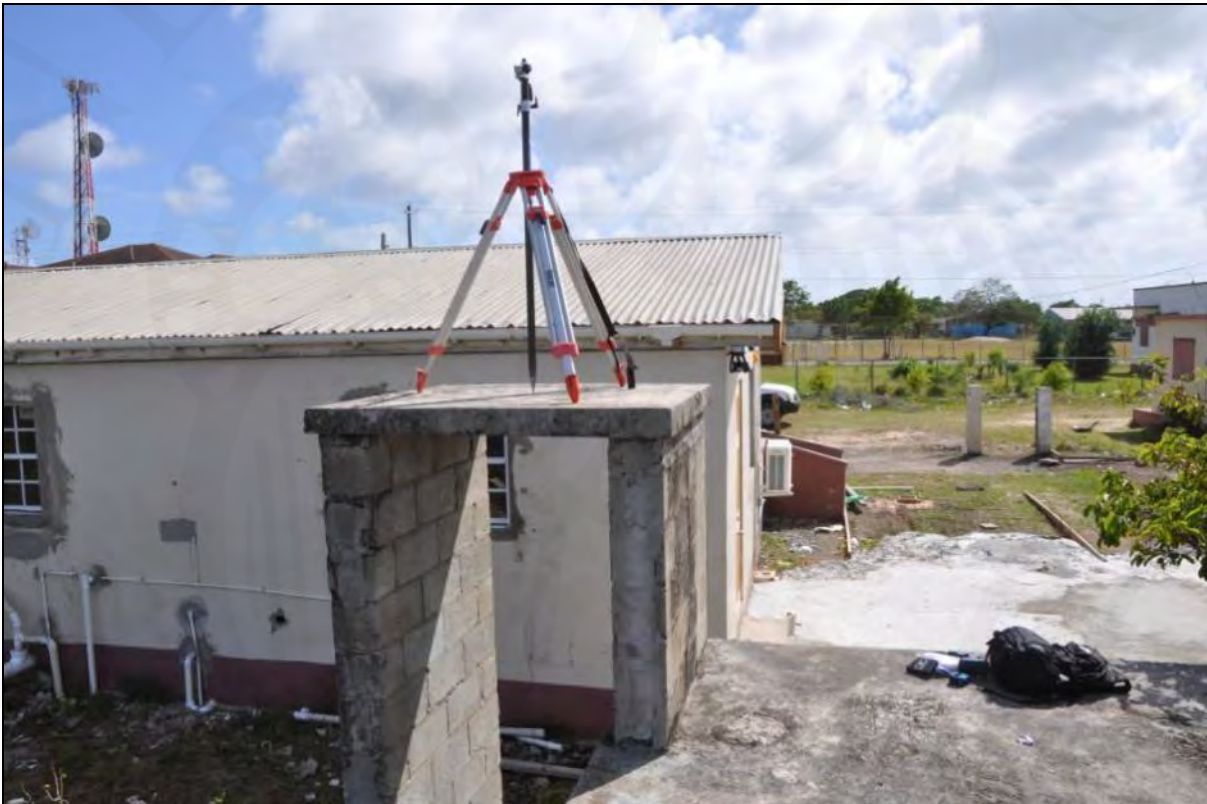
Figure 3. Point BCL01 at Brooklyn College laboratory building. Looking south. (Photo FSI.)

Name	Description/Remarks	E	N	Height
BCL01	Steel bolt in centre on “roof” of concrete “doorway” or “gate” adjacent to a cistern N of NW corner of lab building.	624.479,473	1.950.962,151	4,993

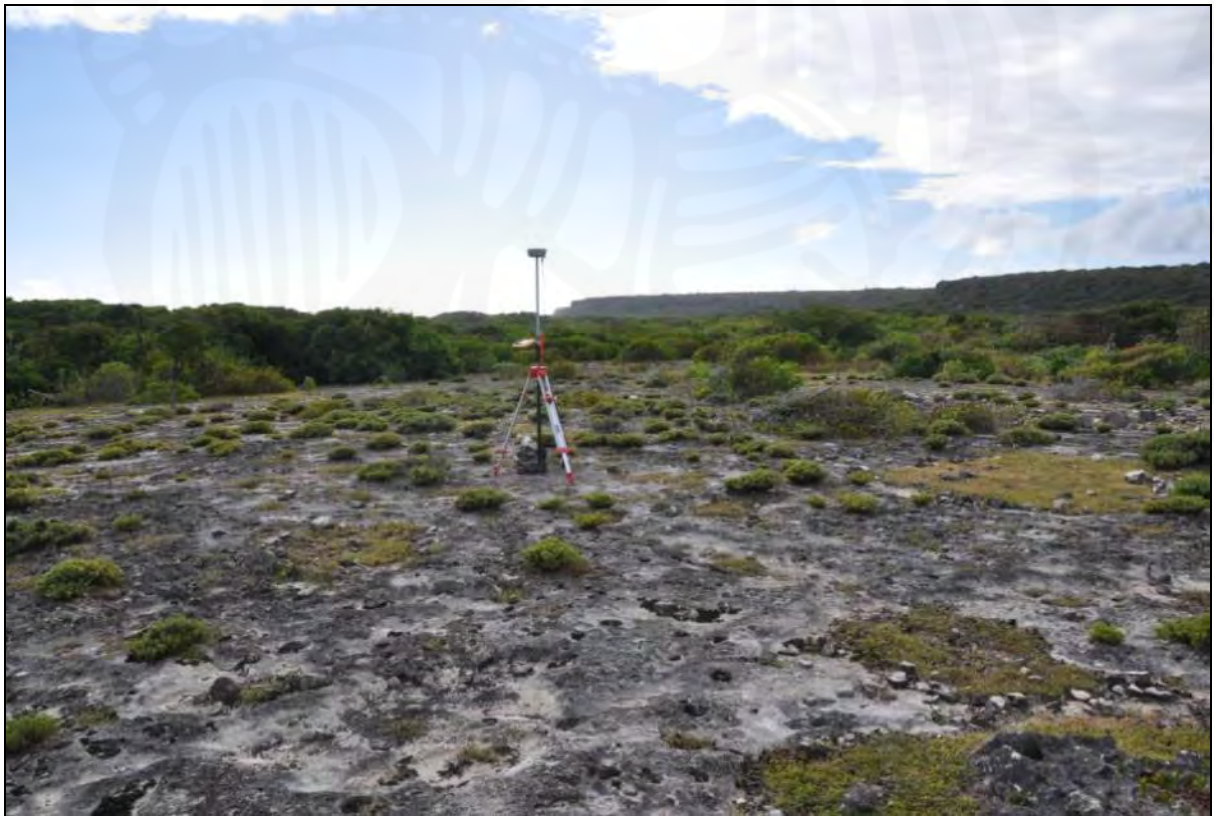
Figure 4. Station SV1 at Seaview. Looking SE. (Photo FSI.)

Name	Description/Remarks	E	N	Height
SV1	Steel screw in bed rock about 110 m SSW of excavation area.	629.892,415	1.954.676,730	4,966
SV2	Steel screw in middle of concrete cistern just inside and about 25 m east of entrance gate to church recreation area. Ca. 250 m west of excavation area.	629.666,919	1.954.808,372	2,245

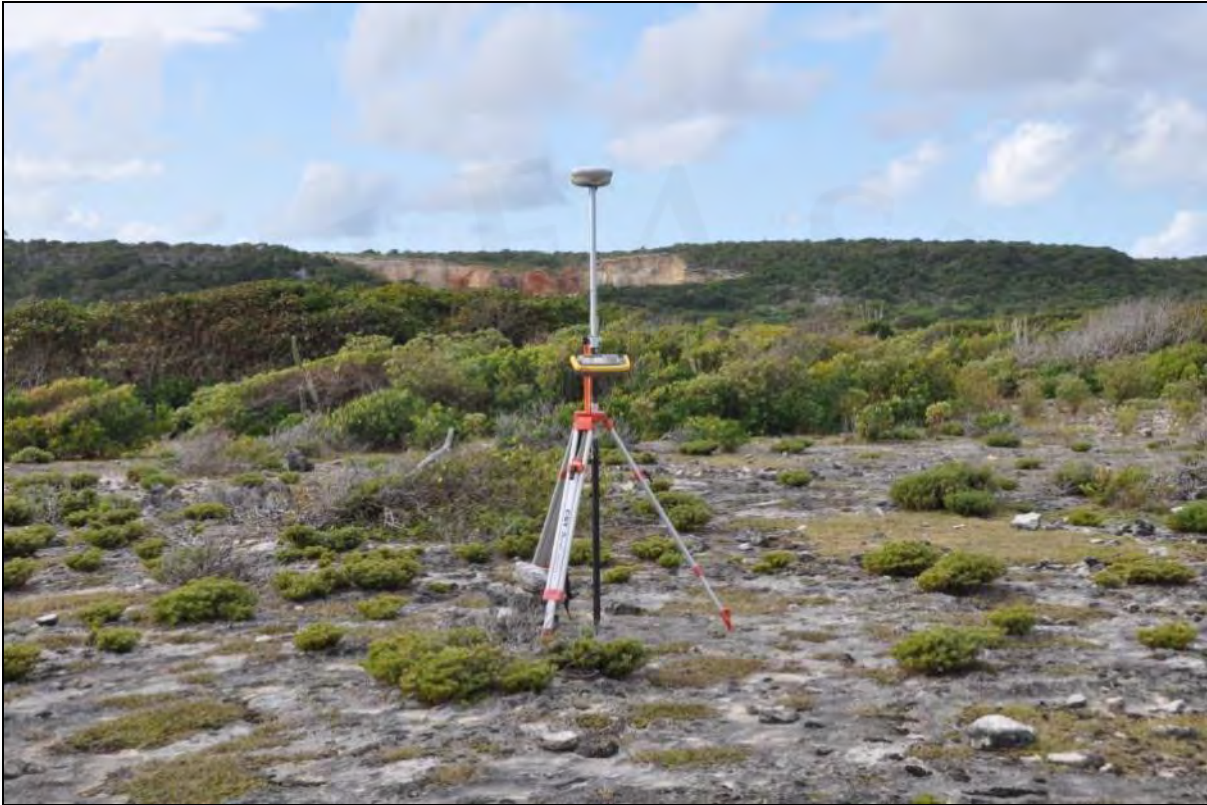
Figure 5. Station SV1 at Seaview. Looking SSW. (Photo FSI.)

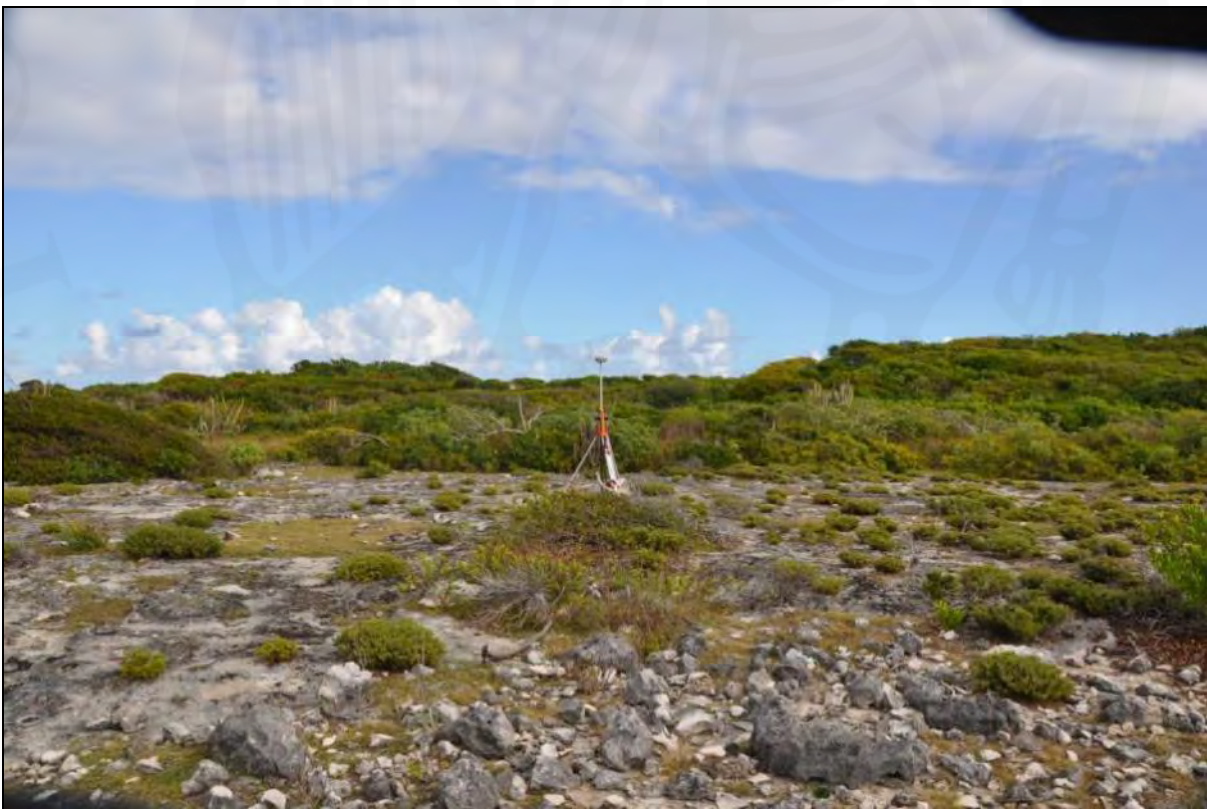
Figure 6. Station SV1 at Seaview. Looking N towards the excavation area. (Photo FSI.)

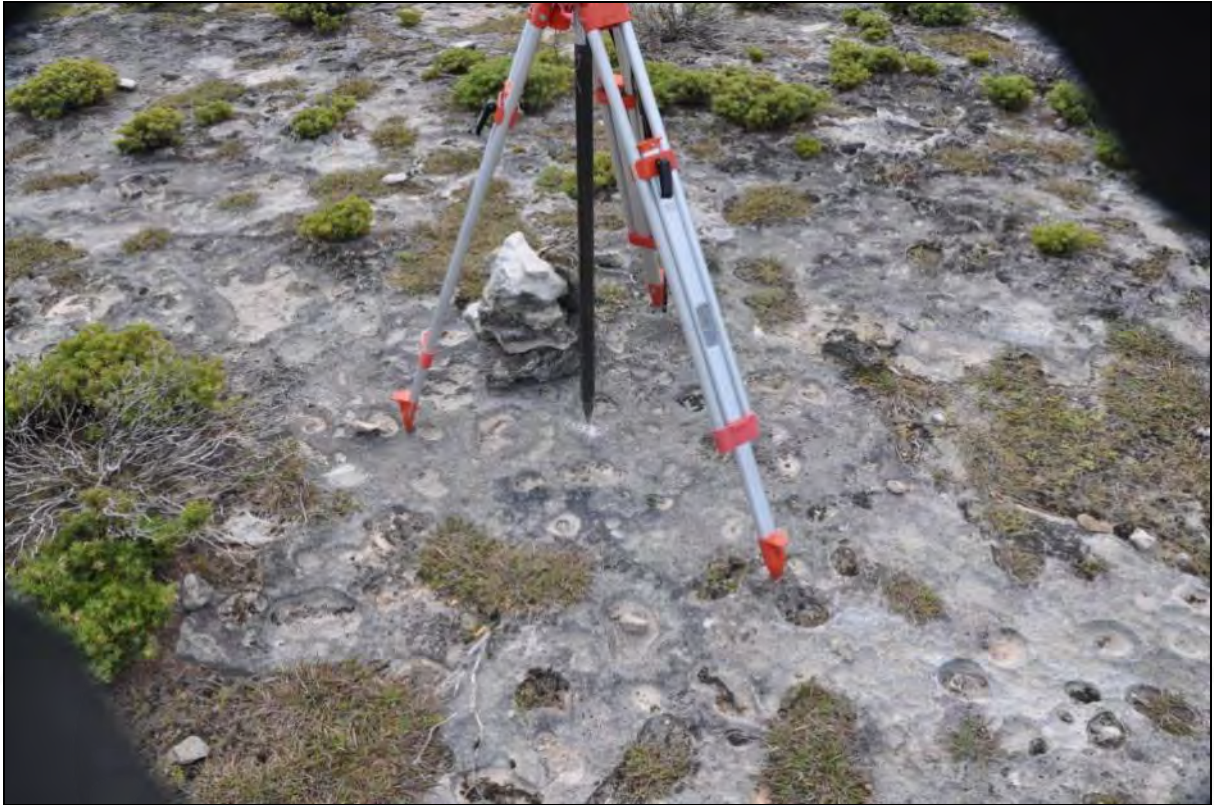
Figure 7. Station SV1 at Seaview. Close up of point. Looking SSW. (Photo FSI.)

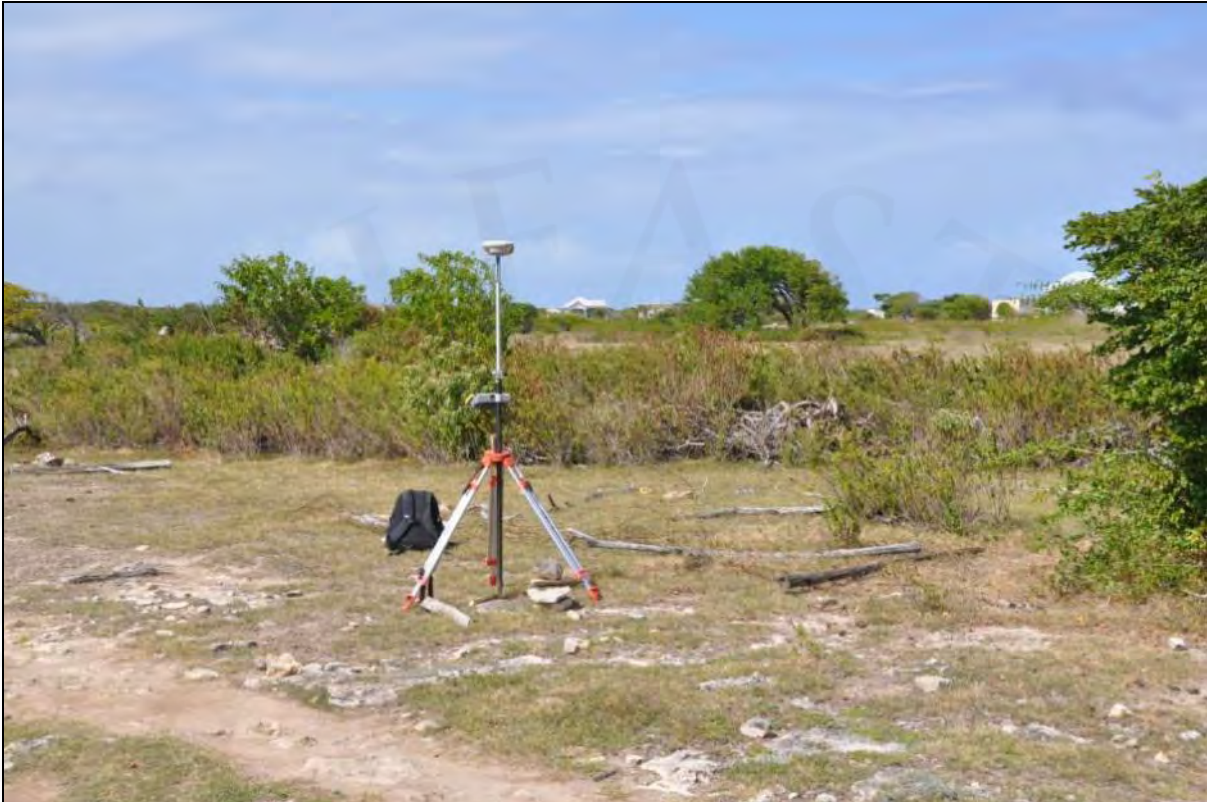
Figure 8. Station SV3 at Seaview. Looking N. (Photo FSI.)

Name	Description/Remarks	E	N	Height
SV3	Steel bolt in bed rock N of track and about 130m SE along it from entrance gate to church recreation area towards excavation area.	629.749,226	1.954.734,501	2,163
SV4	Steel screw in bed rock 5,05m NNW (330° true) from SV1.	629.889,821	1.954.681,095	4,903
SV5	Steel rod W of excavation, one of group of 3.	629.868,630	1.954.768,896	3,457
SV6	Steel rod S of excavation, one of group of 3.	629.873,711	1.954.749,902	3,065
SV7	Steel rod S of excavation, one of group of 3.	629.889,742	1.954.757,818	3,239

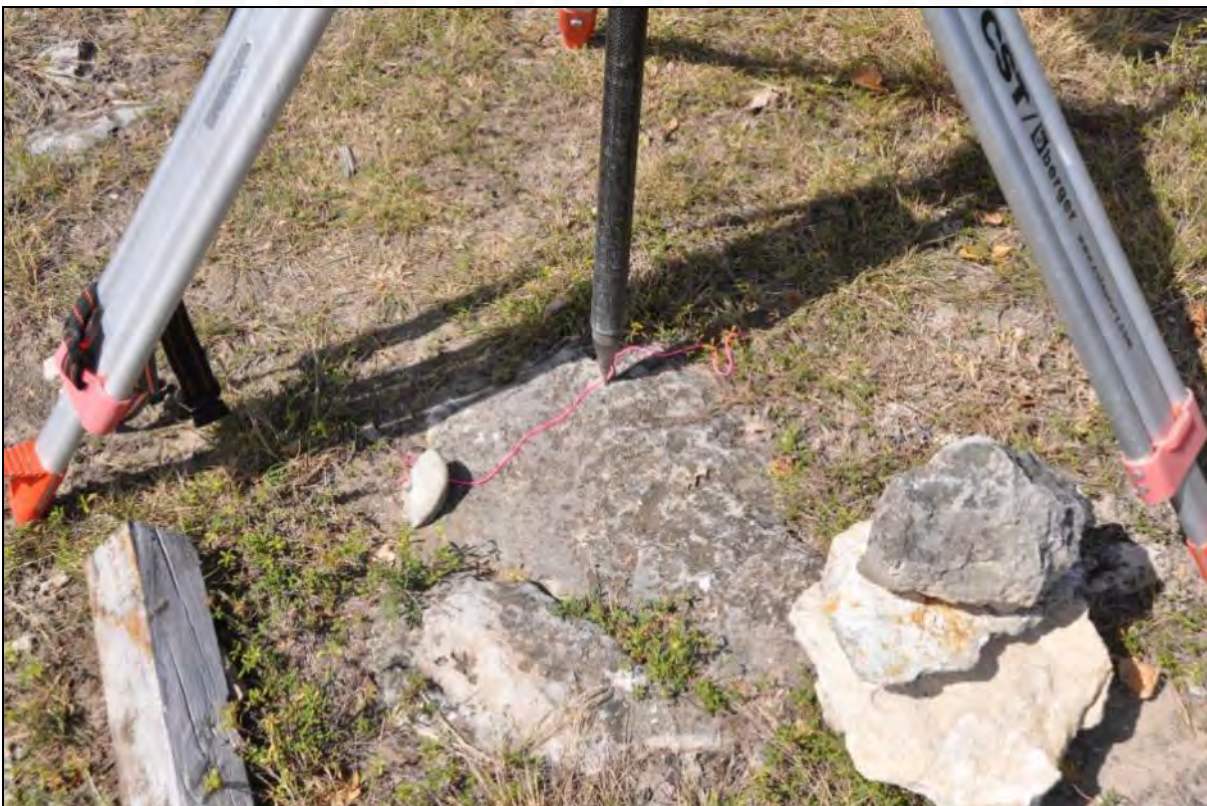
Figure 9. Station SV3 at Seaview. Close up of point. Looking N. (Photo FSI.)

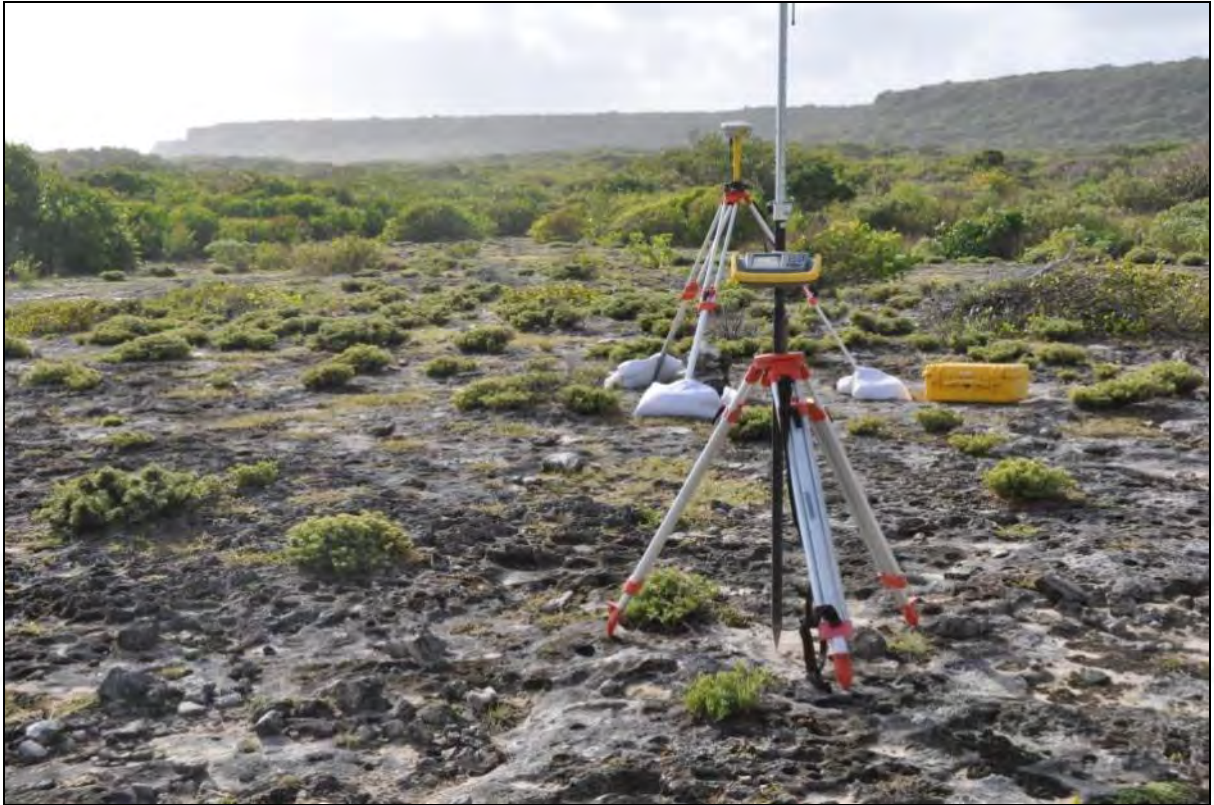
Figure 10. Station SV4 at Seaview. Looking SSE. SV1 in background. (Photo FSI.)

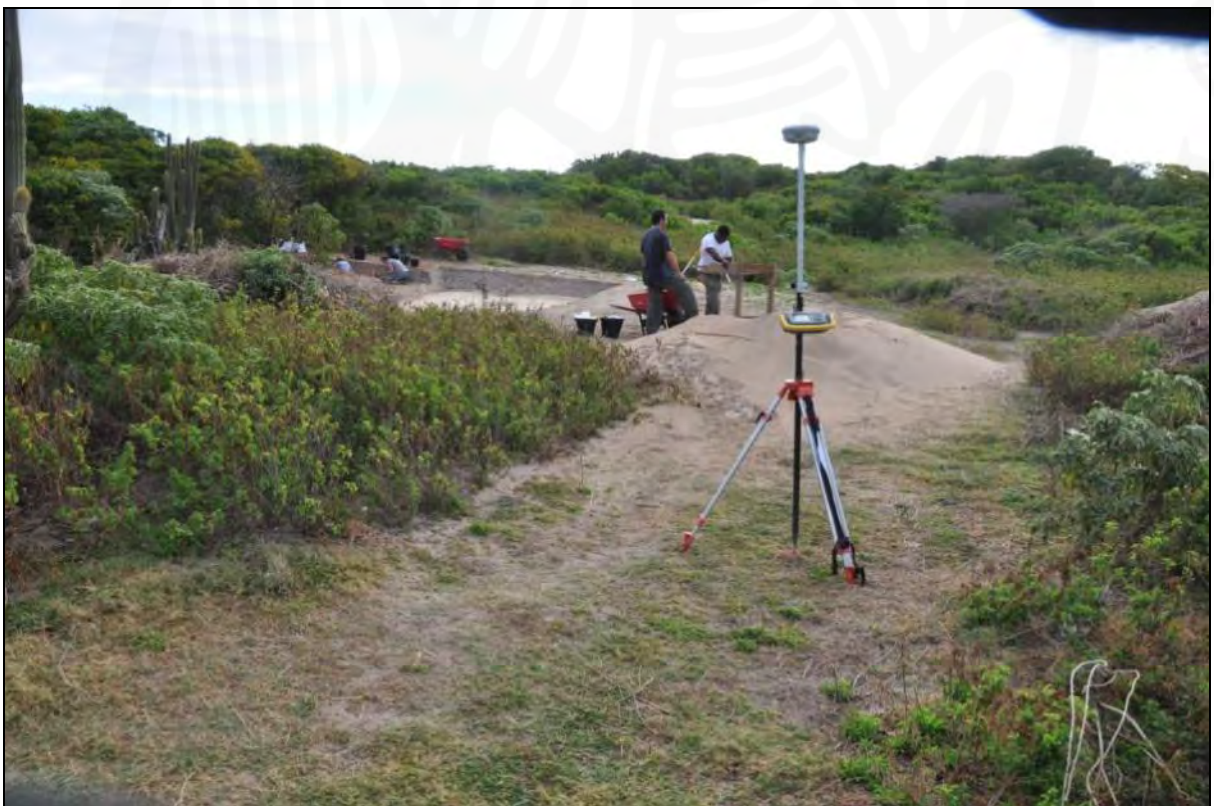
Figure 11. Station SV5 at Seaview. Looking SE. (Photo FSI.)

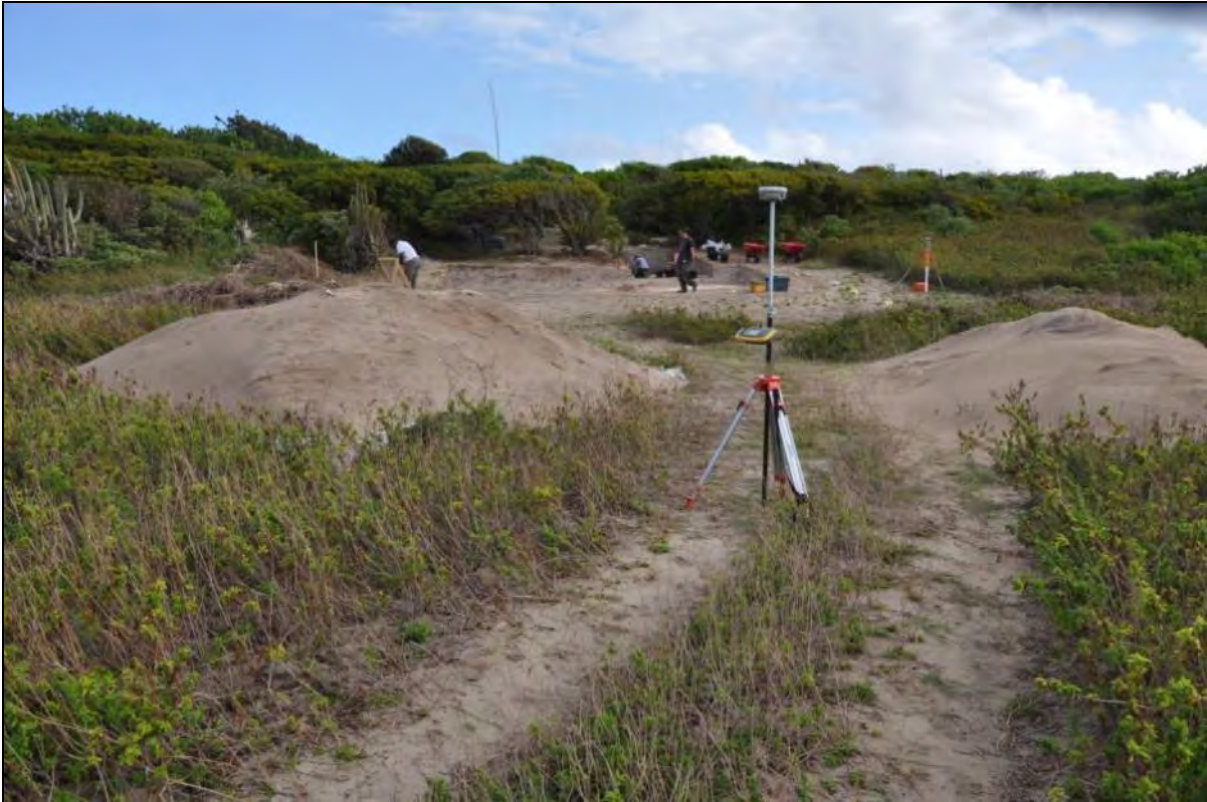
Figure 12. Station SV6 at Seaview. Looking NE. (Photo FSI.)

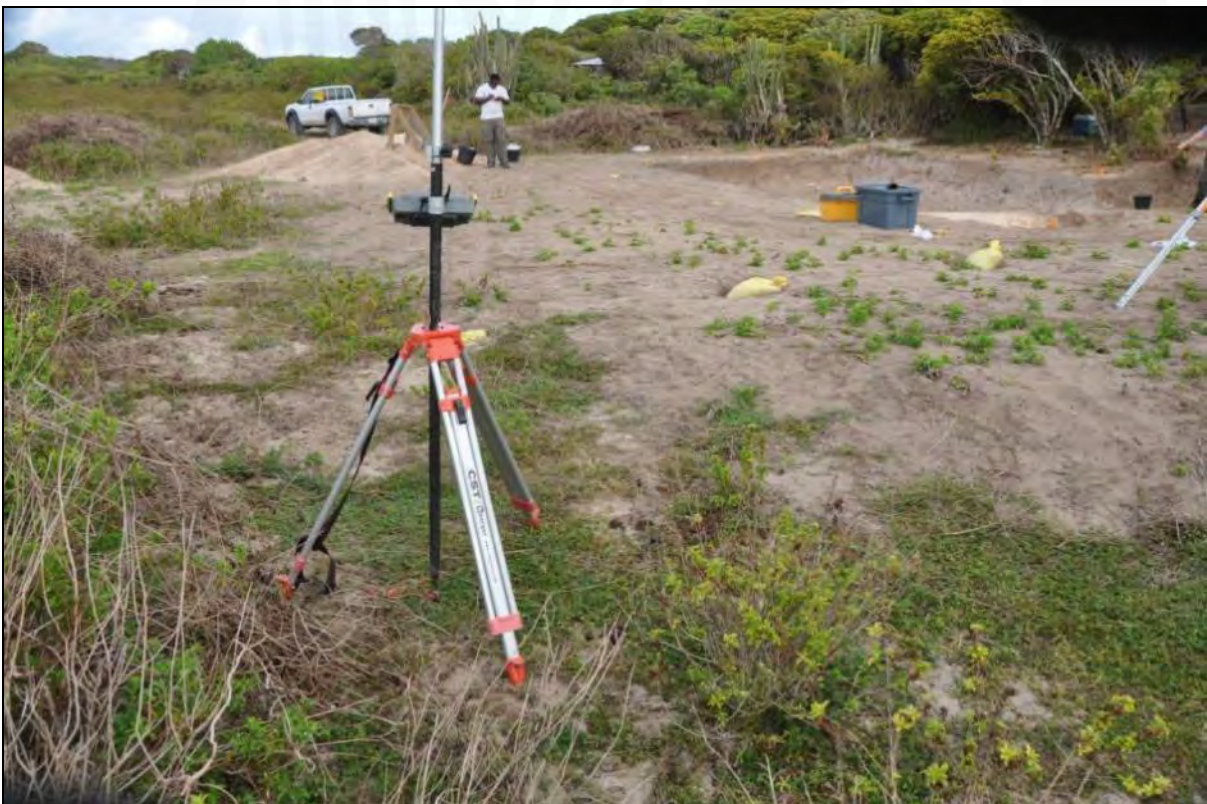
Figure 13. Station SV7 at Seaview. Looking NW. (Photo FSI.)

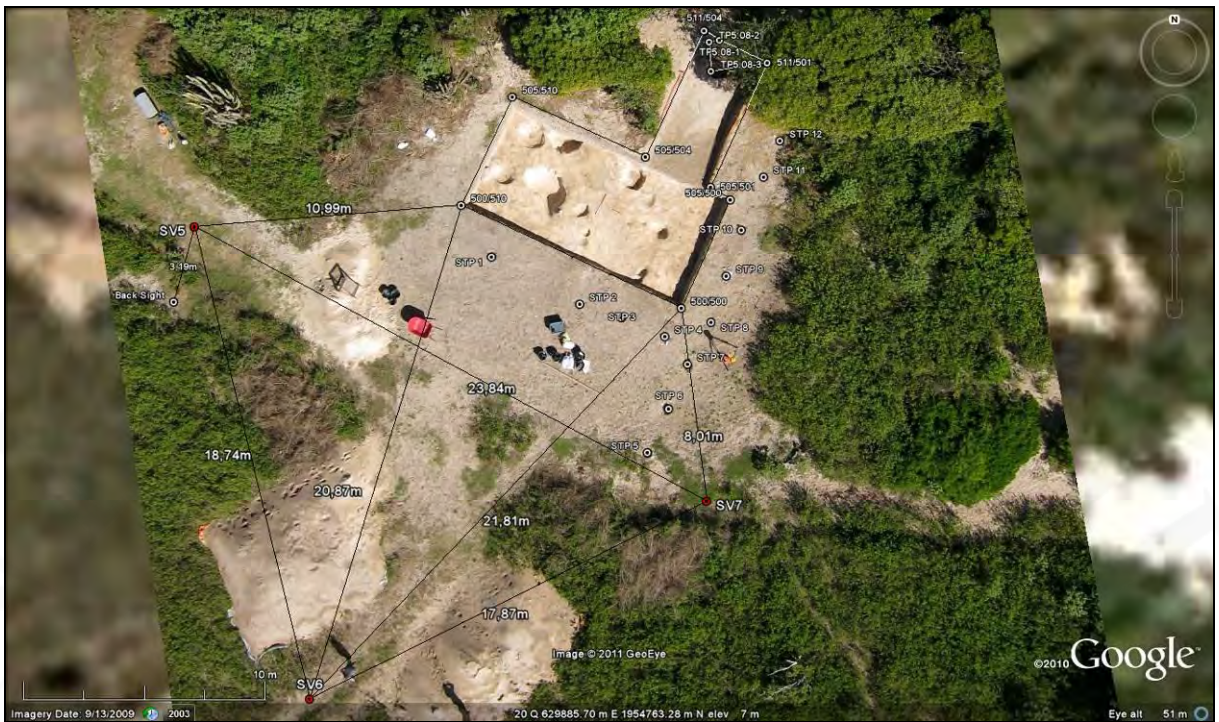
Figure 14. Stations near the excavation trench at Seaview. Points superimposed on a kite aerial photograph imported into Google Earth. Scale not accurate. (Photo FSI/Google Earth.)

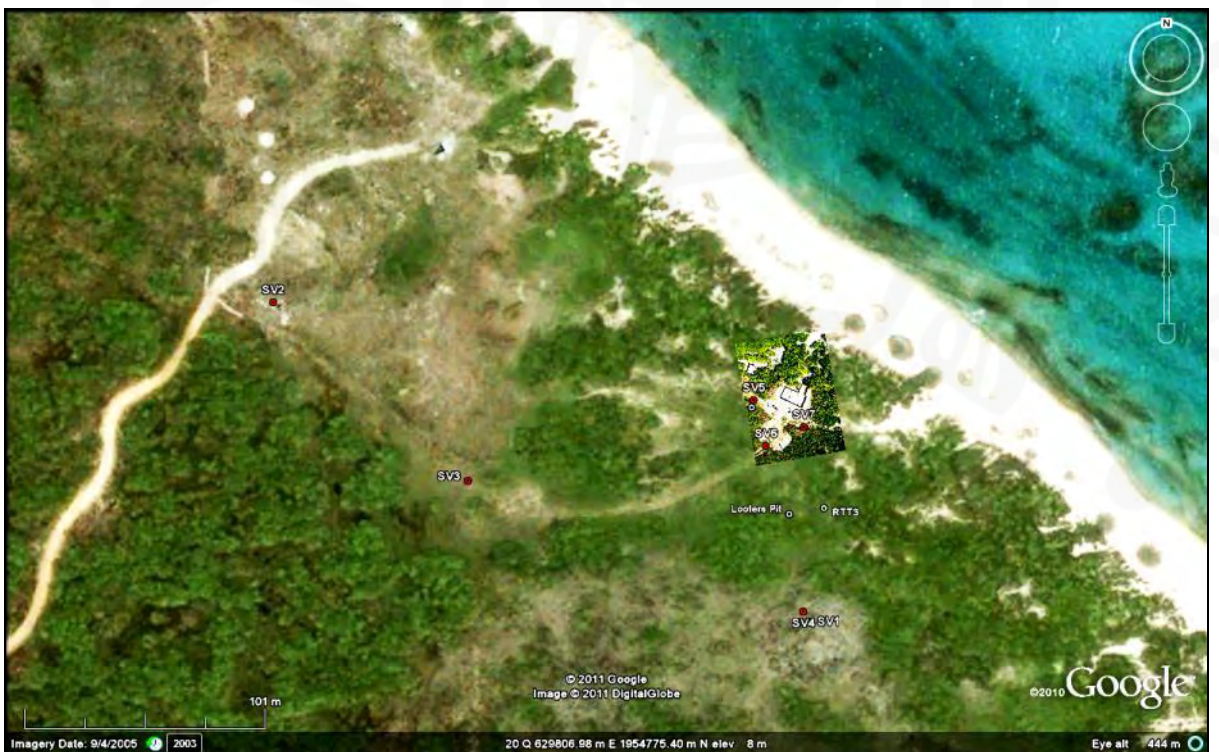
Figure 15. Stations around the excavation trench at Seaview. Points imported into Google Earth. Scale not accurate. (Photo FSI/Google Earth.)

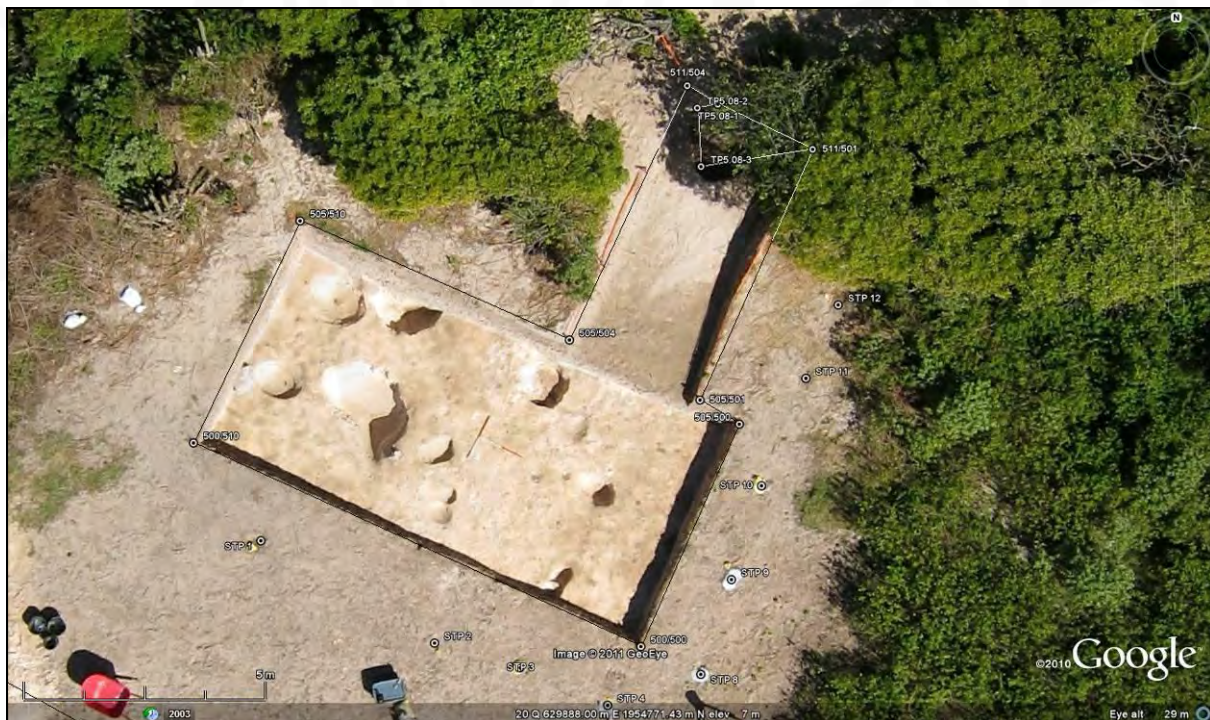
Figure 16. Points marking the extent of the excavation area at Seaview and shovel test pits. Points superimposed on a kite aerial photograph imported into Google Earth. Scale not accurate. (Photo FSI/Google Earth.)

The extent of the 2011 excavation area was measured in with SV1 as base point. The outline of a test pit from 2008, believed to be the number 5 pit, partly exposed in the northern section of the excavation area was also surveyed. Coordinates and height (3,549) for the back sight point for the 2011 excavation were established.

So called shovel test pits, 12 in all, to the south and east of the 2011 excavation area were surveyed in.

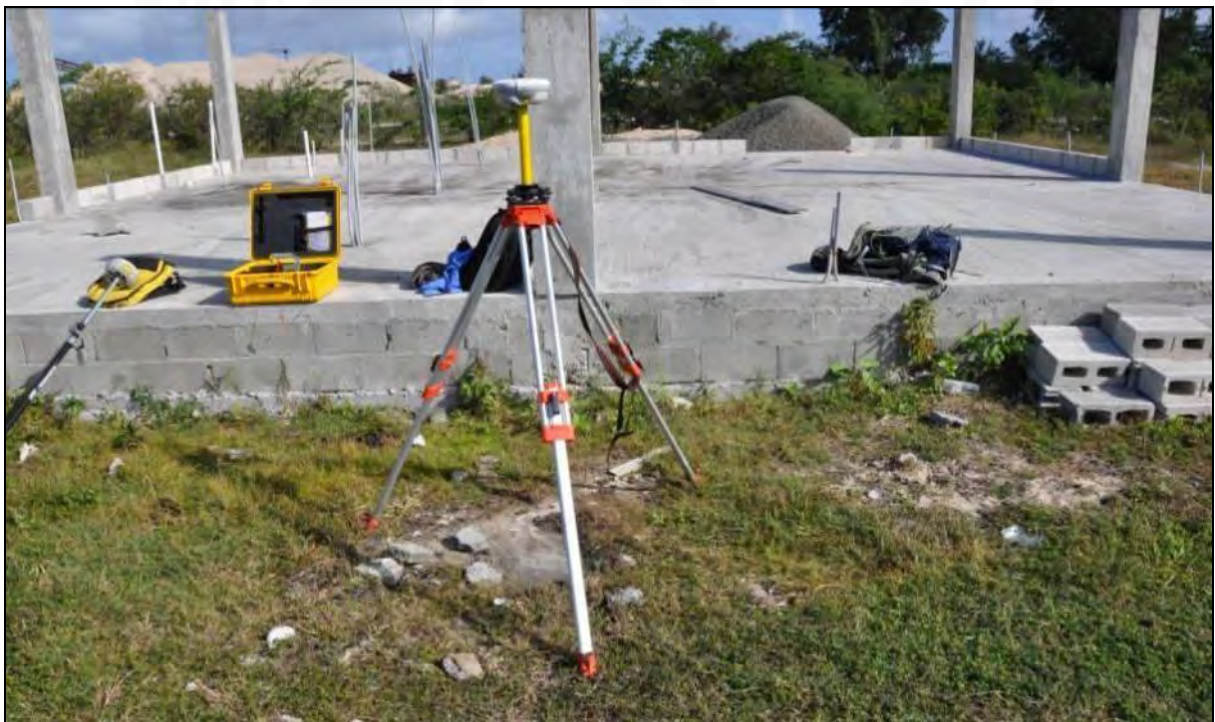
Figure 17. The base station at River. Looking N. (Photo FSL.)

A grid system was established in connection with a small scale rescue excavation at a site called River, approximately 150 m east of the causeway to the harbour on the southern coast of Barbuda. This grid was not tied into the local grid system. A base station was established with a 25 minute run of a DGPS base antenna at a point ca. 160 cm south of the centre of the south site of a house foundation near the excavation site. A proxy height of the base station was calculated from measured sea level height in the nearby harbour, tide tables from St John's harbour, Antigua, and time difference between the two harbours estimated. The base point at River is believed to be within 50 cm accuracy on the east and north axis and within 20 cm for the height. Points in area C were not measured in but added to figure 16 manually.

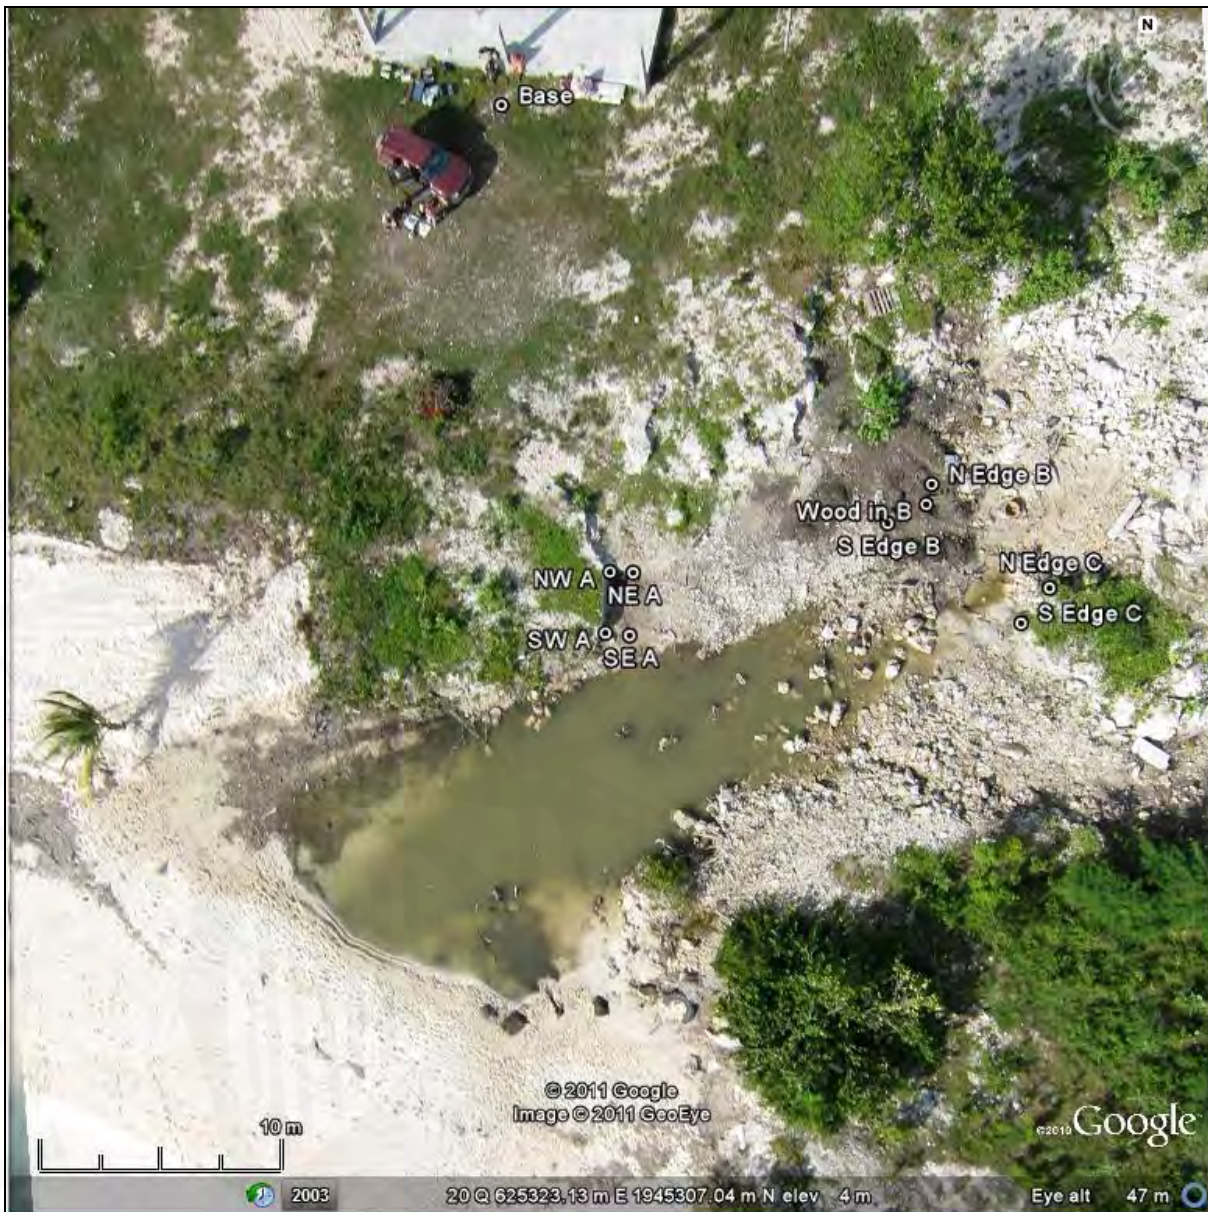
Figure 18. Points at River. Points superimposed on a kite aerial photograph imported into Google Earth. Scale not accurate. (Photo FSI/Google Earth.)

Name	Description/Remarks	E	N	Height
Base	160 cm S of the centre of S wall a house foundation near excavation site	625319.423	1945328.986	1.074
NW A	NW corner of area A	625323.081	1945308.608	0.345
NE A	NE corner of area A	625324.032	1945308.526	0.268
SE A	SE corner of area A	625323.905	1945306.038	0.093
SW A	SW corner of area A	625322.910	1945306.128	0.185
S edge B	S edge of area B	625334.321	1945310.619	0.293
N edge B	N edge of area B	625336.069	1945312.183	0.382
Wood B	Wood-trunk in area B	625335.855	1945311.387	0.136

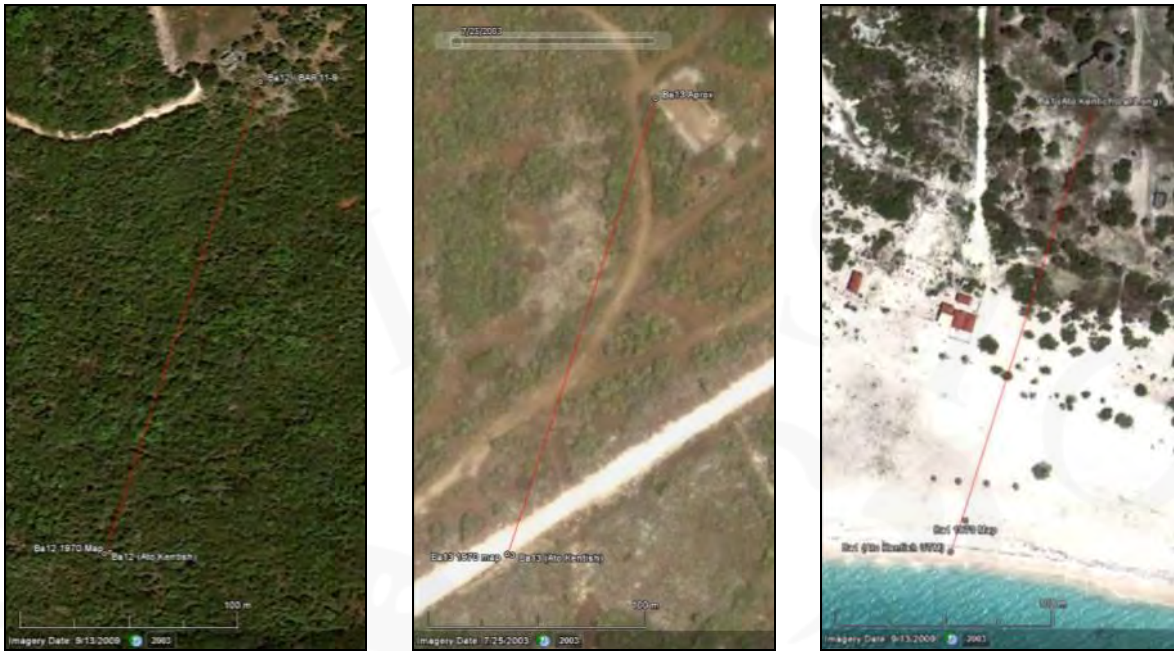
Figure 19. Discrepancy between stations with coordinates from Ato Kentish, with manually measured coordinates from 1970 maps and the location of same stations in Google Earth. Be12 at Highland House left, Be13 at All in Well centre and Ba1 at Martello Tower right. (Photo FSI/Google Earth.)

As stated above it was decided not to make use of coordinates obtained from Ato Kentish, land surveyor at the Ministry of Agriculture and Lands and from the 2009 survey carried out in preparation for a construction of a fish factory in Codrington supplied by Japanese engineers at the site. A certain consistent discrepancy was observed in the data from Ato Kentish and this also applies to some of the coordinates from the 2009 survey on the one hand and the coordinates obtained by initial DGPS measurements by the FSI team and the UTM 20Q grid presented in Google Earth on the other hand (see figures 17 and 18). The position of the points from Ato Kentish and the 2009 survey relative to same stations as seen in Google Earth is consistently ca. 220 m and 199°. The nature of the discrepancy suggests it to be a matter of difference between projections or calculations. Under the circumstances it proved impossible to clarify the root of this problem and rectify it. The FSI's DGPS point measurements were in good agreement with the Google Earth grid. Google Earth, although not accurate down to a metre level, is a useful "safety net" to verify coordinates.

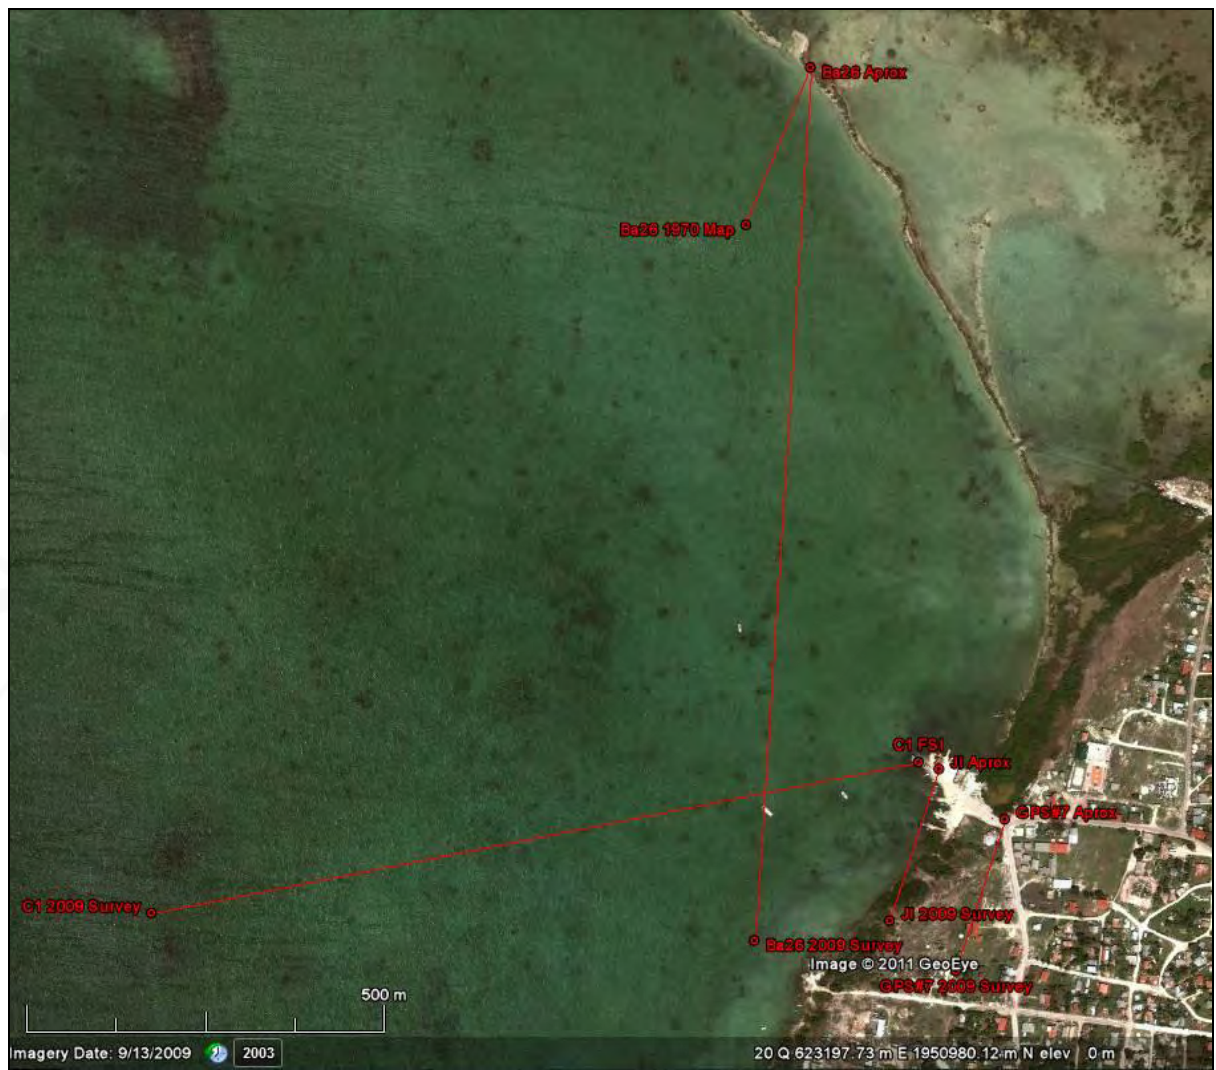
Figure 20. Comparison of location of points, in and near Codrington, according to coordinates from the 2009 survey, 1970 map and FSI's point C1 in Google Earth. (Photo FSI/Google Earth.)

Observation of four points from the 2009 survey show that points JI and GPS#7 are at the same distance and angle from same stations as seen in Google Earth. The error in the location of the other two points suggests, however, a misprint (see figure 18). The height given to C1 on the Codrington jetty in the 2009 survey was more convincing at 0,76 m than the height, 1,651, surveyed in using Ba12 as base and the height of Ba12 (38,056) from Ato Kentish.

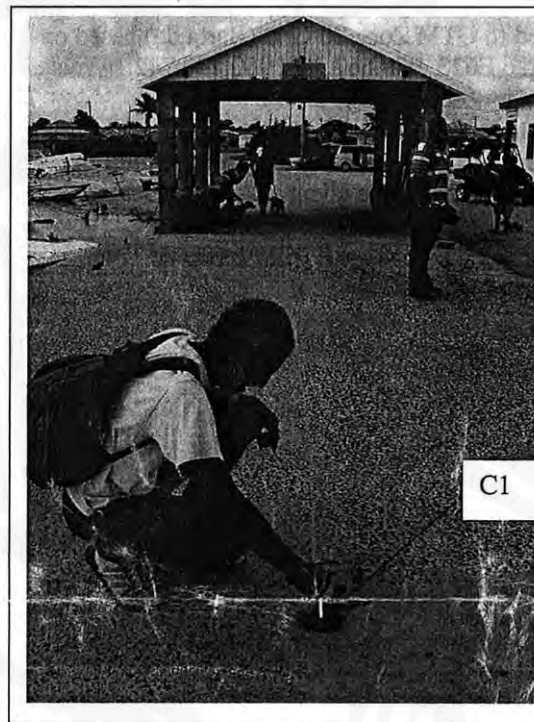
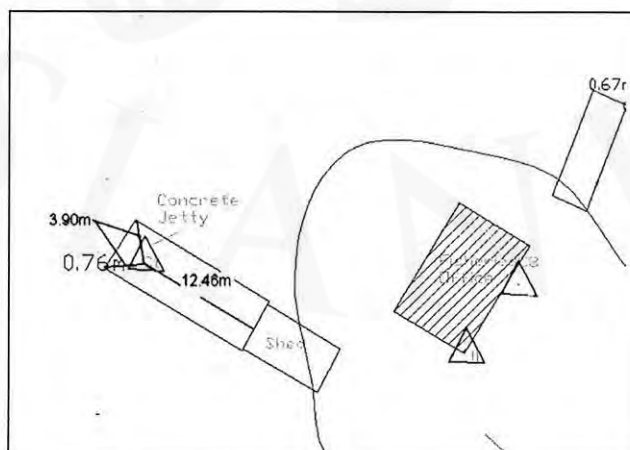
C1

E 623136.62 N 1,950, 778.11
Height: 0.76m

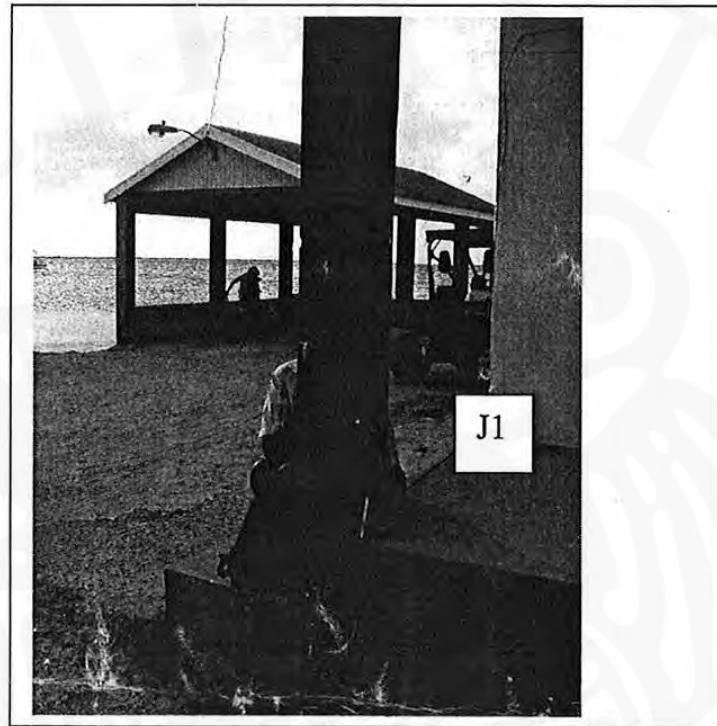
J1 (Mark at SE corner of Fisheries building)

E 624, 167.78, N 1,950,769.22
