SURVEY POINTS AT HIGHLAND HOUSE, SEAVIEW, CODRINGTON AND RIVER IN BARBUDA

GARÐAR GUÐMUNDSSON

REYKJAVÍK 2011
FS458-11031

FORNLEIFASTOFNUN ÍSLANDS SES
INSTITUTE OF ARCHAEOLOGY, ICELAND

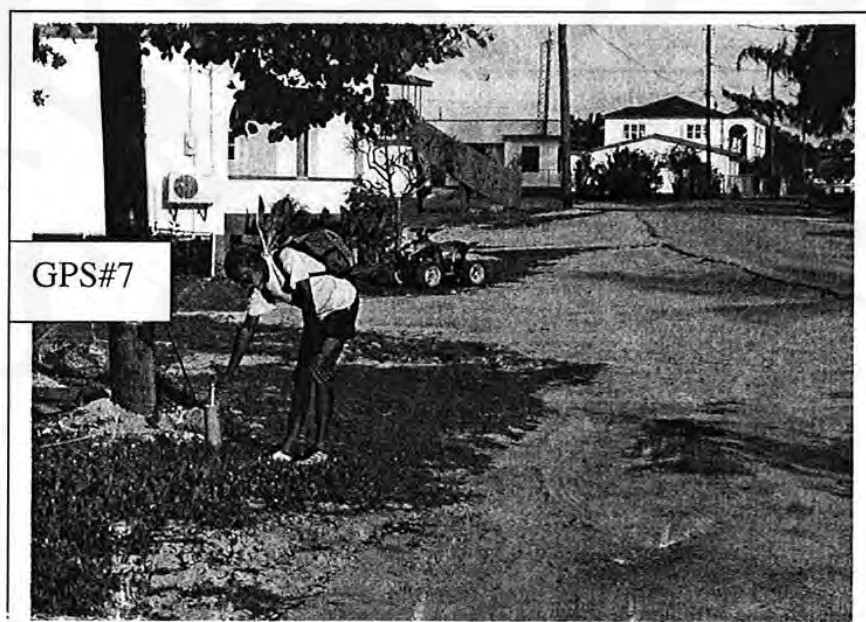
GPS #7 (PVC pipe painted yellow)

E 624,259.96 N 1,950,700.74
