ARCHAEOLOGICAL MONITORING OF MACHINING DURING DEVELOPMENT WORK AT AÐALSTRÆTI 2, REYKJAVÍK

NIKOLA TRBOJEVIĆ AND HILDUR GESTSDÓTTIR

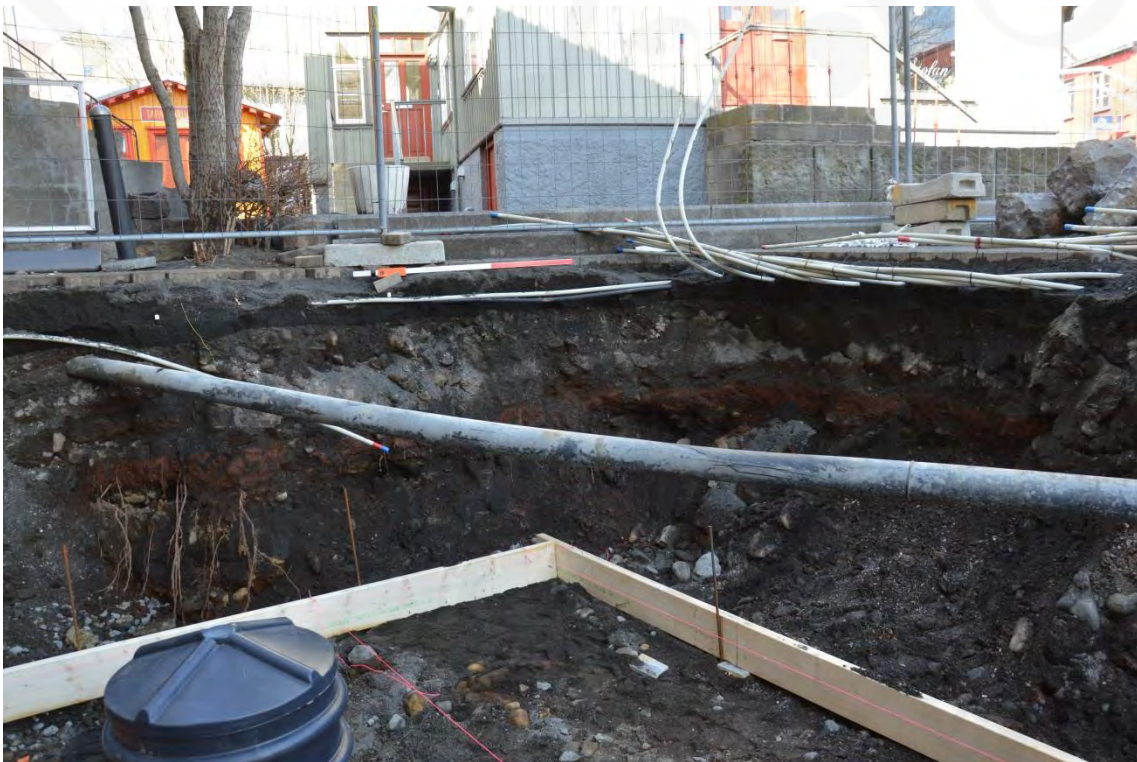
Figure 2. Peat-ash layer in the N-NW corner of the excavated area

In brief, no substantial, structural archaeological features were identified or noticed in the excavated area. The excavation revealed only few deteriorated unstructural layers and deposits of different kinds. Most noteworthy of those was (at some places up to 25 cm thick) peat-ash layer, positioned in the N-NW corner of the area, c. 70 cm beneath the surface. The layer extended further towards north, outside of the boundaries of the area and its remains were clearly visible at the end of excavation in the N-NW profile of the area. The location of these deposits, as well as the outline of the area affected by the development were recoded with a total station.

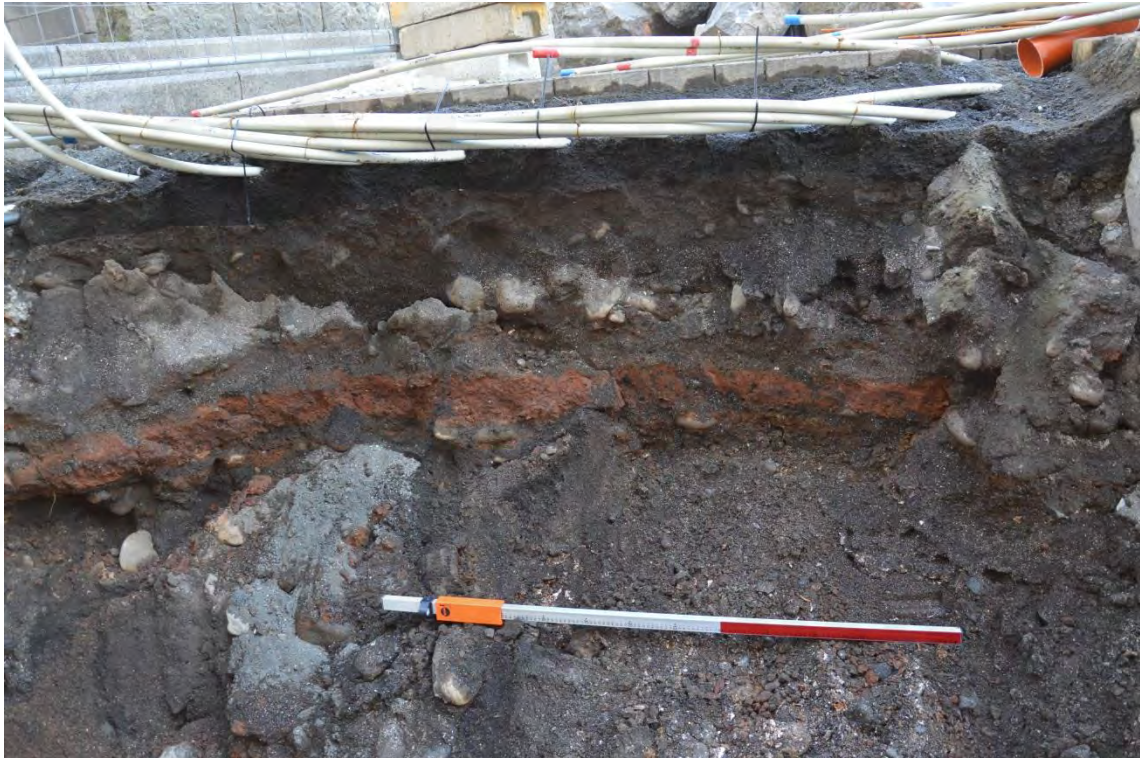
A single find – fragment of a clay-pipe was recovered from the layer during the machine-excavation. As an addition to this, it is noted that the peat-ash layer was partially covering remains of a deteriorated non-structural turf deposit.

Figure 3. Close-up of the peat-ash layer in the N-NW corner of the excavated area
