**FORNLEIFAEFTIRLIT VIÐ BYGGGARÐ Á SELTJARNARNESI.
FRAMKVÆMDARANNSSÓKN**

**DEVELOPMENT-RELATED MACHINE-EXCAVATION AT
BYGGGARÐUR, SELTJARNARNES
- REPORT ON ARCHAEOLOGICAL MONITORING -**

NIKOLA TRBOJEVIĆ

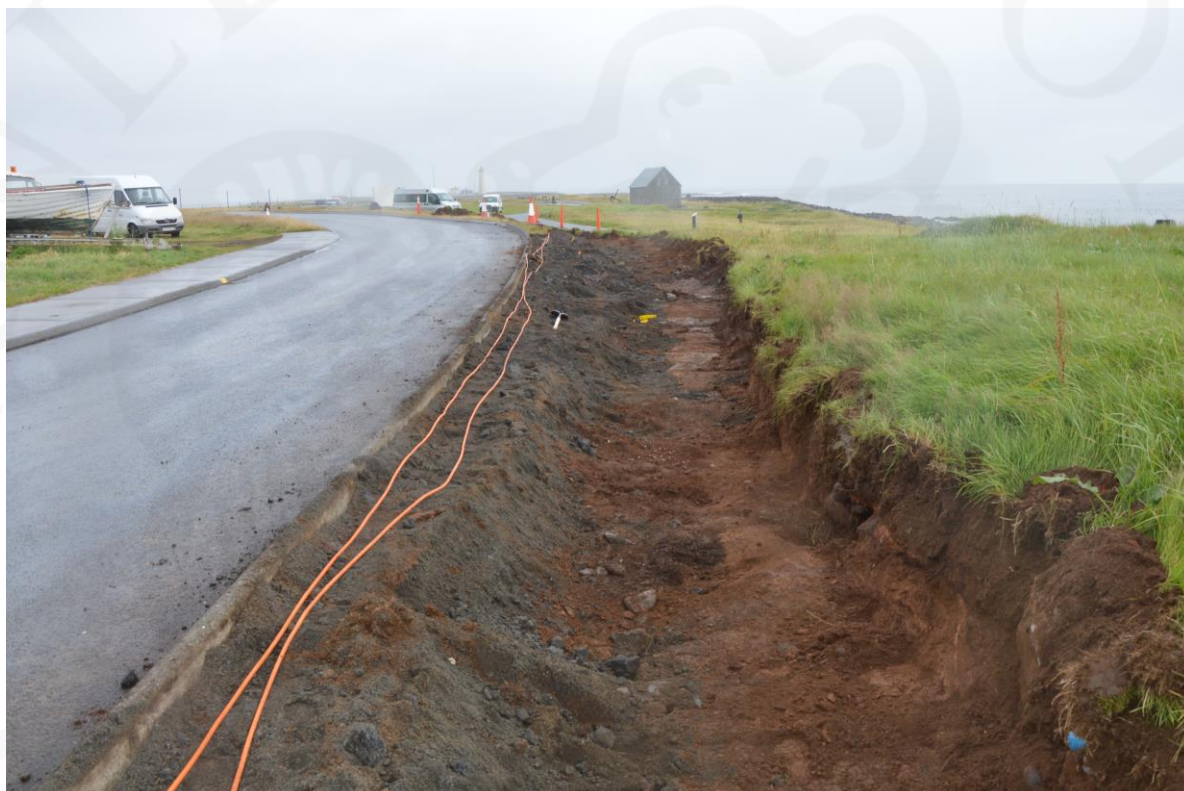
*Front-cover photo shows the excavation area after machine-excavation. Facing north-west.
Photo: Nikola Trbojević*

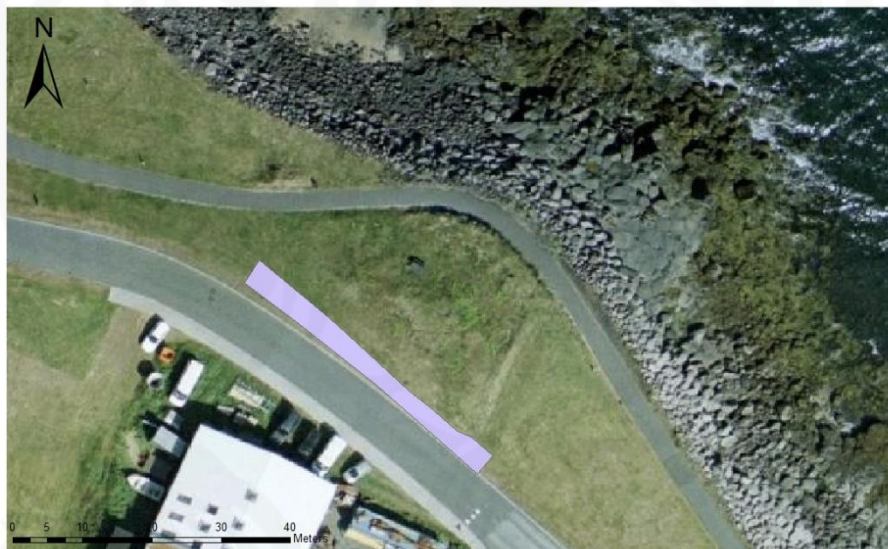
Figure 1. Location and extent of the excavation area (colored pink).

The extent of the excavated area subjected to monitoring was ca. 133 m² (Figure 1) and the area was excavated down to depth of ca. 0.45 m. The excavation revealed that a large proportion of the site was already truncated by an earlier development work when (gravel- and sand-made) foundations for the Norðurströnd street and infrastructural features (i.e. optical fibre-cables) were laid down.

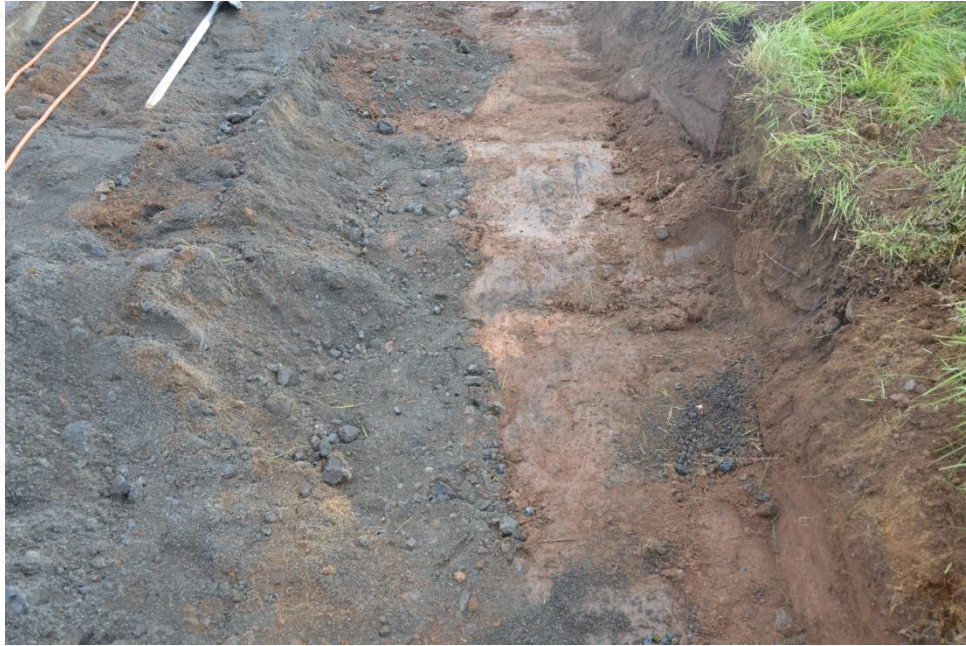
Figure 2. Excavation area. Facing north-west. The gravel to the left on the photo is in a modern truncation and the brown soil to the right is the archaeological deposit.

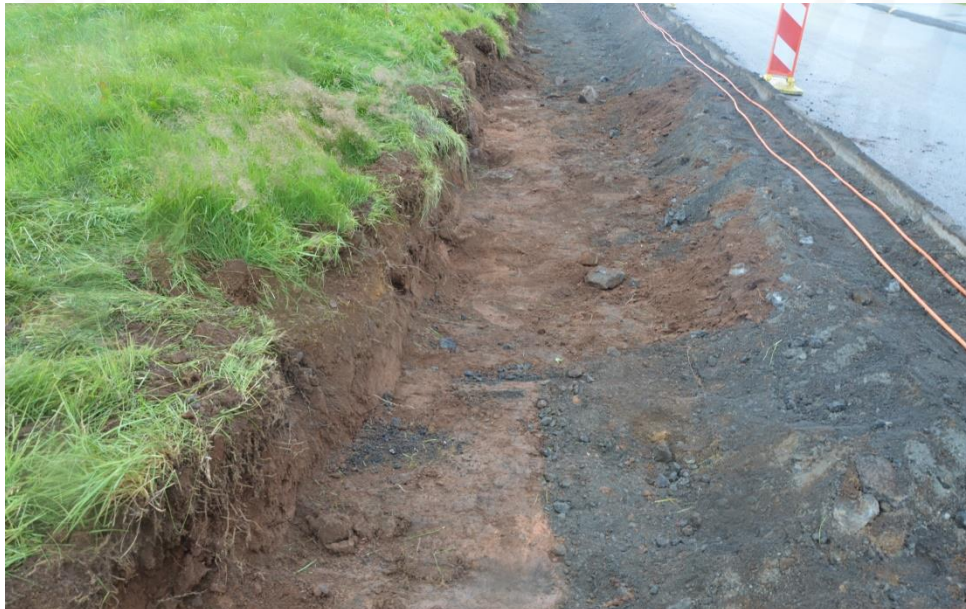
Figure 3. Excavation area. Facing south-east. Note truncation made by earlier development work.

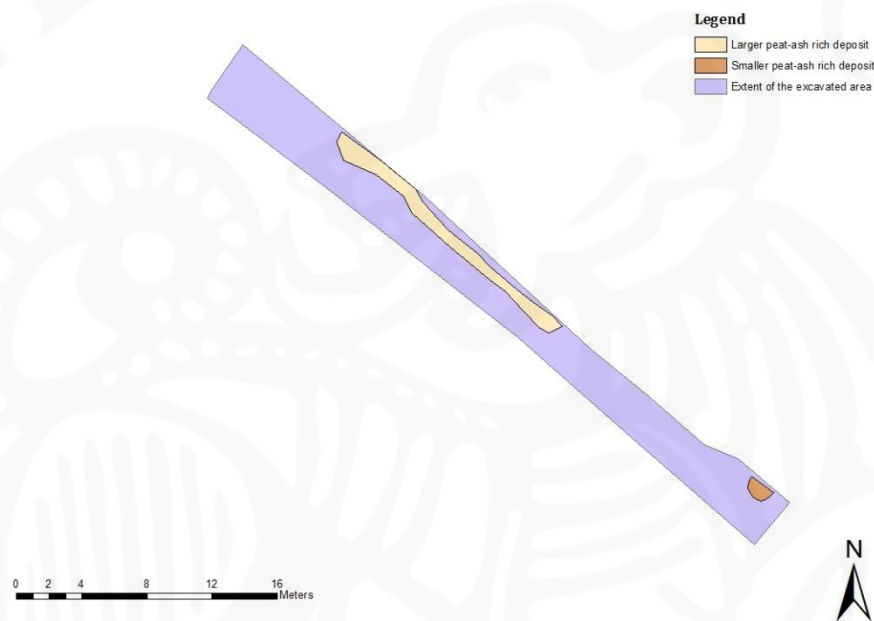
The larger deposit (Figures 4 & 5) was positioned in the central part of the excavated area. It was ca. 18 m long, between ca. 0.6 – 1.4 m wide and it covered an area of ca. 15 m². Most of the deposit was fairly uniform and it contained only occasional charcoal bits and decayed patches of turf-debris.

Figure 4. Extent of excavation area and two peat-ash rich deposits.

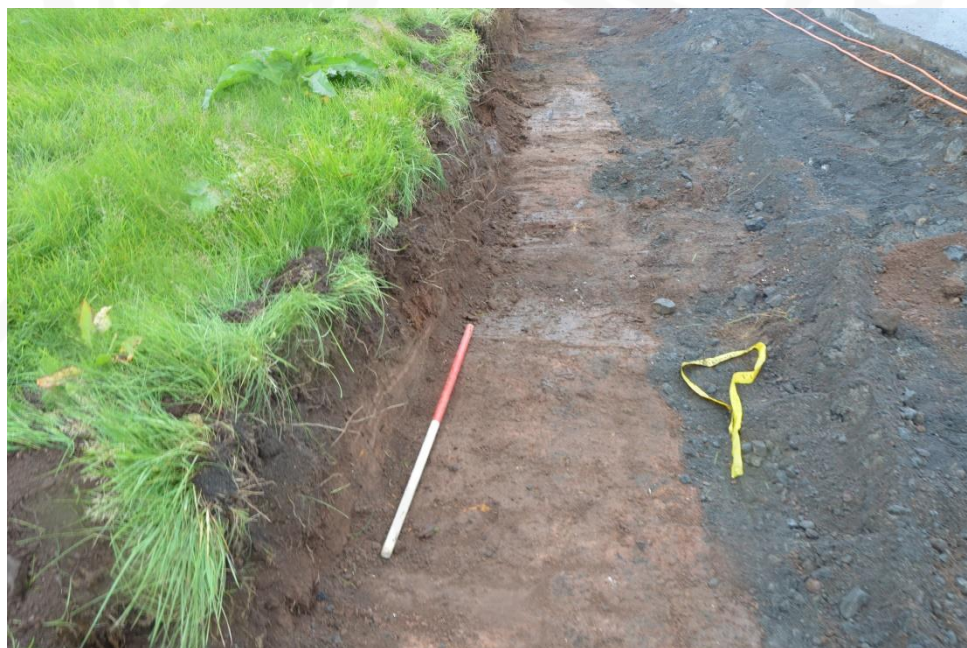
Figure 5. Part of larger peat-ash rich deposit. Facing south-east.

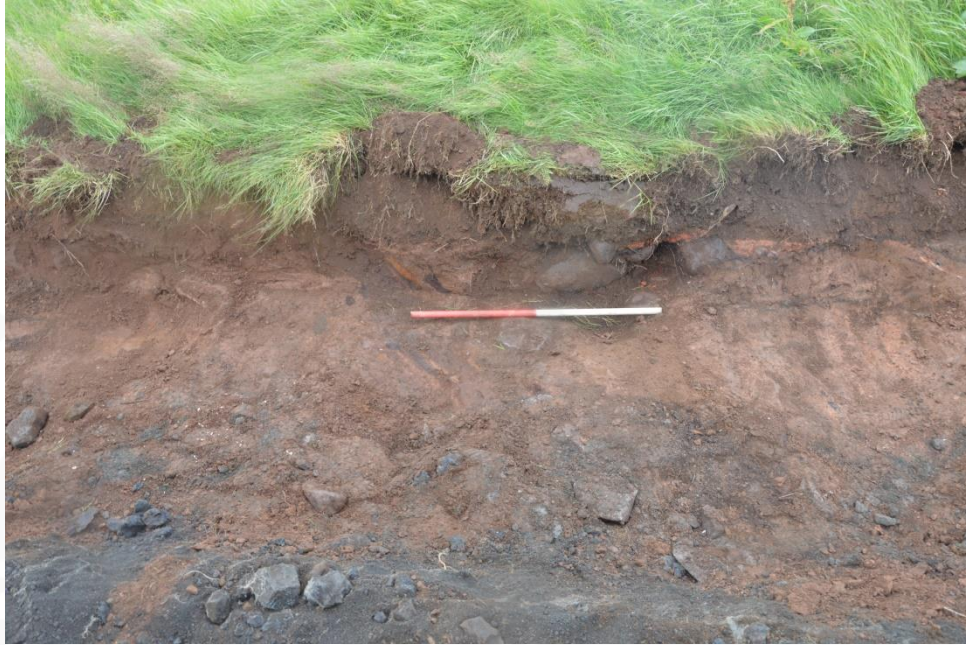
Still, somewhat higher concentration of turf-debris patches but also presence of collapsed material originating from a neighbouring farm mound was noted in its central part and in the profile of the excavated area at the side adjacent to farm mound (Figure 6).

Figure 6. Part of larger peat-ash deposit with higher concentration of turf debris and remains of material collapsed from the neighbouring farm mound. Facing north-east.

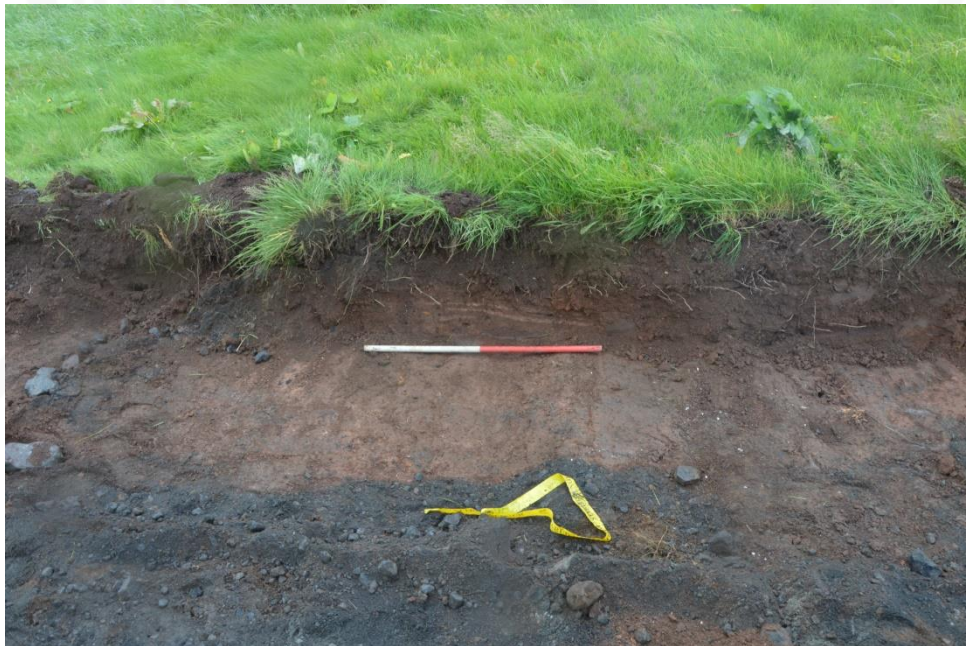
Clearance of the same profile of the excavated area further towards north-west also revealed that there may have been several phases of deposition of the peat-ash material in the past (Figure 7).

Figure 7. Part of larger peat-ash deposit. Note distinct phases of peat-ash deposition (profile). Facing north-east.

The machine-excavation and subsequent clearance of the site suggested that this layer extended over much larger area in the past. Unfortunately, it was truncated by the previously mentioned development work.

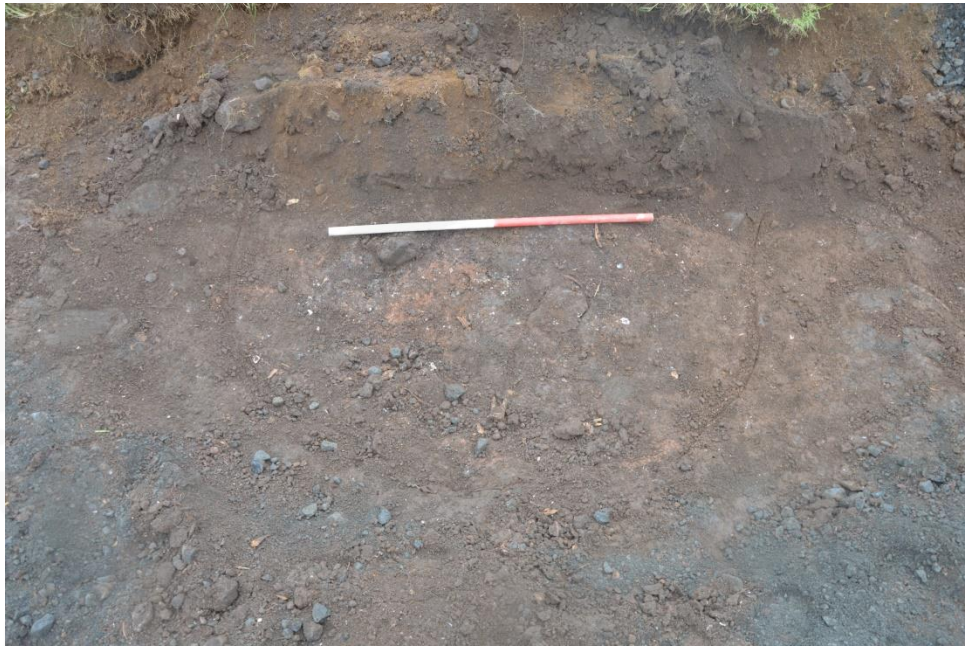
At the very south-east end of the excavated area another, minor peat-ash rich deposit was uncovered. Unlike the larger peat ash deposit that occupied the central part of the excavated area, this deposit contained remains of crushed shell and decayed animal/fish bones (Figure 8).

Figure 8. The smaller peat-ash rich deposit. Facing north-east.
