# ***The church in Gásir***

## ***Interim report on excavations in 2004 and 2006***

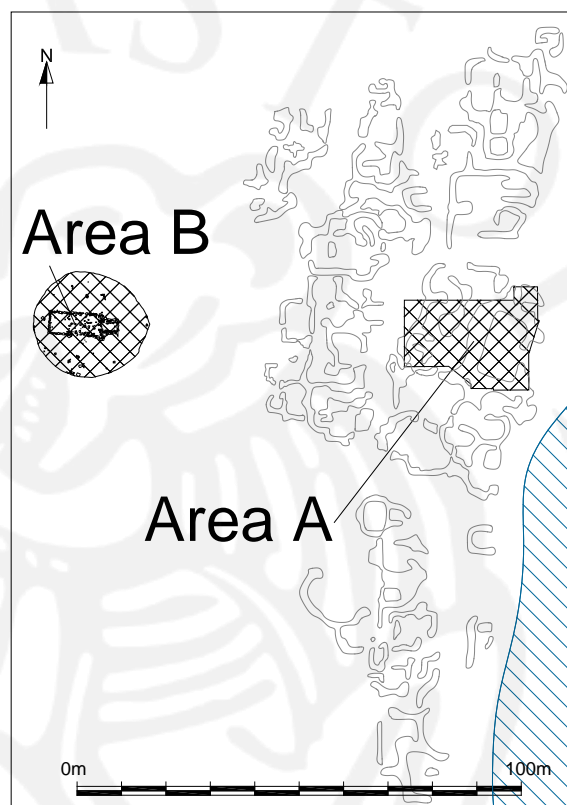
**Plan of Gásir showing the two main excavation areas.**

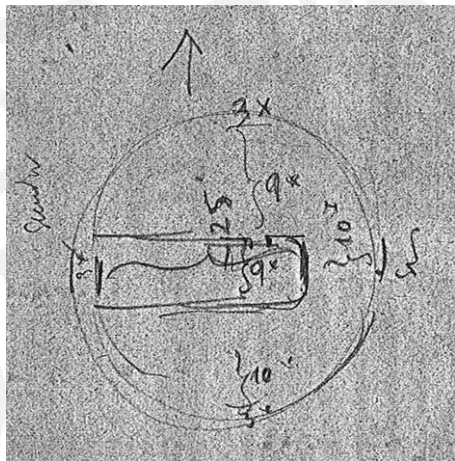
**Daniel Bruun's 1898 sketch of the church at Gásir.**

The sketch is annotated with measurements in ells and shows the church-ruin joined to the

western side of the churchyard, where a row of stones is also indicated. A gate on the eastern side of the churchyard is also shown. The length of the church given (25 ells = 15,7 m) accords well with the actual length of the excavated ruin but its joining to the church-ruin to the churchyard wall does not. This is something of a conundrum, especially as the joining of church and wall persists in all representations of the site down to and including the excavation of 1907. Considering that the

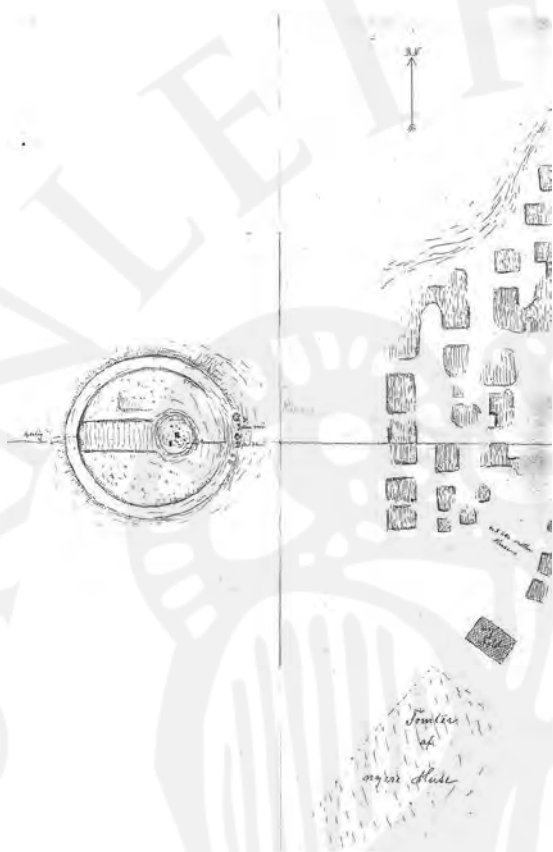
**Part of Froda's plan of the Gásir ruins from 1902.**

Another two years later, in 1902, Premierløjtnant F. Froda, appears on the scene, apparently on assignment from Daniel Bruun, among whose papers Froda's report is found. He produced the first map of the whole site (above), including church and churchyard, and wrote a description of what he saw. About the church he says:

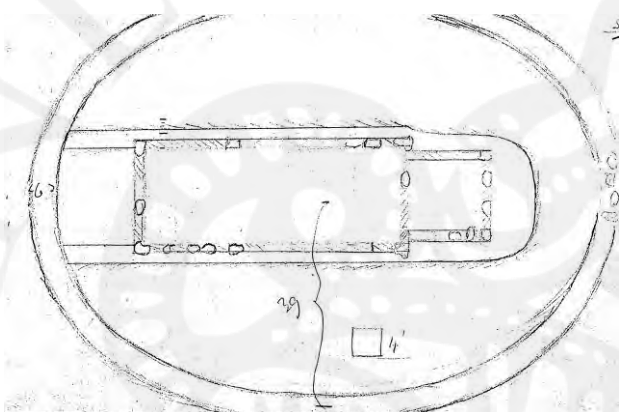
**Plan A. Unpublished sketch of the church in Bruun's archive.**

The published plan B shows a neat and continuous row of evenly sized stones in the foundations of the church, with the corner stones of the nave slightly exaggerated in size. On the other hand the unpublished plan A clearly only shows occasional stones, and although it does not jump out, the same stones are shown with less shading than the others on plan C. This does not make immediate sense. It is possible that these were the stones visible on the surface prior to the excavation, but the stones shown do not match well those which stand highest in the foundation. For instance the large boulder in the northern side of the chancel, the highest of all the stones in the foundation, is not indicated. It is also difficult to see why Bruun would have felt the need to highlight such stones on his published plan. The other possibility, that these were really the only stones exposed, is contradicted by the clear statement that the full length of the foundations was uncovered by the excavation.

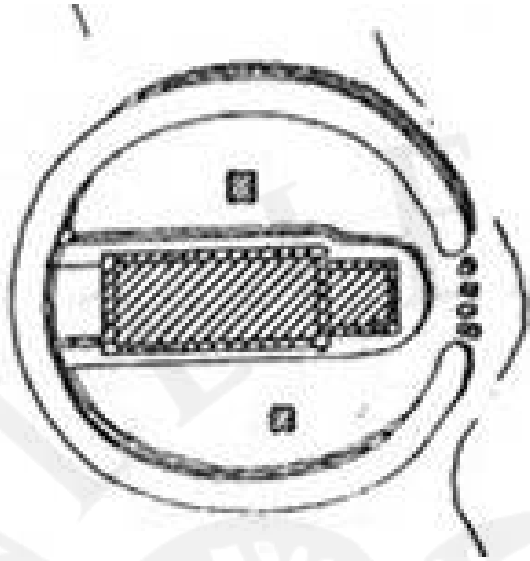
**Plan B. Detail from the general map of the whole site.**

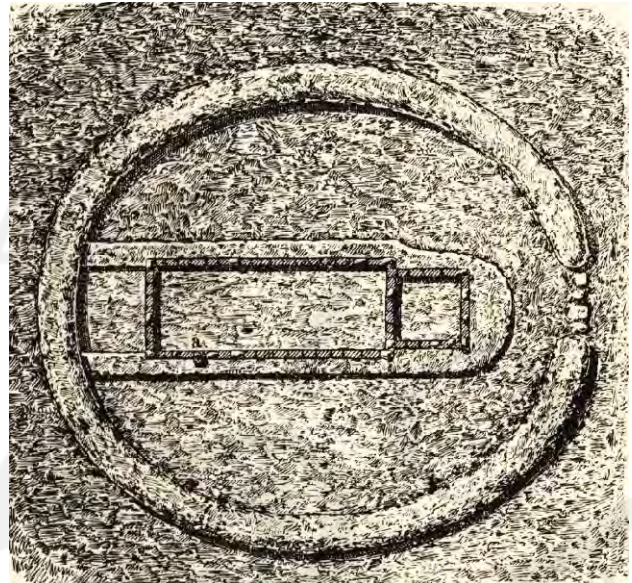
**Plan C. Larger scale map of the church and churchyard.**

of the south side, where they say a flat slab was found – and this is shown on plan C. There is in reality a large flat stone outside the row of foundation stones, but this is considerably further east than shown on the plan, at the junction of the nave and western extension. That location would be inherently unlikely for a door and Bruun may have been tempted to nudge it westwards on the plan to make it look more convincing – if it was not drawn in

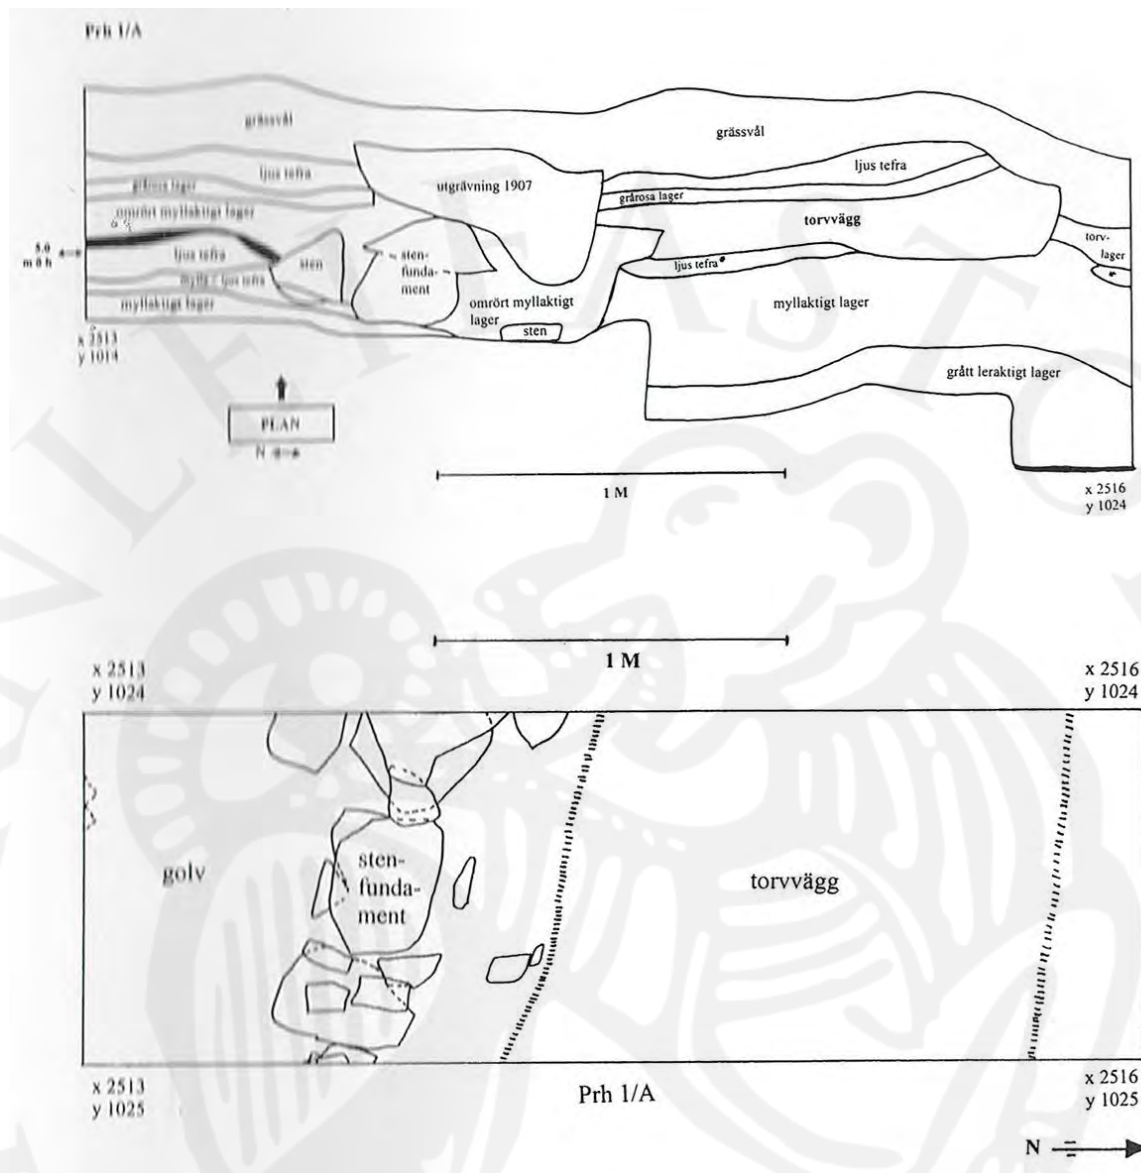
Section and plan of the 1986 trench.

The trench revealed a two course row of stones, the foundations for the church, and a layer interpreted as a floor on the inside and another interpreted as a turf-wall on the outside. Margrét concluded from this that the church at Gásir had been a turf-church in contrast to Finnur and Bruun's findings.<sup>18</sup>

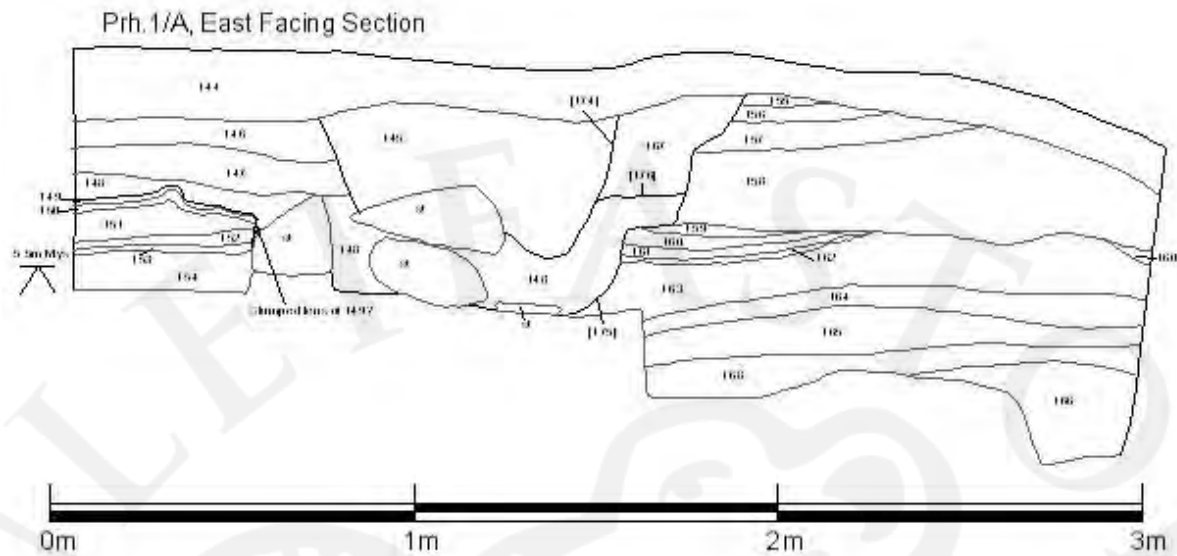
The 2001 drawing of the same section as shown above.

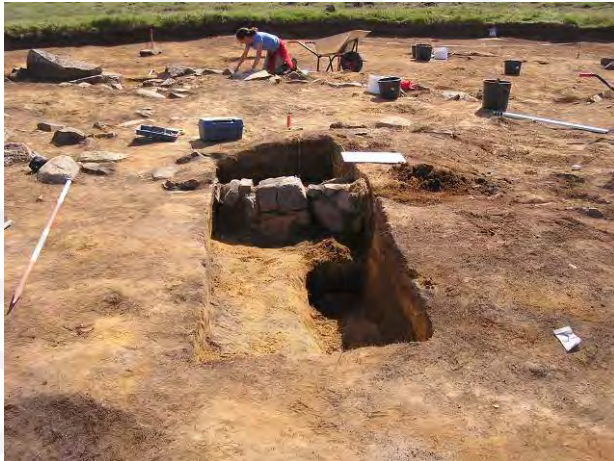
**The 1986 trench [5034], looking south.**

*Modern excavations.* The first objective of the excavation was to establish the extent of previous incursions into the site. The 1986 trench, reopened in 2001 [5034], was clearly

visible on the surface in 2004 and this was easily emptied out as it had been backfilled with sand imported to the site [5033]. This had been emptied out and re-backfilled in 2001. Earlier incursions proved to be less clear cut. It was expected that traces of the 1907 excavation would appear once the top-soil had been removed, but these proved more elusive than had been anticipated. The 1907 cut was clearly visible in the 1986 trench [5034] but in plan this turned out to

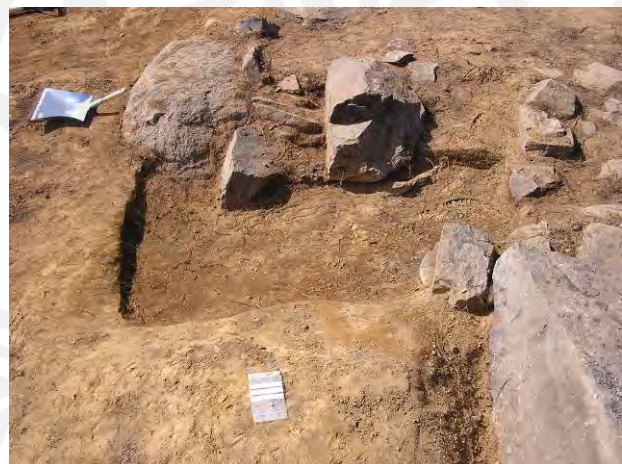
**Bruun's trench [5037] on the south side of the chancel, looking west.**

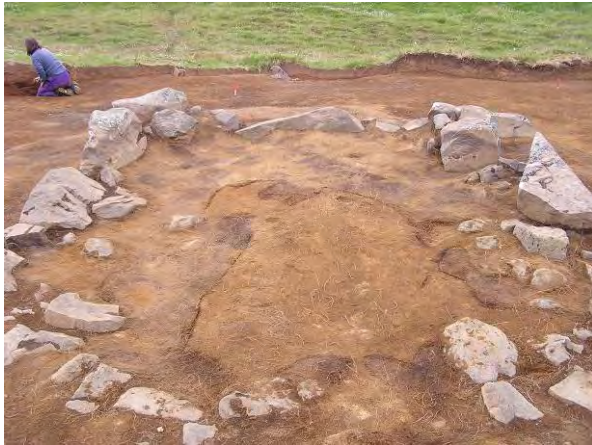
**Fill [5071] covering modern trenches [5072] in the chancel, looking east.**

very irregular cut [5071/72]. It is a discontinuous trench which follows the insides of the walls of the chancel, including the partition between the chancel and nave. There are separate sondages adjacent to the insides of the stones in the eastern gable, but the trench parallel to the north-side is set some 0,3 m inside the foundations. The trenches are dug to the base of the foundation stones or to where progress was blocked by smaller stones and it is not apparent that any structural remains were removed by these excavations. In the easternmost part of the chancel there are additional irregular spade marks and the main trench is decidedly more uneven there than further west. It is possible that these trenches, all or in part, are from the yet earlier excavations in the chancel reported by Brynjúlfur Jónsson and Froda in 1900 and 1902 respectively. While more irregular than the trenches outside the chancel these trenches are however very much in Bruun's style.<sup>22</sup> His main concern was to establish wall-lines and he would dig around stones rather than remove them. The possibility that these trenches are a mix of both earlier and the 1907 excavation cannot be ruled out.

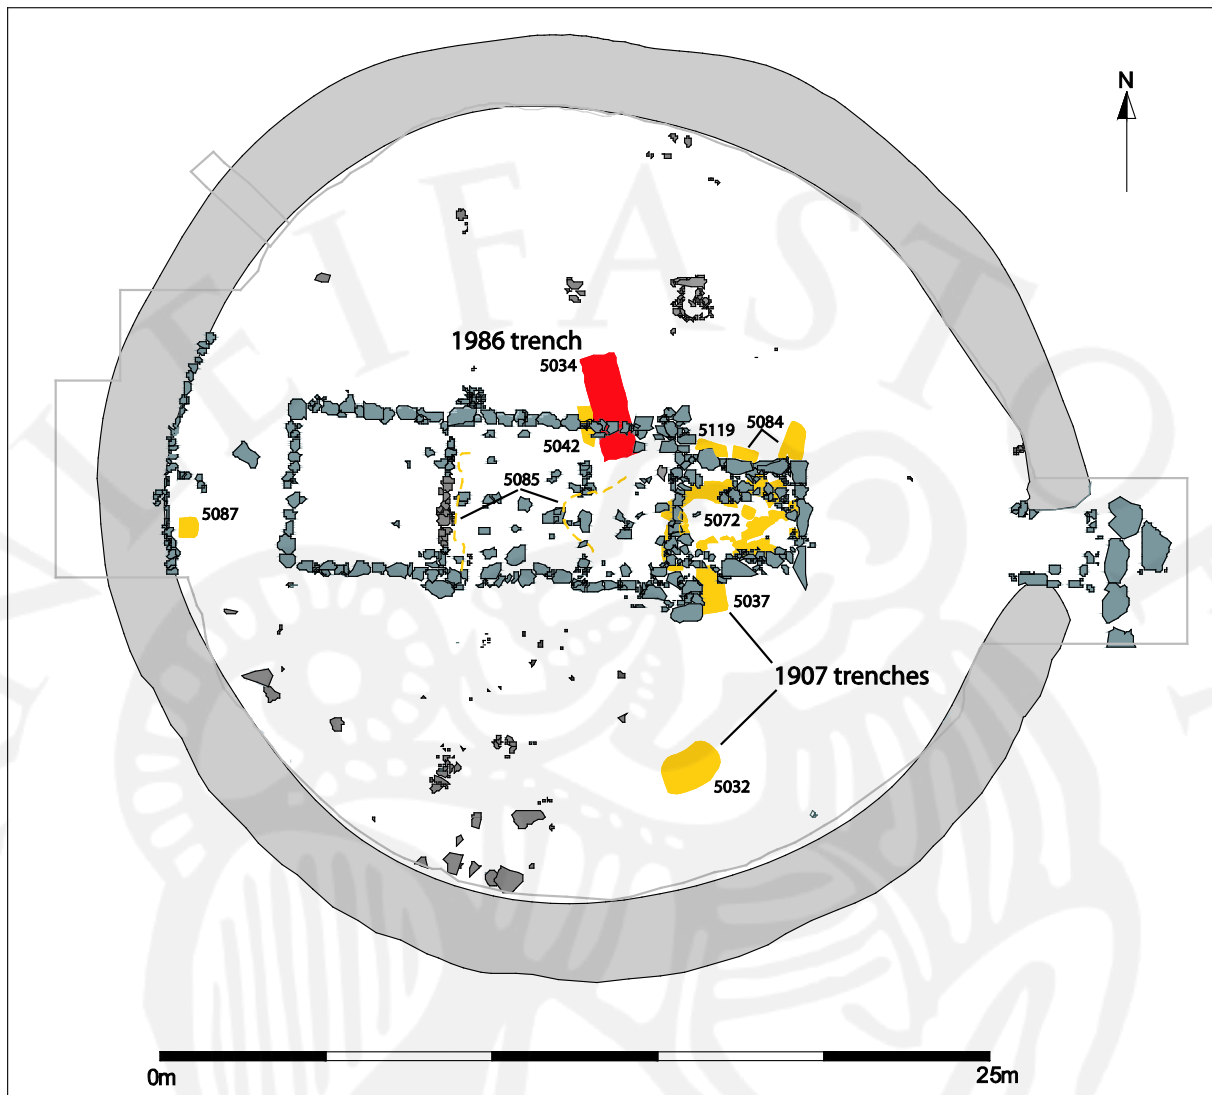
#### Features associated with 20th century excavations.

Outside the church Bruun has clearly dug at least two pits. There is a large and deep pit [5031/32] on the south side of the church, more than 70 cm deep and 1,7x1 m in size. From its position and unusual depth, considering Bruun's other trenches, it seems that this one may have been dug because indications of an underlying structure had been visible on the surface. That would then have been a structure paralleling the buttress foundation [5219/5223] on the northern side of the church. If this is true Bruun's excavation has removed all traces of the more southerly buttress foundation. Finally there is a small trench [5086/5087], some 0,4 m deep, dug against the inside of the churchyard enclosure, at the

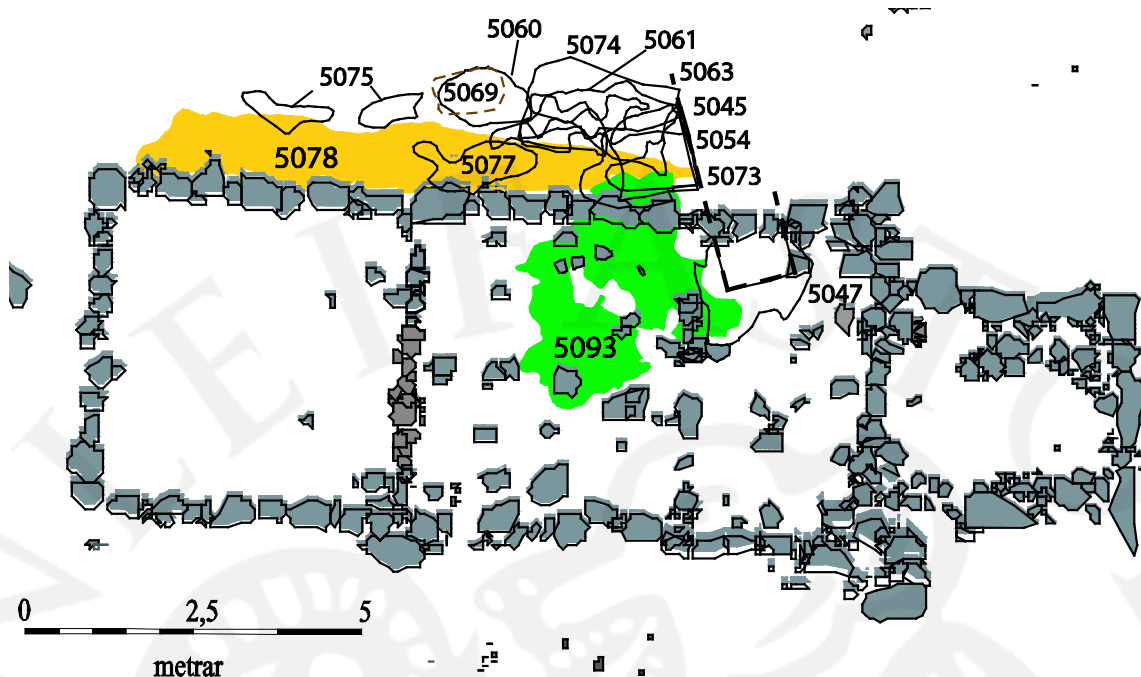
#### **Deposits post-dating the church.**

*Deposits post-dating the church.* Adjacent to the northern wall of the church there was a series of deposits overlying a layer of turf-debris [5093] which spread over the stones in the foundation. At the top of this sequence there was a layer of gravel and turf debris [5045 and 5047], truncated both by Bruun's trench [5042] and the 1986 trench [5034]. This layer had a roughly N-S orientation, 3,5 m long, extending more than 1 m north and south of the foundation, and therefore clearly not shaped by it at all. Nearly 2 m further west, outside the wall there was a shallow sub-rectangular pit [5069] with a fill of grey ash and silt [5068], partly obscured by heavy bioturbation [5060] – reminiscent of the ash pit [5035/5040/5220] discussed below. West of this pit there were two small patches of identical turf debris [5075]. The gravel layer capped a series of silt deposits with some turf debris and up-cast (H3 and H4) [5054, 5061, 5063 (with animal bone 5022), 5073, 5074, and 5077]. All of these had accumulated in an area little more than 3x3 m north of the wall, and some of them were cut by the 1907 and 1986 trenches. It is these mixed turf debris layers, esp. [5054] and [5073], which appeared as a possible turf wall in the 1986 trench, but their limited extent clearly shows that they are only small spreads of debris, probably a dump created in the aftermath of the church's demolition. Below these layers was a much more widespread deposit of silt and turf debris [5078] (with animal bone (5026) and slag (5027)), which runs alongside nearly three quarters of the length of the northern foundation, washing up against its stones, but caps the aforementioned layer [5093] which overlies the foundation stones at the middle of the

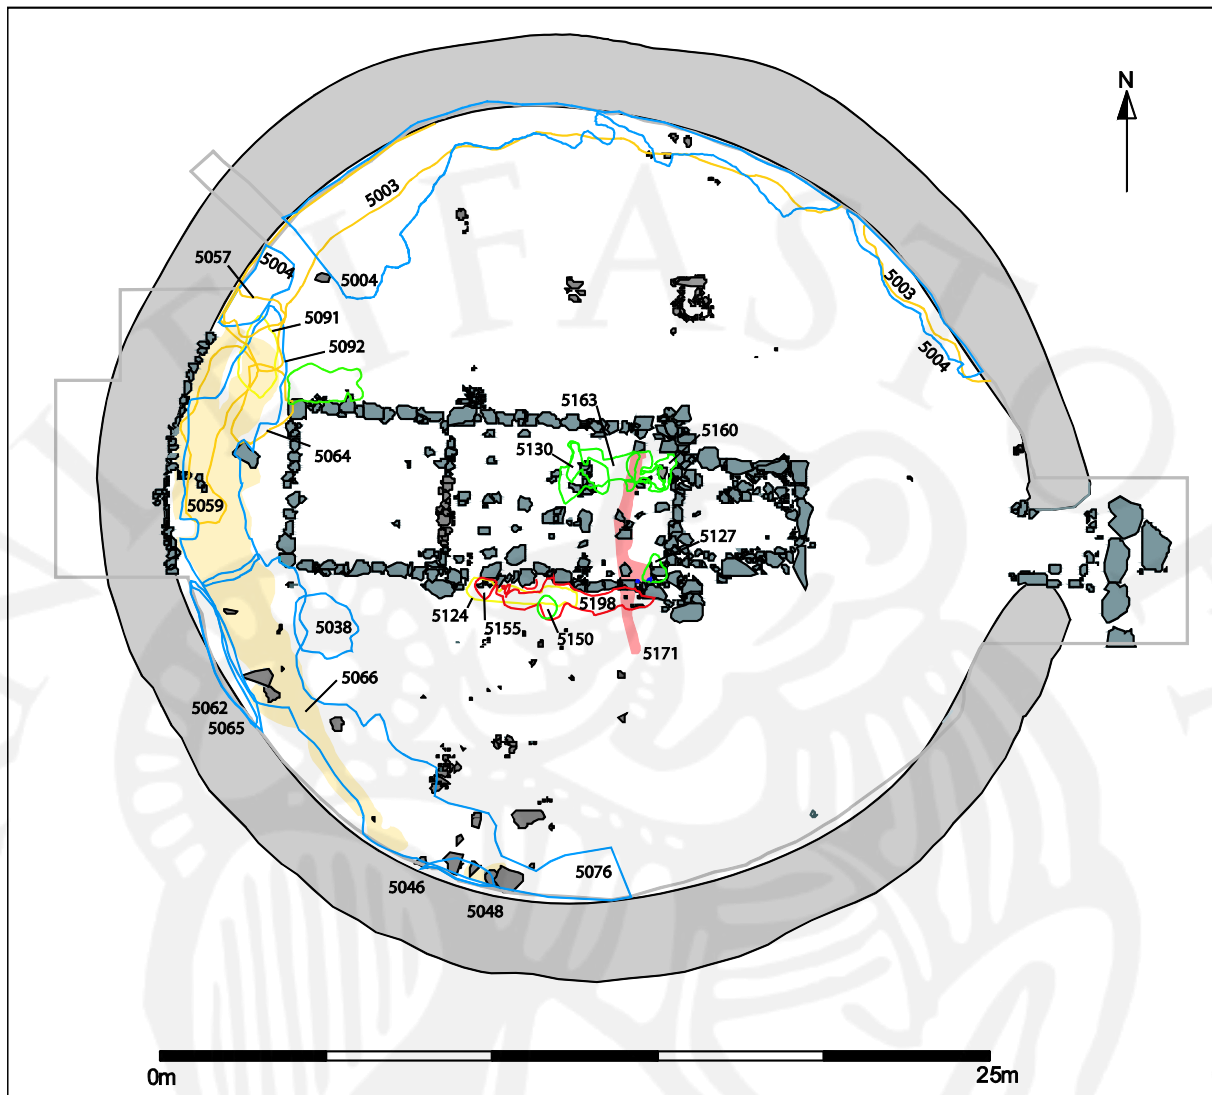
#### Deposits post-dating the H-1300 tephra.

*Post-1300 deposits.* In the western half of the churchyard, accumulated against the inside of the enclosure wall, there is a series of deposits overlying the H-1300 tephra. At the top of this sequence there are two mixed layers with some ash and charcoal, [5057] and [5059], to the west and northwest of the church and two layers of turf collapse from the churchyard enclosure, [5046] and [5062] to the south and southwest of the church. These last two relate to the slumping of the turf-wall, no doubt a long-term process which may have continued long after activity ceased in the churchyard. Also at the top of the sequence there is a dump of turf-debris [5038] outside the southwest corner of the church, possibly of the same origin as the dump on the northern side discussed above.

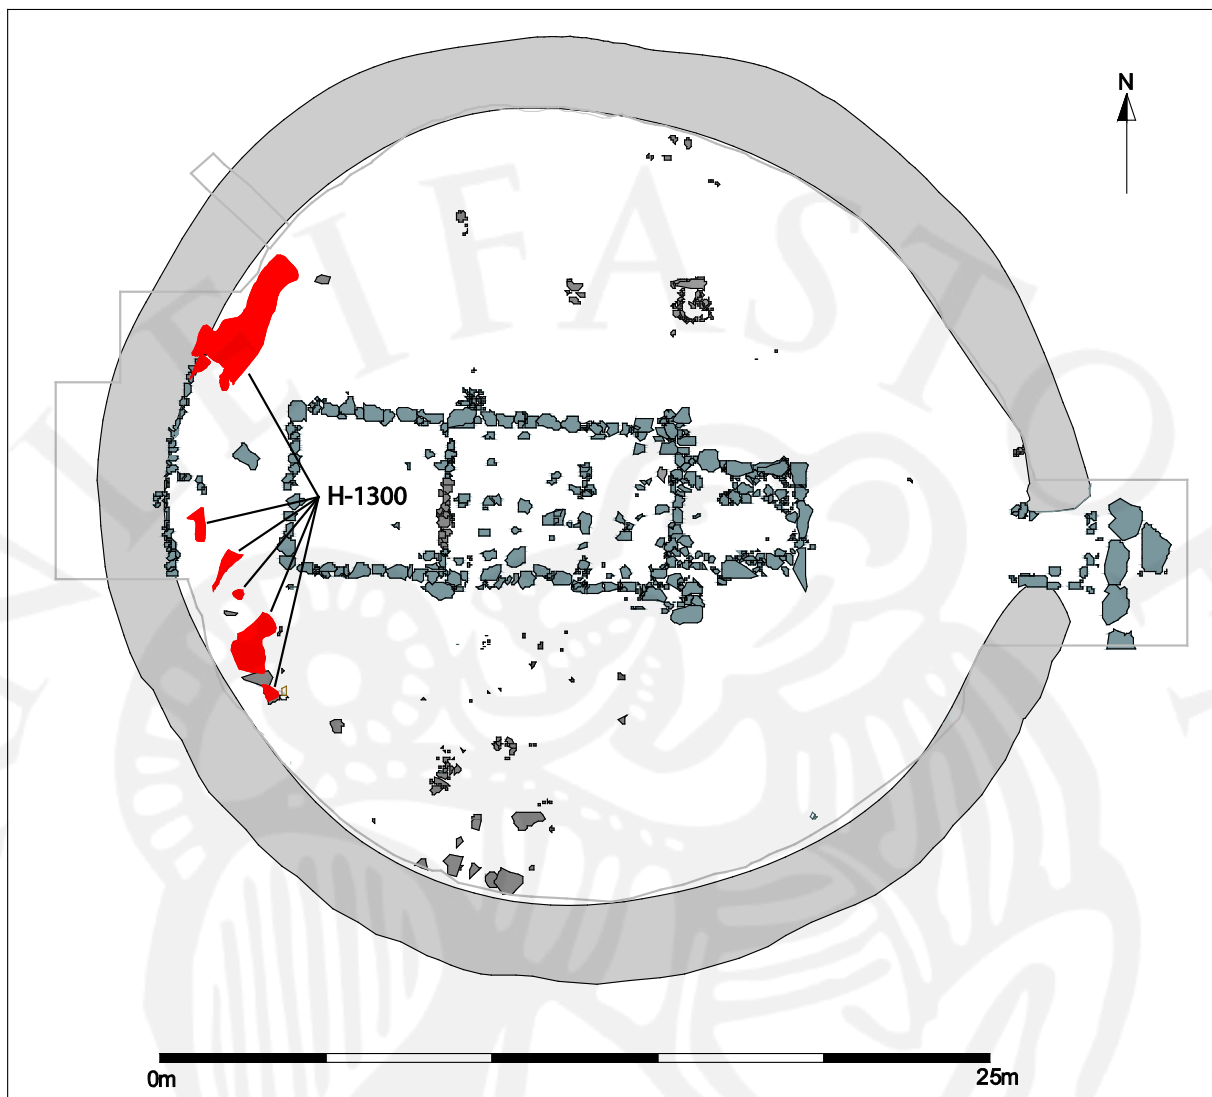
#### **Distribution of H-1300 in situ.**

*Pre-1300 deposits.* The H-1300 tephra [5123] survived in several flecks, large and small, in the western side of the churchyard, where it had accumulated against the enclosure wall (maximum thickness in excess of 0,5 cm), but it owes its preservation no doubt largely to the fact that it quickly became sealed under turf collapse [5076/5092]. The tephra seals two

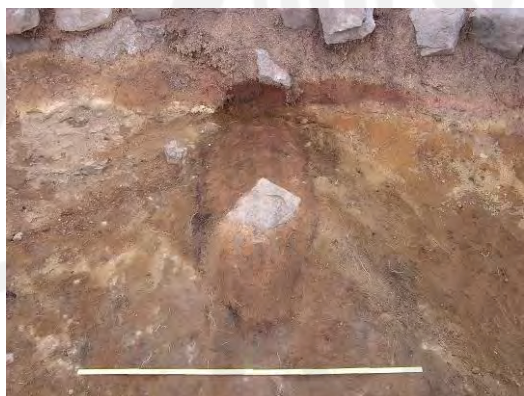
**Pit hearth [5169/5170] looking west.**

[5169/5170] dug up against the churchyard enclosure due west of the church, and shallow near-rectangular cut [5196] with fill [5195] similar to the mixed layer above. Cut [5196] is suspiciously similar in size to a large stone with a flat top which sits askew just north of the cut. It seems likely that this stone originally sat in the cut (which can be regarded as an extension of the foundation trench of the third phase church), but its function is not immediately apparent. It could have been a step to enter the church, a necessity if there was a horizontal beam on top of the foundation stones, but a 0,4 m gap

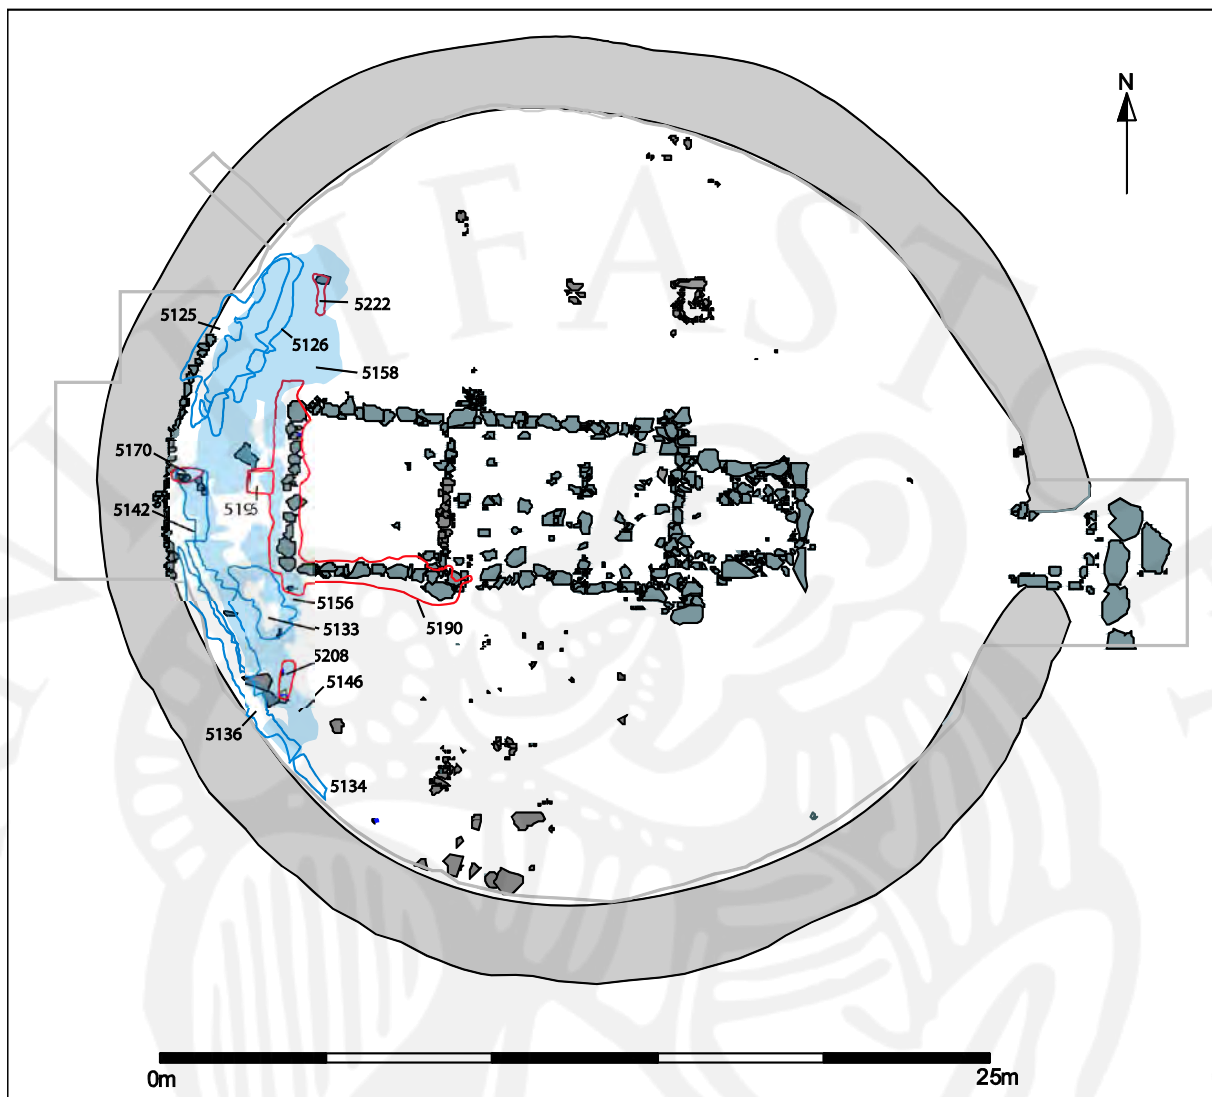
#### Deposits pre-dating the H-1300 tephra.

layers of mixed aeolian and turf debris; [5125] up against the enclosure northwest of the church and [5133] by the southwest corner of the church. It also seals a layer of turf collapse from the enclosure wall [5142] (with slag (5112), probably intrusive) to the west and southwest of the church. This layer was also capped by later turf collapse layer [5134/5136]. [5125] was above another similar mixed layer (5158)) which, along with [5133] and [5142], seals a widespread mixed layer with turf debris and up-cast west of the church. It is discontinuous and was recorded as three separate contexts [5146] (with animal bone 5119)), [5156] and [5158] (with animal bone (5125)) but can safely be regarded as a single stratigraphic event. This widespread layer seals the fill [5190] (with animal bone (5148)) of the foundation trench on the west side of the western extension as well as the buttress foundations [5207] and [5221], showing not only that the westernmost extension of the church dates to before 1300 but also that the buttresses supporting its northwest and southwest corner had come and (possibly) gone before 1300 (see further below). [5146/5156/5158] is also effectively the earliest layer in the sequence west of the church. The only features below it are a pit hearth

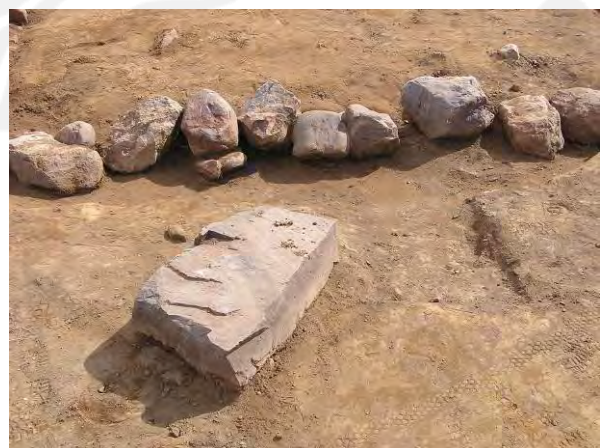
The large stone besides the cut [5196], looking east.

between the cut and the western extension's foundation may cast doubt on that explanation. Another, only marginally more plausible, is that the stone was a weight for a tether, possibly a chain, to keep the church in place, the removal of which would have entailed shifting the stone from its original location. Whatever its function it is clear that the stone was moved at an early stage and that all the subsequent deposits west of the church accumulated against it in its dislocated position. That in itself speaks against the main entrance into the church being on its western gable.

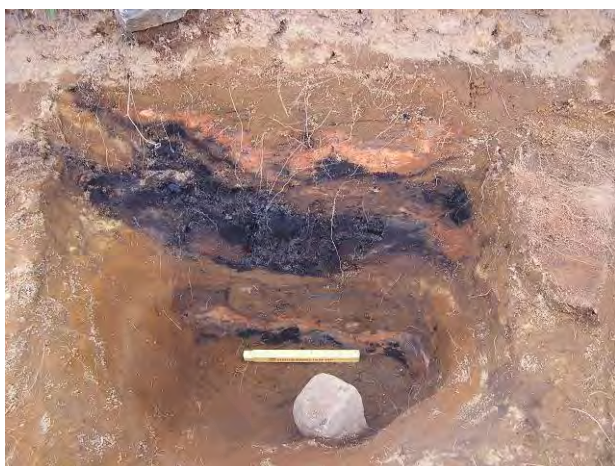
**Series of fills of charcoal and peatash in pit hearth 5200/5201. Looking south.**

A small blob of turf collapse [5151] separates [5076] from yet another, similar turf collapse layer [5167] which is spread along the inside of the enclosure wall in the southeast quadrant, stretching all the way to the entrance on the east side. It included a stone manuport (5126), a possible iron buckle (5130), a ceramic sherd (5133), a whetstone (5134), some charred wood (5132) and animal bone (5128). There were two deposits of burnt turf collapse on top of this layer, layers [5143] and [5161], the former unusually rich in finds, with an iron nail (5113), a piece of worked wood (5114), an iron rivet (5117) and animal bone (5115, 5116). [5167] seals a pit hearth [5200/5201] (with animal bone 5139)) dug up against the

enclosure wall, and is above sandy silt layer [5194] which is at the bottom of the sequence of deposits associated with the entrance to the churchyard (see below). Most of the finds in [5167] were found in a relatively small area which included the pit-hearth [5200/5201] and the upper deposit [5143], suggesting that some relate to the hearth (including the ceramic sherd) and other to a later midden deposit.

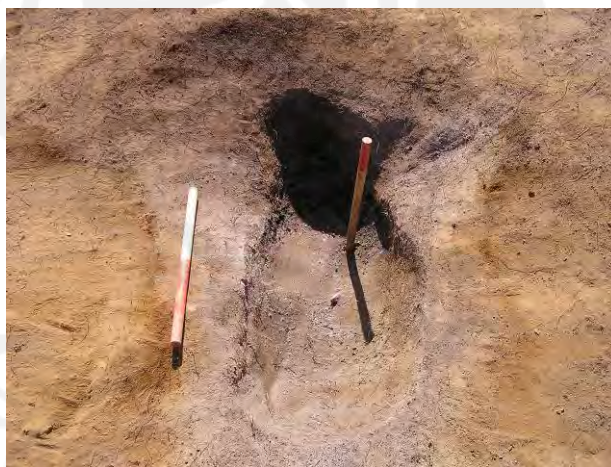
**Complex pit group [5041] looking south.**

Complex pit (group [5041]) north of the church with mixed fill [5035] of sand and ash with textile (5038), charred wood (5011) and animal bone (5012), re-cut [5040] into earlier fill [5220], also a mix of sand and ash with frequent charcoal with textile (5147). The sandy matrix of the fills in this pit is similar to the pit [5068/5069] described above.

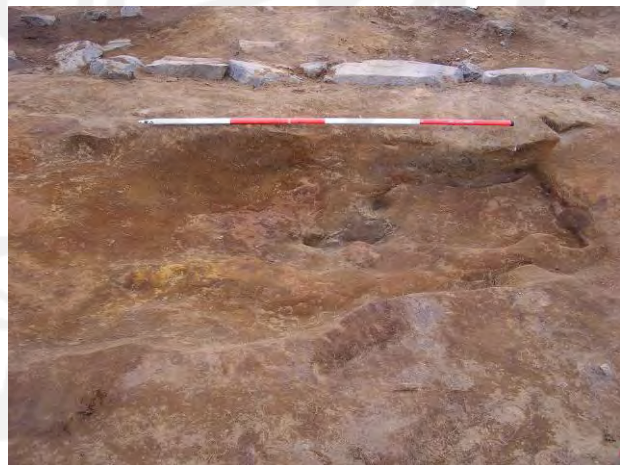
**Pit [5070], looking south. Note the yellowish stains to the left. Possibly sulphur.**

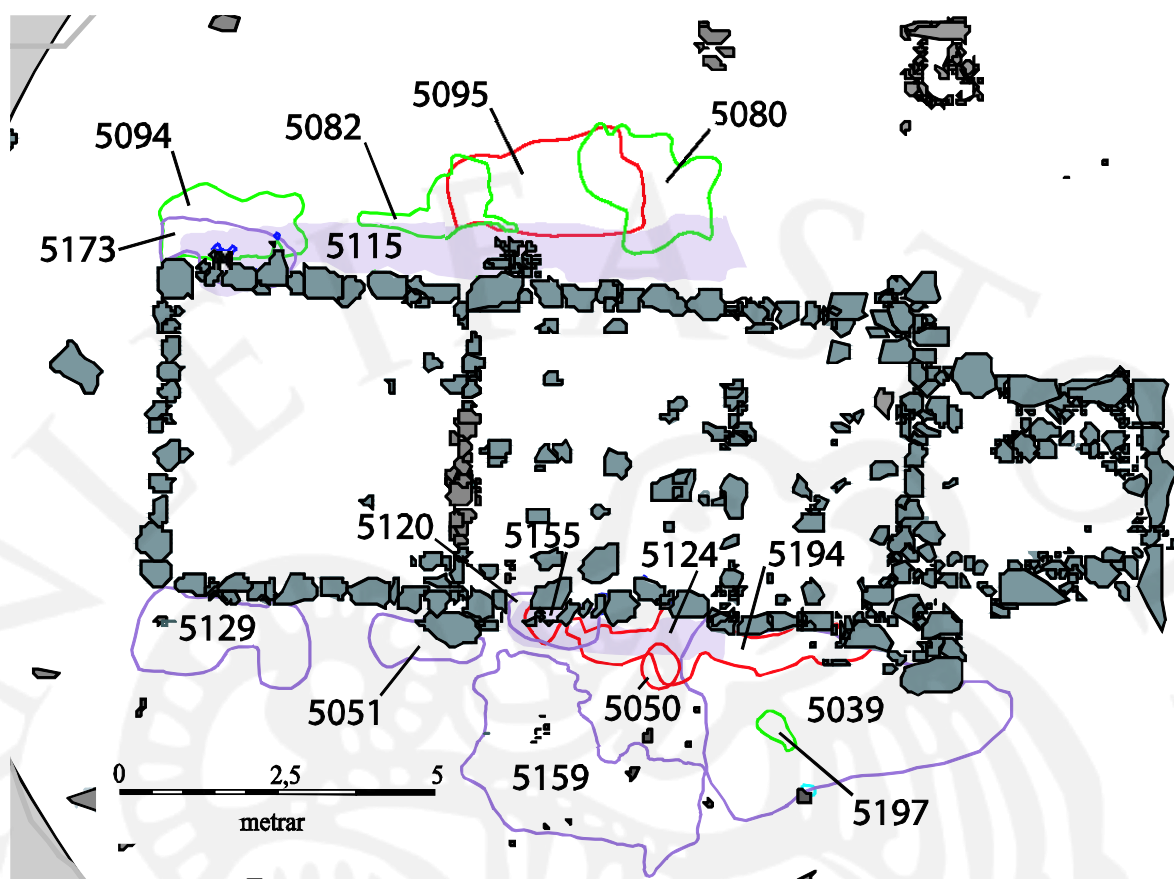
**Deposits and features on either side of the church, coterminous with it.**

*Contexts on the northern and southern sides of the church.* On the northern side of the church, below the sequence of deposits post-dating the church and described above, there are three separate but similar layers of sandy silt with some turf debris, gravel and occasional charcoal [5080], [5082] and [5094]. The first two are on top of a fill [5070] of a large sub-rectangular pit [5095], measuring 3x1,5 m. This fill was very heterogeneous and seems partly to have accumulated in situ, and partly to have been dumped into the pit and mixed with pre-existing material. It is a blend of turf chunks, sandy silt, gravel, ash (both from peat and wood), fire cracked stones and charcoal and had some animal bone (5024), a wooden object (5030) and some textile remains (5031). In addition there was yellowish staining reminiscent of sulphur deposits seen in area A. Confirmation of this identification is awaited. This pit was cut mainly into natural but it post-dates a layer of sandy silt with some turf debris [5115] which has

accumulated against the foundation stones, stretching from the north-western corner of the church to the middle of the nave where its eastern end was cut by the 1986 trench. This layer respects the stones in the foundations except immediately east of the northwest corner. There it seals another layer [5173] of more definite turf debris which fills a gap in the wall-line, 1,5

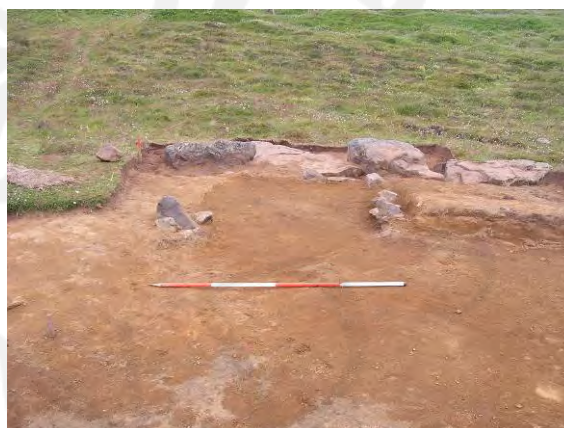
**The churchyard entrance after excavation, looking east.**

*Contexts in the entrance to the churchyard.* The entrance to the churchyard is on the eastern side and there the area of excavation was extended outside the enclosure to include the large boulders which have been arranged as steps up into the churchyard. In the entrance itself, an area some 2,5x2,25 m in size, there were a number of deposits, apparently relating mainly to the final and abandonment phases of the site.

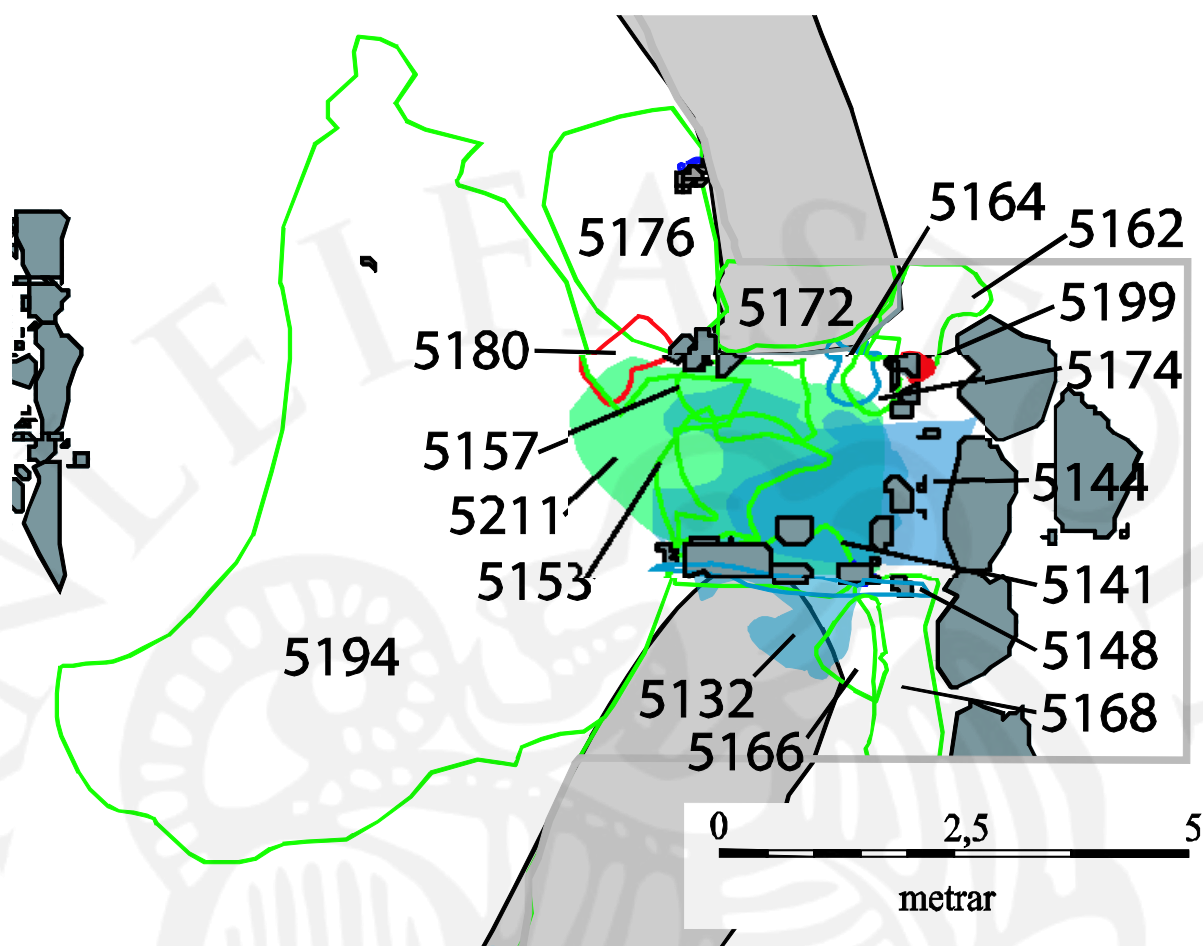
#### **Deposits and features in the entrance to the churchyard.**

[5166] with animal bone (5124), has accumulated against the north-eastern corner of the southern enclosure wall, below [5132] but above burnt turf [5168] in the same location. Further north in the entrance the turf debris layer [5144] is above aeolian spreads [5153] (with animal bone (5121) and an iron pin (5122)) and [5157], the latter extending to the northern side of the opening. At the south-eastern corner of the northern entrance wall there is an isolated sequence with humic silt [5162] (with an iron nail (5123)) accumulated against the remains of the wall [5172] (with animal bone (5127) and capping a small patch of turf debris [5164], which in turn is above a small spread of aeolian [5174] and a post-hole [5199] with remains of a wooden post [5191]. This post-hole is the only structural feature in the entrance, other than the turf walls and stones that is, and could be a gate post. There is no hint of a parallel hole on the southern side of the entrance, but a concentration of stones at the south-western corner of the northern entrance wall may represent a post-pad. There is another similar concentration of stones 1,8 m further north along the inside of the enclosure wall..

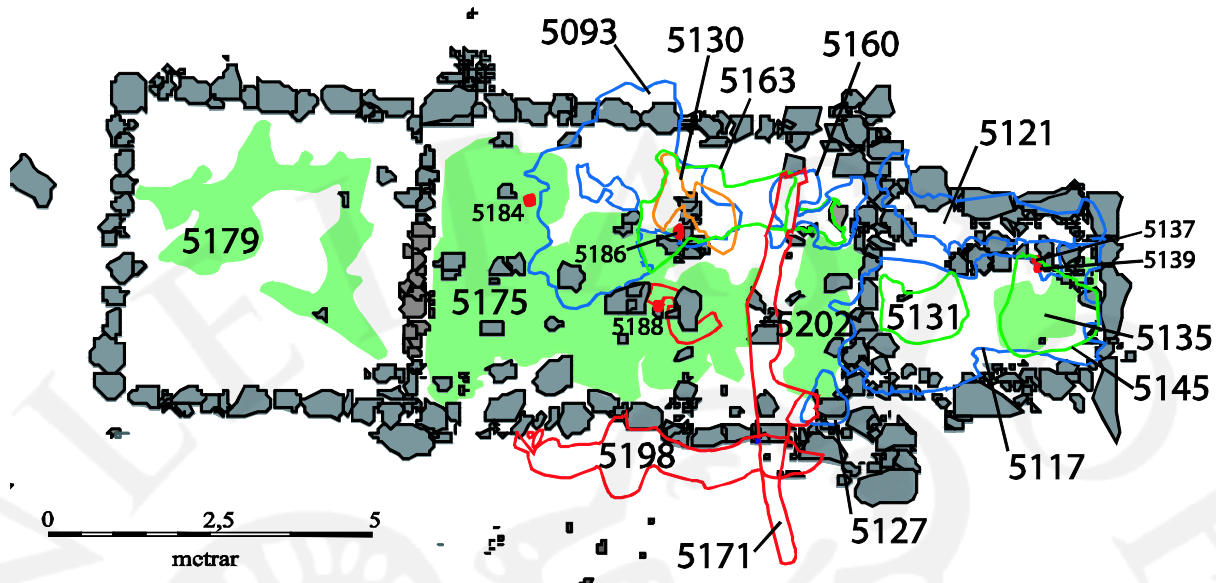
#### Deposits and features inside the church

In the western extension only a single surface layer remained. [5179] is a layer of sandy silt with some turf debris and gravel, 1-5 cm thick. It covers about a quarter of the surface of the western extension and has accumulated on top of a very thin spread of mixed up-cast and turf debris with some ash and occasional charcoal. This latter layer was not removed as it clearly sat on top of natural, but it was spread more evenly over the floor area of the western extension. The lower layer could be associated with the construction of the western extension

In the nave the post-abandonment layer [5093] had accumulated on top of mixed silt deposit [5130], with some gravel and occasional charcoal, which was on top of a pile of up-cast [5163], which also partly covered by a patch of turf debris [5160] in the very north-eastern corner of the nave. In the south-eastern corner of the nave there was a small patch of turf debris [5127] identical to [5117] in the chancel. All these layers may belong to dilapidation and/or post-abandonment phases of the church. They are all later than the fill [5152] of a ditch [5171] which runs north-south from the northeast corner of the nave through

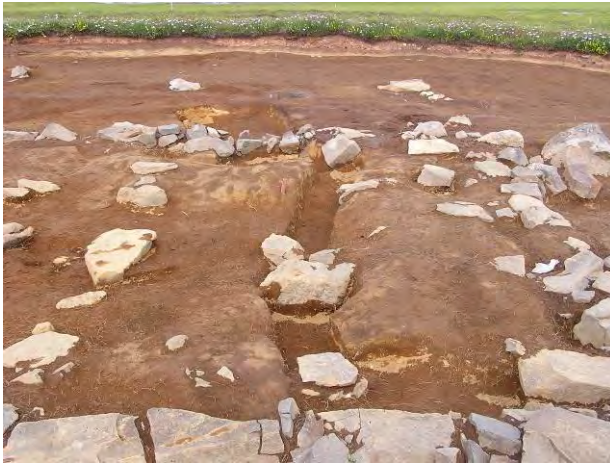
**Ditch [5171] inside the church, looking north.**

the southern foundation and ends 2 m south of the church. It is 1,5 m west of the partition between chancel and nave and describes a wide arc. In all it is 6,2 m long, mostly some 0,4 m wide and has a 0.7 m long eastwards extension under the easternmost section of the foundation in the south side of the nave. It is carefully dug, some 0,2 m deep, with vertical sides and a flat base. The fill [5152] is up-cast and the ditch seems to have been backfilled in one

The purpose of the ditch [5171] is far from clear. It does not have any obvious structural function and can hardly have been a drain – its sides are too freshly cut and the backfill clearly a single event deposit. It should probably be seen as evidence for repairs, possibly related to the same problem as is evident with the southern foundation of the nave. It is clear that the stones in the foundation of the south side must have been reset after the ditch was backfilled. The ditch therefore belongs to the last phase of the church but was clearly dug and backfilled and the foundation reset some time before its demolition.

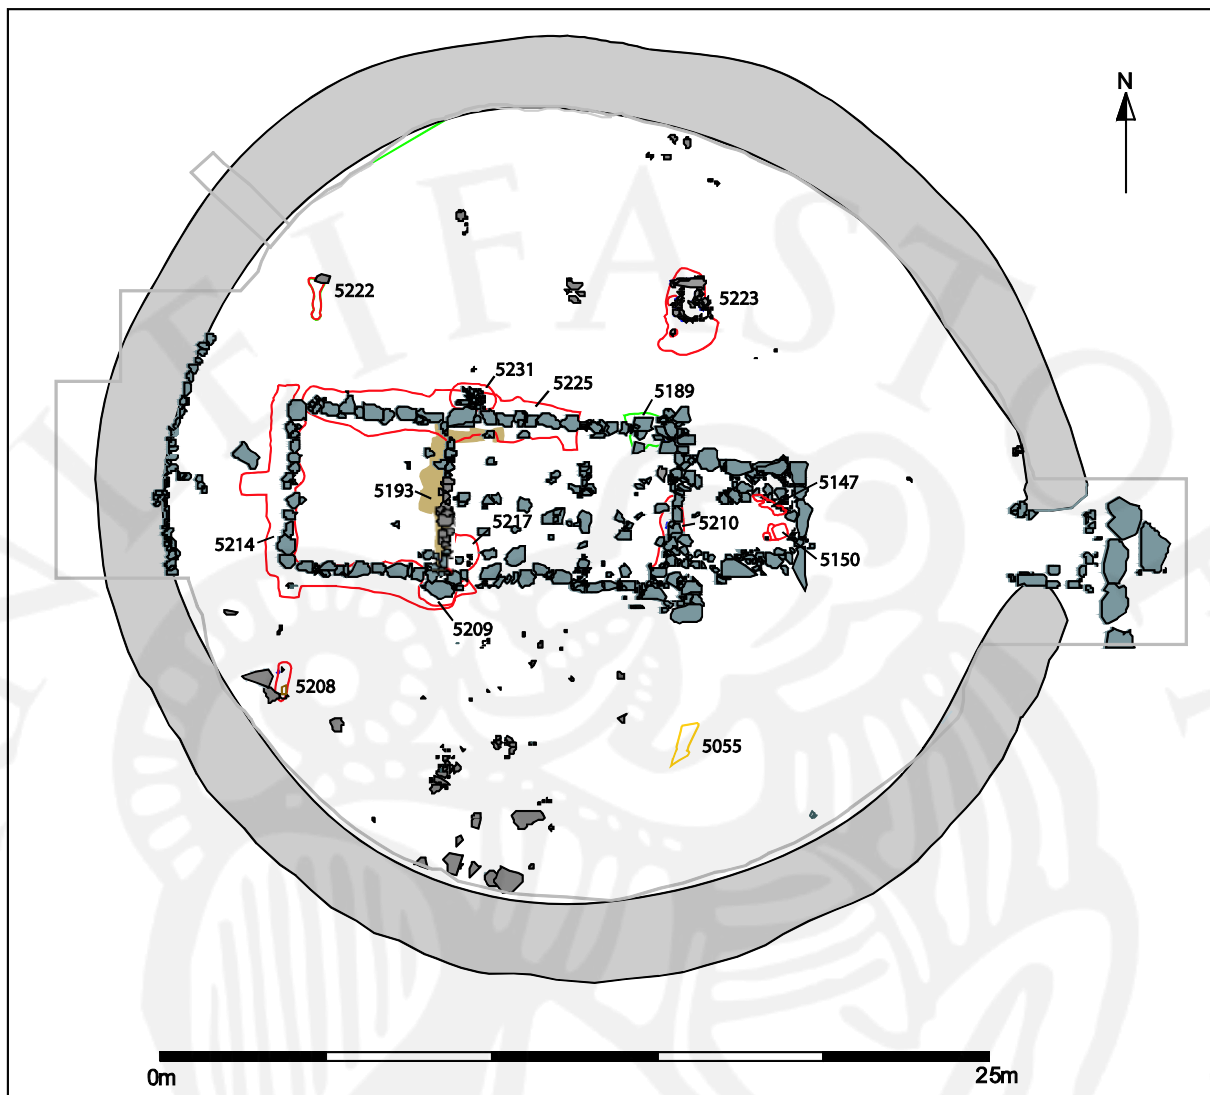
**Foundation trenches, structural post-holes and buttress foundations.**

*Structural remains. Buttresses.* In the churchyard there are three features interpreted as foundations for buttresses. In the western half there are two identical elongated features, aligned roughly with the western gable of the western extension, 2,5 m south and north from the south-western and north-western corners of the church respectively. The more northerly of the two [5221/5222] is 1,1 m long and 0,2 m wide. It is 0,1 m deep in the southern end (closer to the church) but 0,19 m at the northern end where there is a single stone sat on edge, which has functioned as a stopper to wedge down the wooden buttress. The pressure from the weight of the buttress has been greatest by the stone and this presumably explains why the cut is deeper at that end. The corresponding, more southerly buttress foundation [5207/5208], is 1 m long and 0,3 m wide and also has a stone sat on edge at the end facing away from the
