# ***The church in Gásir***

## ***Interim report on excavations in 2004 and 2006***

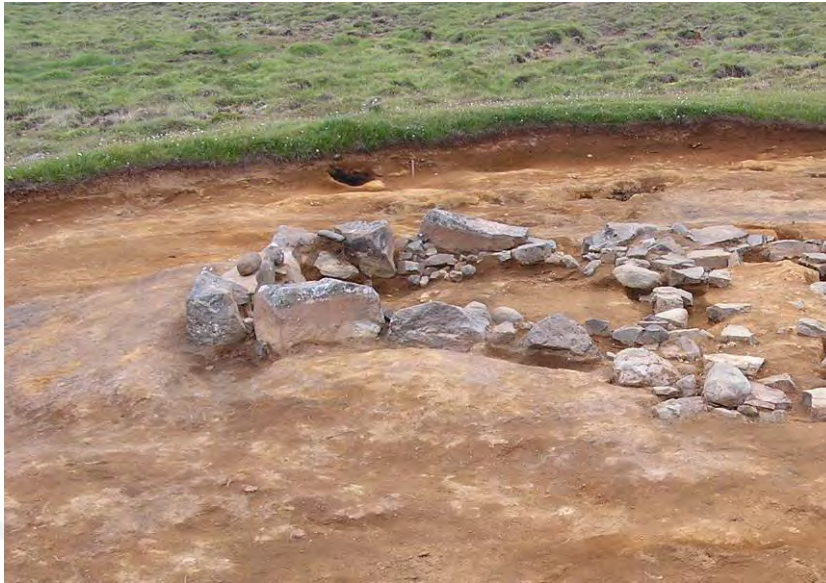
**The foundations of the chancel, looking south.**

Unlike the nave and western extension the stone foundations for the chancel do not sit in trenches. The stones in the chancel foundations are also much larger, substantial angular blocks set on edge, standing 0,5-0,8 m high. They rest on the H3 tephra – suggesting that some truncation was made to get them in place, but the edges of this do not remain. On the outside turf-debris and up-cast has been piled up against the foundation stones, creating a U-shaped collar of earth around the chancel. This pile post-dates the fill (not excavated) in the foundation trench/pit around the large boulder that is suggested to have been the southeast corner post pad of the second phase (see below). That suggests that the chancel in its preserved state belongs only to the final, third phase, of the church.

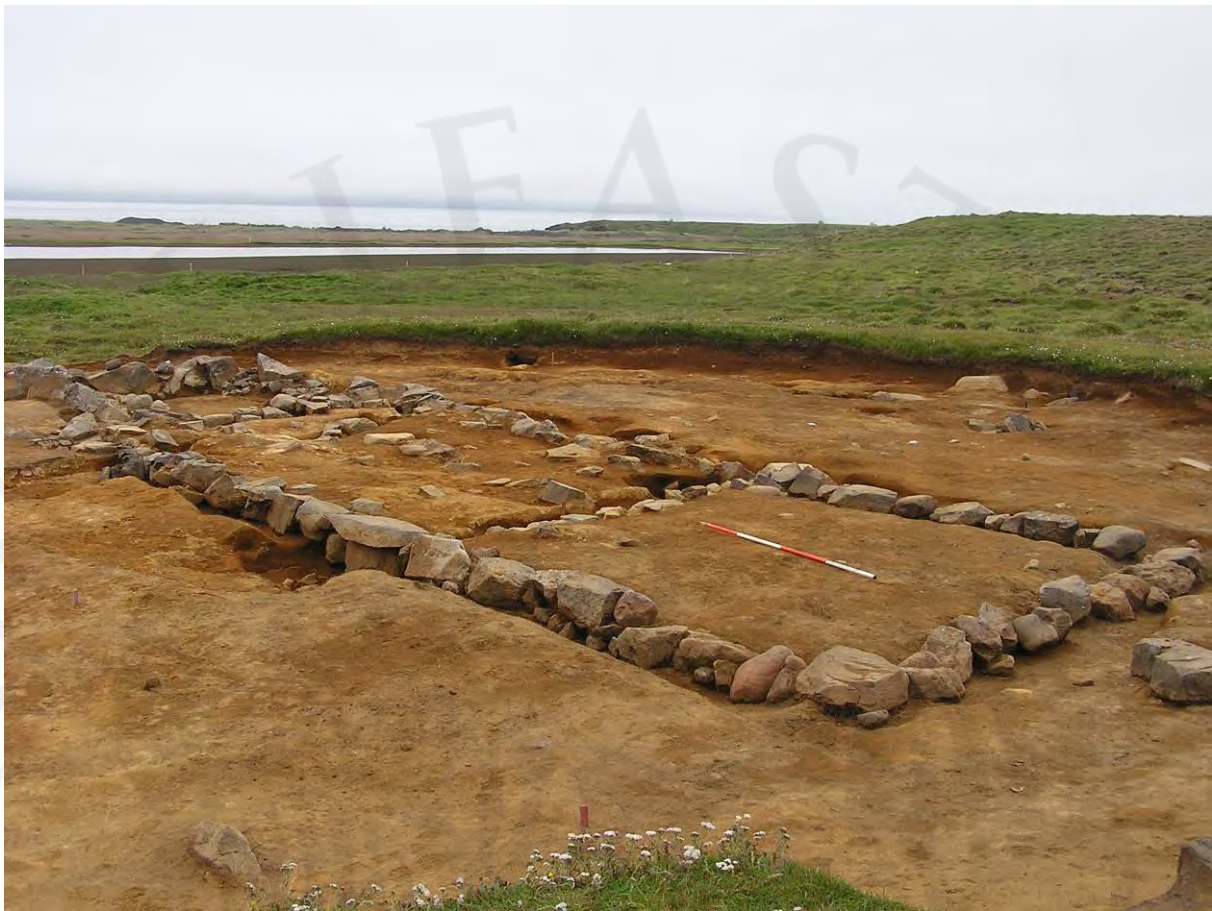
**The church at the end of excavation in 2006, looking southeast.**

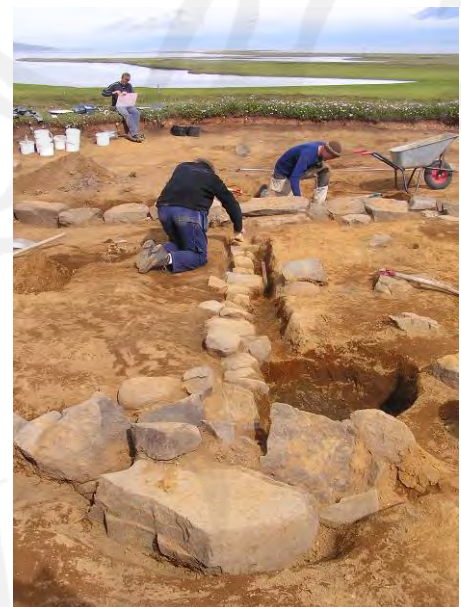
**Foundation for the western gable of phase 2, looking north. [5209] in the foreground, pit [5217] to the right.**

northern wall of the nave, suggesting that an earlier row of foundation stones was also removed there before the final construction event. The original cut [5216] for the foundation trench under the west side of the nave seems to be contemporary with the cut [5209] in which the large boulder outside the southwest corner of the nave is set. If that is true then both can be regarded as belonging the second phase of the church. Both of these second phase cuts postdate a large pit [5212/5217] inside the southwestern corner of the nave. It is semi-circular, 0,5 m deep, 1,1 m in diameter and has signs of robbing and backfilling before the construction of the second phase foundations. It is probably contemporary with another similar pit [5229/5230/5231], more oval in shape (1,4x0,85 m),

The principal evidence for the second phase of the church comes in the form of two very large flat boulders outside the row of foundation stones in the southern side of the last church. Both sit in truncations that are earlier than the final phase, and the more westerly of the two sits in a cut that postdates the large pit suggested to be from the south-western corner of the first phase. It is also stratigraphically at the same level as the foundation trench with row of stones running northwards from this point. It is suggested that this was the foundation for the western gable of the second phase church and that the two boulders represent post-pads for the south-western and south-eastern corners of that building. The width of the nave of this building is suggested by the eastwards extension of the robber's trench [5165], but the boulders supporting the two northern corner posts have been moved and incorporated into the foundations of the third phase church. In both cases it is however possible to identify the stones and in neither case have they been moved far at all. Indeed the north-eastern post pad seems only to have been tilted to align it to the other stones in the foundation for the northern side of the chancel. It is also possible that the rows of stones, interpreted as supports for floor-beams, in the nave, belong to this phase. Their east-west orientation aligns best with this phase and the absence of such stones in the western extension of the last phase suggests that in that phase there was some other arrangement for supporting the timber floor. This however is circumstantial and the stones could have been used in both phases. There is no direct evidence for a chancel in this phase but it can be suggested that the truncation [5147] within the later chancel relates to the north-eastern corner of a second phase chancel. Again there is no support for this apart from that it would fit the proposed dimensions and alignment of the nave, and there can well have been a chancel which left no traces.

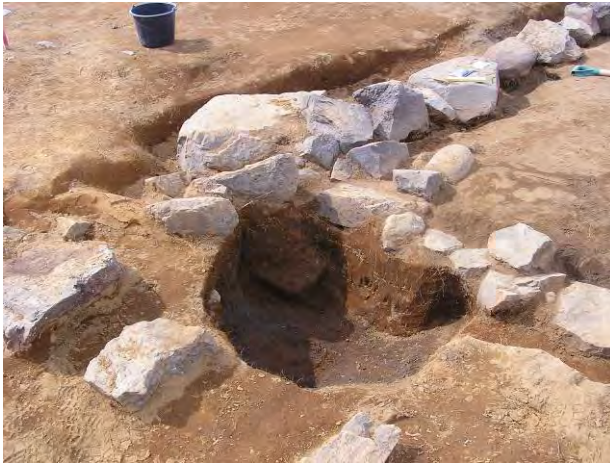
**Pit [5217], looking southwest. Southwest corner- of the phase 1 church, partly filled by the foundation for the western gable of the phase 2 church.**

outside the north western corner of the nave. It is also 0,5 m deep. This pit had also been robbed and backfilled but a pile of stones has been left in its base. It is suggested that these two pits, possibly along with the post-hole [5150], represent the first phase of the church. A cut observed under the stones in the southwest corner of the chancel, predating foundation trench [5210] could also belong to this earliest phase, representing the southeast corner post of the nave.

The earliest phase of the church is represented by the two large pits at the base of the stratigraphic sequence. It is suggested that these are the foundation pits for the north-western and south-western corner posts of the first church at this site. A truncation observed below the later wall between nave and chancel could be the foundation pit for the south-eastern corner post. This truncation is stratigraphically at the same level as the two pits and is at right angles to them. A fourth feature that could be associated with this earliest phase is the post-

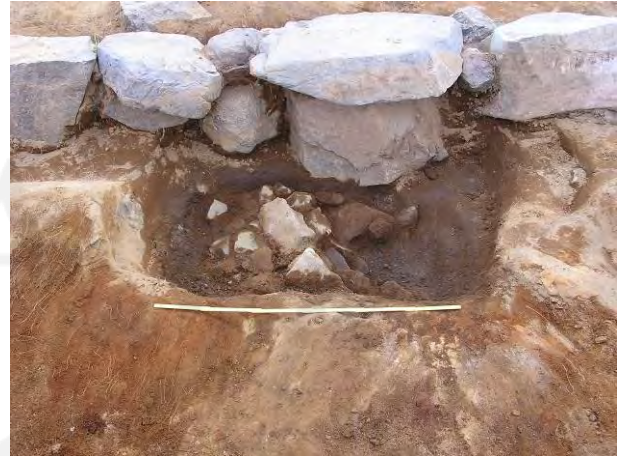
**Pit [5231], looking south. Northwest corner of the phase 1 church, partly filled by the phase 3 foundations.**

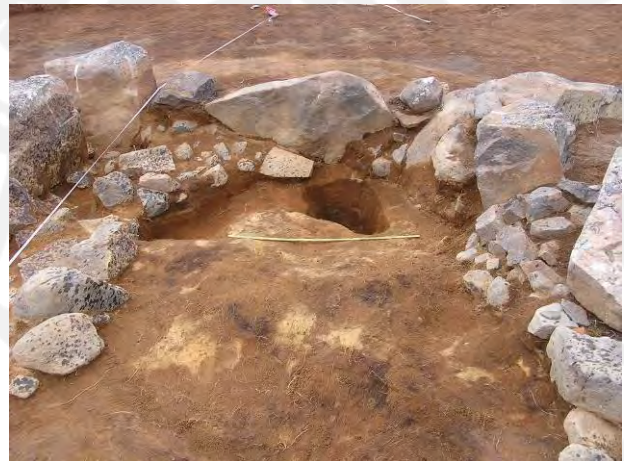
**Post-hole [5150], right, and cut [5147] in the chancel, looking east.**

In the chancel modern excavations (esp. [5072]) had taken a relatively heavy toll but the recovered sequence is nevertheless comparable to that of the nave. A layer of turf debris [5117] is identical to the small patch [5217] in the south-eastern corner of the nave and most likely represents also a dilapidation or post-abandonment phase of the church. It included a stone manuport (5104). [5117] has accumulated in the southern two thirds of the nave and is probably contemporary with [5121] in the northern one third. The latter deposit is similar except that it has a high frequency of small stones and some sand lenses. [5121] extends over the wall-line at the junction of chancel and nave, supporting the interpretation that it belongs to a post-abandonment phase. The two deposits are divided by a row of stones. Below [5117] there is a layer of up-cast [5131] and a surface [5135] (with a stone manuport (5110)) in the south-eastern part of the chancel, formed on a layer of up-cast [5145] identical to [5131]. These latter two represent levelling events, infilling cuts and depressions from earlier phases and can be associated with the construction of the final phase. To this final phase belong also two small but deep post holes side by side in the northern part of the chancel ([5138/5139] and [5137] – the latter was a 0,32 m deep cavity). Up-cast/levelling layer [5145] in-filled an elongated cut [5147], with a steep 0,23 m high north side but a more gradual south side in the northern half of the chancel. It also caps the fill [5149] (with stone manuport (5118)) of a complex posthole [5150]. [5150] is two postholes within the same cut, with a ridge between them. The more easterly hole is more substantial, sub-rectangular, 0,4x0,4 m and 0,36 m deep. The more westerly is also sub-rectangular, 0,18x0,18 m in size and 0,24 m deep. These holes along with cut [5147] most likely belong to an earlier phase of the church.

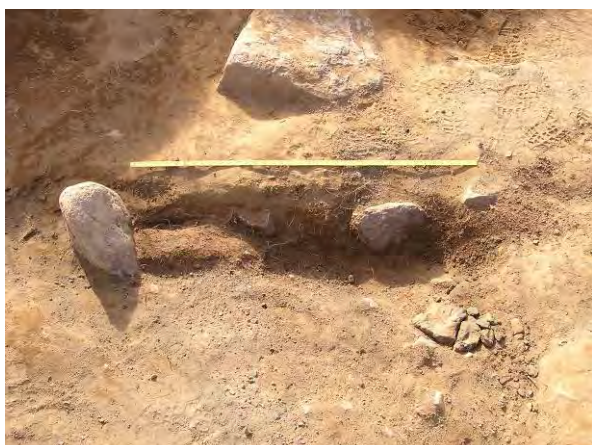
**Southwest buttress foundation [5208] with wooden plank, looking west.**

*Structural remains. Buttresses.* In the churchyard there are three features interpreted as foundations for buttresses. In the western half there are two identical elongated features, aligned roughly with the western gable of the western extension, 2,5 m south and north from the south-western and north-western corners of the church respectively. The more northerly of the two [5221/5222] is 1,1 m long and 0,2 m wide. It is 0,1 m deep in the southern end (closer to the church) but 0,19 m at the northern end where there is a single stone sat on edge, which has functioned as a stopper to wedge down the wooden buttress. The pressure from the weight of the buttress has been greatest by the stone and this presumably explains why the cut is deeper at that end. The corresponding, more southerly buttress foundation [5207/5208], is 1 m long and 0,3 m wide and also has a stone sat on edge at the end facing away from the

church. Here a small wooden plank (5145) was found in the cut, pressed against the stone. 0,2 m of its length remained but it can be surmised that the plank originally filled the length of the cut. The plank is 0,1 m wide and 0,05 m thick. The fill also contained some animal bone (5144). Both buttress fills were covered by layers predating the H-1300 tephra and this might indicate that they had therefore ceased to function and were not a part of the church structure in last the 60+ years of its life. This is not bullet-proof however as the fills could be capped by layers while the buttresses were still functioning. A resetting of the buttresses after 1300 would however have left traces and it must therefore be considered likely that the buttresses had disappeared when the church was blown of its foundations in 1359.

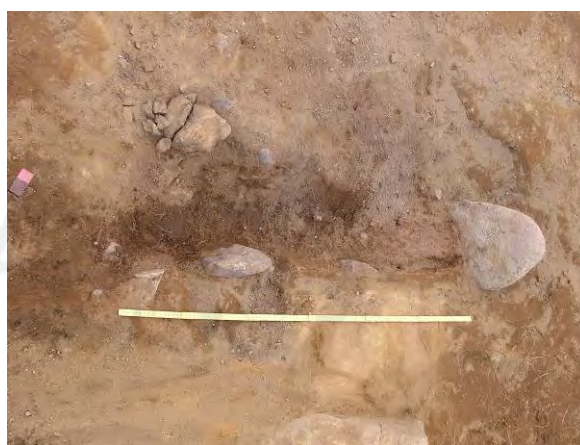
**Northwest buttress foundation [5222], looking west.**

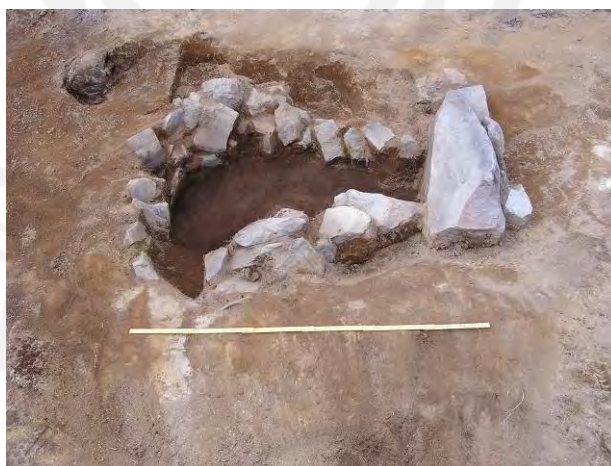
**Northeast buttress foundation [5223], looking west.**

The third buttress foundation is a much more substantial construction. It is 2,5 m north of the north-eastern corner of the nave. The cut [5223] is close to oval, 2,5x1,5 m in size. The fill [5219] is very mixed and contained a concentration of ash in a limited area by the middle of the western edge of the cut. This may represent a secondary event, a fire pit dug into the side of the buttress cut, but as there was no cut associated with the

concentration of ash it seems more likely that the fill represents mostly the backfilling of the pit, with material including this ash, after the buttress end had been removed. The design of this buttress foundation is identical to the others, with a large stone sat on edge at the end of

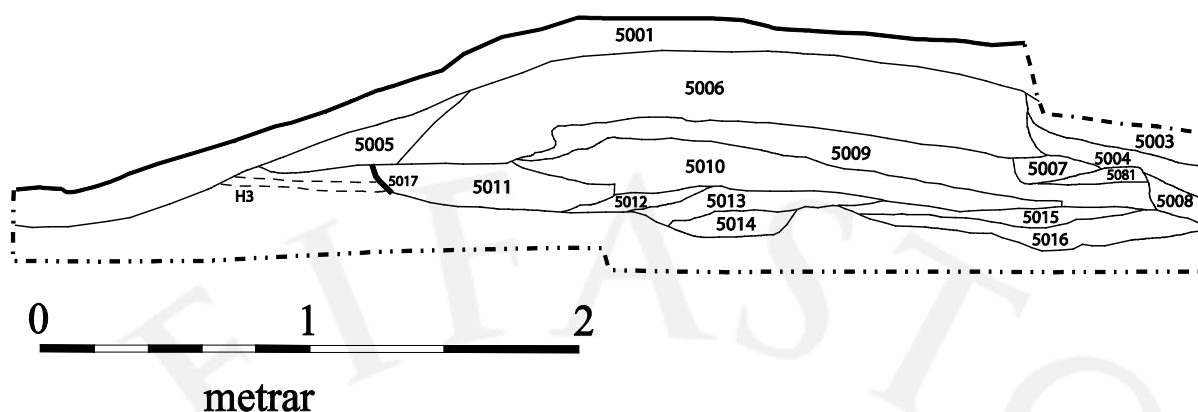
#### **Northeast section of trench through churchyard wall.**

In the west side of the trench B2 layers [5021], [5022] and [5023] represent the base of the wall (group [5018]). [5023] is a layer of turf, presumably for levelling whereas [5021] and [5022] are up-cast deposits, [5022] also for levelling while [5021] may represent a loose core of the wall. Similar deposits are not visible on the eastern side where the wall proper [5006] is much more substantial. There it is 0,3 m thick as opposed to 0,1-0,2 m on the west side. The turf construction is of indeterminate type. It is too short for *strengur* but too narrow for *hnaus* or *snidda*, but something akin to *snidda* seems most likely. [5005] is turf collapse on the outside of the wall and [5007], on the inside, predating the more widespread turf collapse layer [5004] already described. It seems therefore that the elevation of the wall is created partly by a truncation on the inside, an interpretation consistent with the levelling of the platform for the church by removing material from the west side and dumping it on the east

side. There is also a cut on the outside, approximately 0,3 m deep, suggesting a shallow ditch running the length of the wall, at least on the western side. It probably is the result of digging material to build the wall but it will also have added a little to its height. The apparent thinning of the turf wall towards the west is consistent with this scenario. More surprising than the limited thickness and what appears as the shoddiness of the turf construction is the fact that the turf wall is built on an accumulation of earlier deposits which are related to some other function than enclosing the churchyard. Below the wall there is a midden (group [5019]; layers [5009] and [5010] in the east side and [5024] on the west side) which produced a substantial collection of animal bones (finds no. 5003, 5101, 5102), a worked bone (5001), a bronze object, possibly a rove (5008) and iron slag (5150). This is probably a localised dump which the trench has cut through on its western side. It has

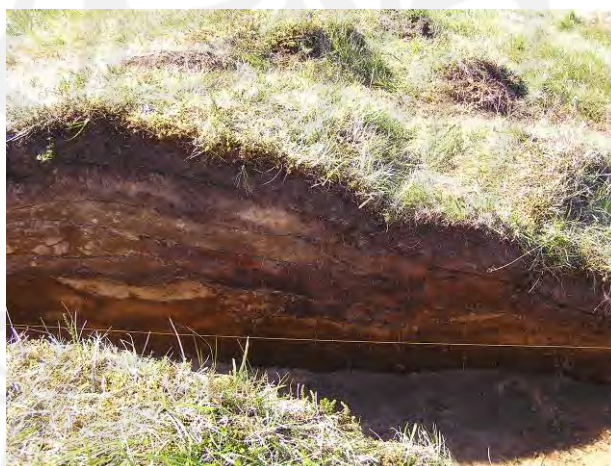
**The section, looking northeast.**

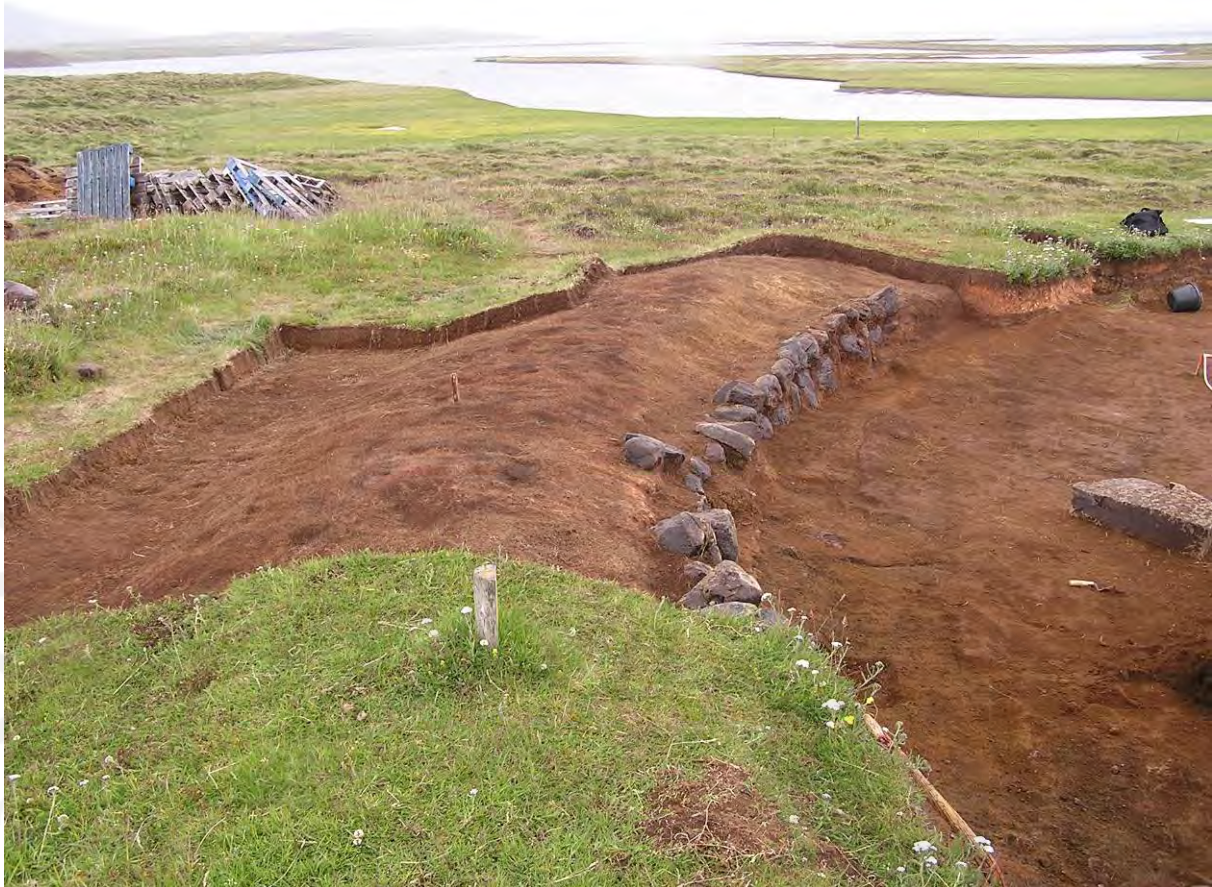
**The extension over the west-section of the churchyard wall with the full length of the stone facing exposed. Note the signs of burning on the turf. Looking north.**

In the extension the width of the turf wall, including turf collapse on the outside, is 2,0 m, comparable to the width observed in the trench. The original width of the wall can be estimated as 1,8 m at the base, judging i.a. by the depth of the entrance on the eastern side. In the western extension the turf wall had visible signs of burning and this was also observed in the eastern extension, where the turf on the south side of the entrance was clearly singed. Some of the turf debris deposits in the entrance area showed signs of burning (see above) and small pockets of burnt turf were also observed here and there in the southern side of the churchyard. It is possible that this burning represents the same event as the charred wood deposits in group [5058] (discussed above), and if so may support the idea that the wreck of the church was burnt after it had collapsed or been torn down. The complete absence of any signs of burning in or around the church's foundations speaks against the possibility that the church structure burned while still standing.

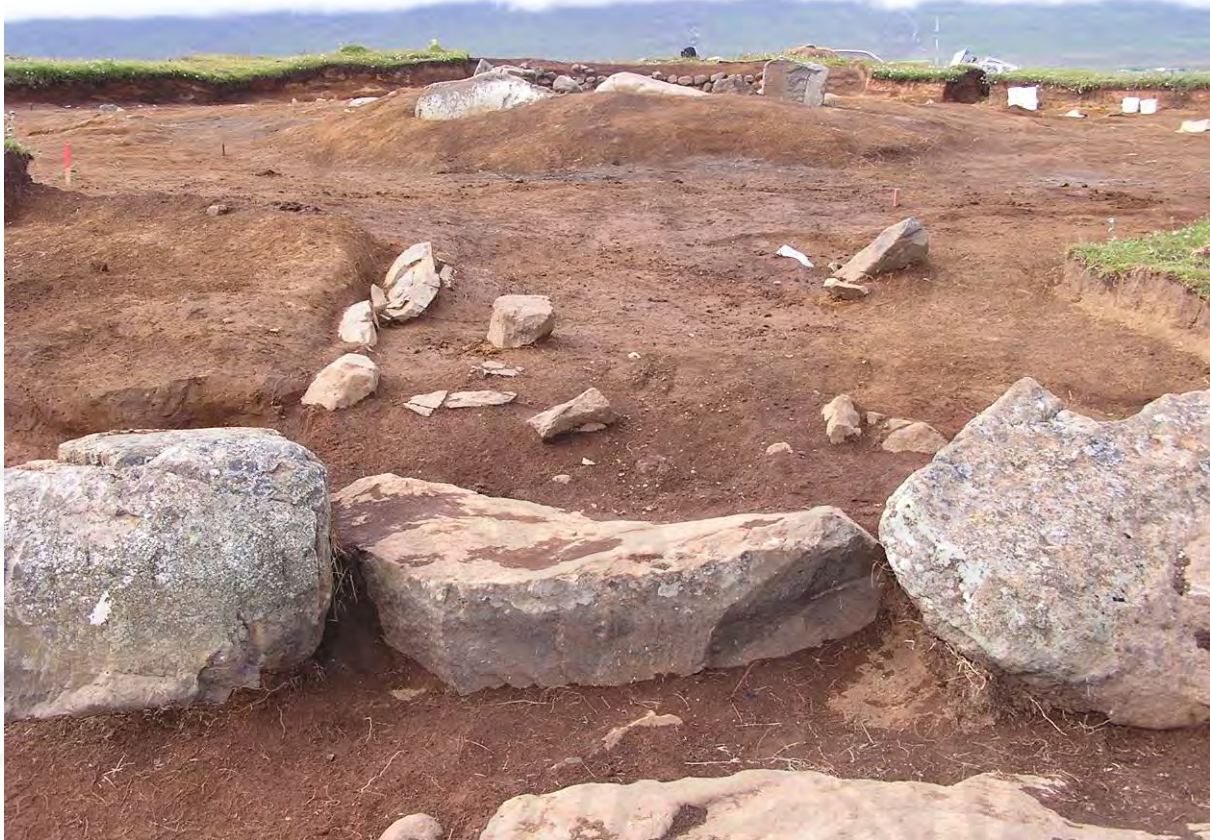
**The entrance under excavation, looking west towards the church. The collar of earth around the chancel can be clearly seen.**

Before excavation the entrance on the east side appeared as a wide gap of almost 8 m, associated with a row of large boulders outside and below the enclosure it self. The excavation revealed that the entrance had originally been much narrower or 2,2 m, clearly defined by a row of stones on the south side and a post-hole and some stones on the north side. The ends of the enclosure wall on both sides of the entrance had eroded to a considerable degree, particularly on the northern side where a nearly 4 m stretch has more or less eroded away. Within the extension a thin layer of turf [5172] was interpreted as the remnants of the wall on the northern side, but this was more due to its extent being consistent with the expected lay-out of the wall than it being possible to characterise it as a turf-wall. On the southern side the turf-wall, although thin, was preserved all the way to the entrance (not excavated).

A line of basalt boulders arranged below the entrance give it a monumental aspect. These are up to 1,5 m in length and 1 m in width, and in the centre two of them have been selected for their flat sides, creating steps leading up to the churchyard entrance. The lower step has apparently slid some 0,4 m down-slope to the northeast. Flanking these at both sides there are two higher boulders, framing the steps. There is a fifth large stone to the south of this construction but its function is not clear. These stones come from the same, or similar,

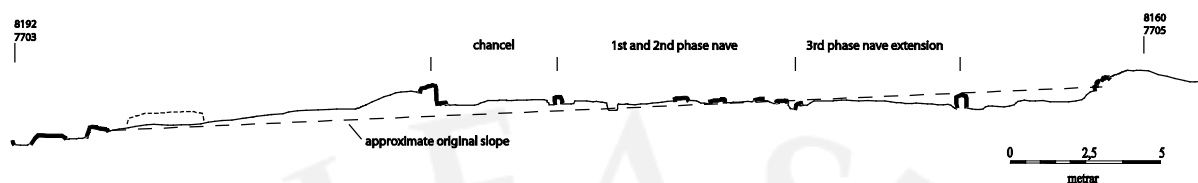
#### **East-West elevation through the churchyard.**

The turf wall encloses an area approximately 25 m in diameter (490 m<sup>2</sup>). It is located on gently sloping land, the difference in height between the area west of the churchyard and

east of it being approximately 1,8 m. As far as can be seen the original church was located on a relatively flat natural ledge, at least flat enough not to require any significant levelling. This is suggested by the level of the prehistoric tephra H3 under the chancel compared to its level within the entrance, suggesting a nearly 1 m drop in the prehistoric land-surface over a distance less than 10 m from west to east. In other words the incline of the original land-surface was not even and was steepest towards the northeast. When the enclosure was built the area within it was made more level by shovelling material from the western side, digging to a maximum depth of 0,8 m, more typically 0,5 m, and transporting the material to the north-eastern side where it forms a 0,1-0,3 m thick layer. It is estimated that some 150 m<sup>3</sup> of soil were moved – a significant but by no means major undertaking, easily achieved by a group of 10 men in less than a week. It was not investigated whether the east side of the enclosure wall was built on top of the artificial platform, but this seems likely. Despite this landscaping the surface within the churchyard did not become completely flat, and the easternmost third of the area slopes eastwards with a 0,7 m difference in height from the east side of the nave to the entrance to the churchyard. The collar of up-cast around the chancel may have been created at the same time as the platform, but it can also be later. To the west of the chancel however the surface is more or less flat, with less than 0,3 m difference in height from the southwest to the northeast.

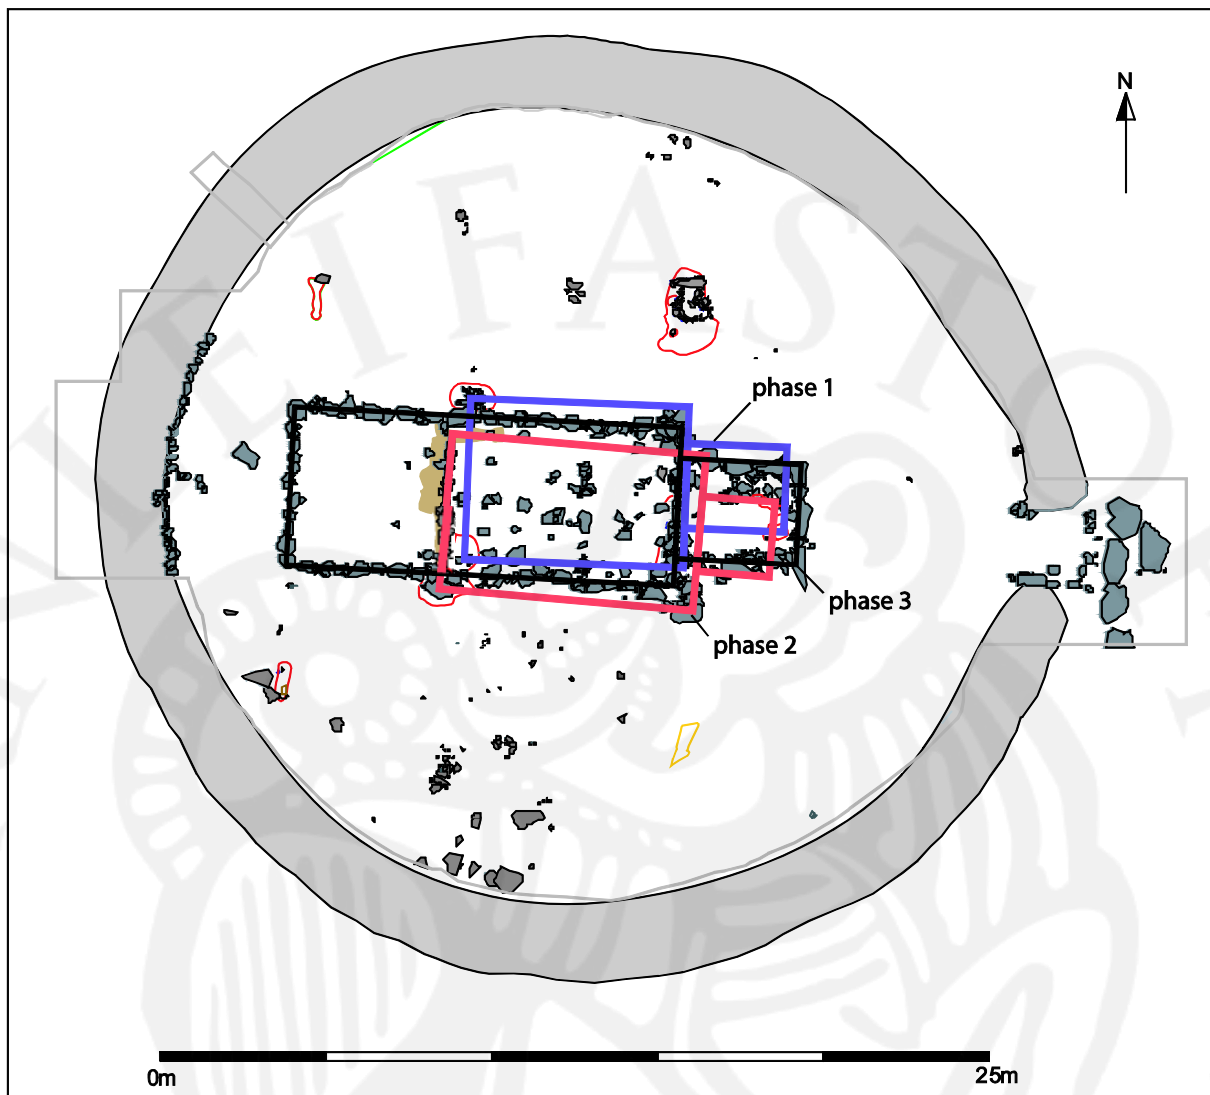
**Reconstruction of the three different phases of the Gásir church.**

The third, and final, phase church is the only one which can be described in some detail. Its nave is 11,6 x 5,0 m and the chancel is 3,8 x 3,1 m. It is 0,5-1 m further north than its predecessor and oriented closer to compass east-west. Unlike its predecessors this church did not have any particular arrangements for the foundations of the corner posts. The walls of the nave rested on stone foundations, mostly a single, but in places two, courses of large (0,5 m+) stones, sitting in a trench, typically some 0,2 m deep and 0,6 m wide. The foundations of the chancel are made of larger stones placed directly on the natural, with loose earth piled up around the stones on the outside. The chancel foundations are some 0,3 m higher than those of the nave, suggesting, along with the eastern wall of the nave which is supported in the

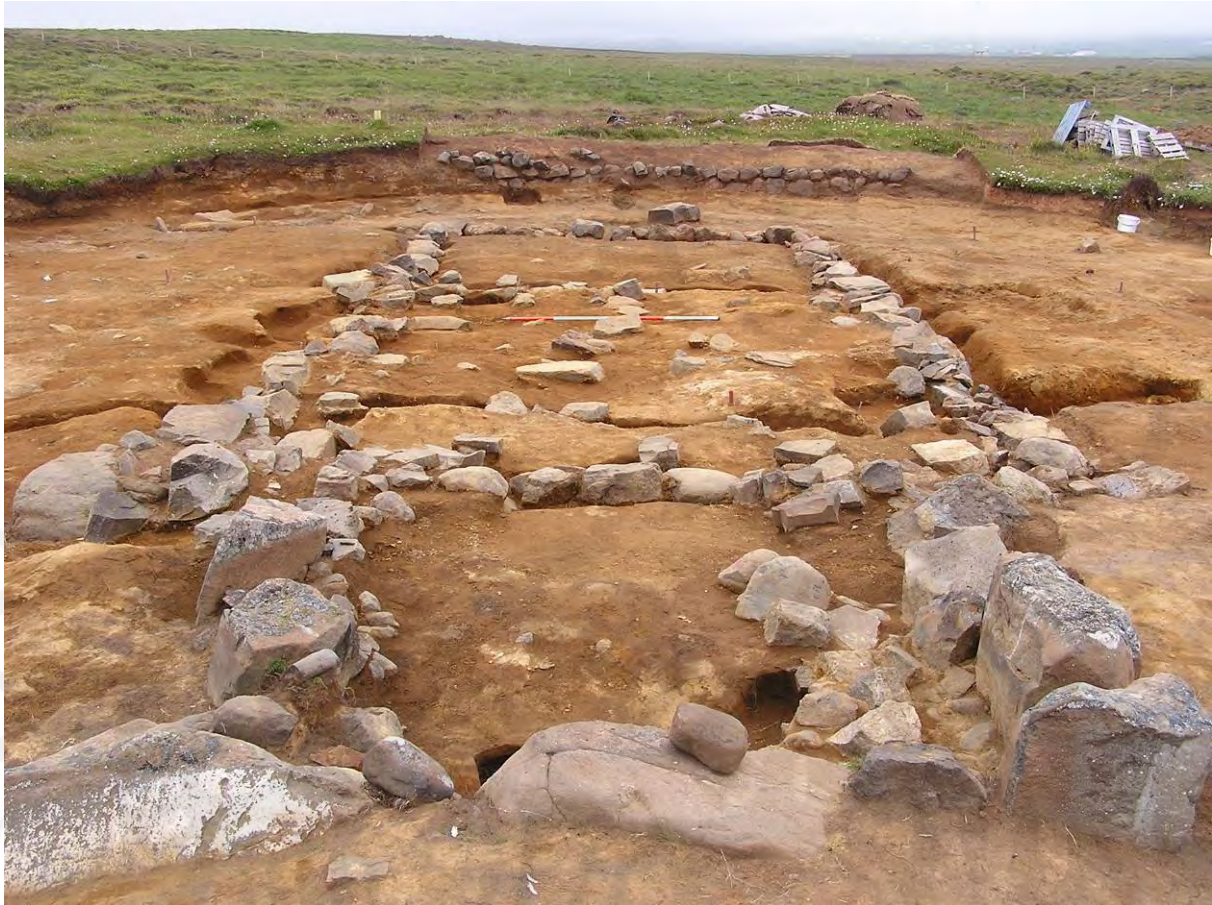
**The church after excavation, looking west.**

same way as the others, that the chancel was a structurally separate unit, possibly with a higher floor level than the nave. The nave was supported by wooden buttresses at each corner (three of which survive) suggesting that the weight of the roof rested entirely on the walls, which as a result required buttressing so that they did not fall apart. There is no evidence for buttressing of the earlier phases, which were more or less of equal width, but neither is there of internal supports (unless the stones suggested as supports for floor beams in the second phase are interpreted as such). It seems therefore that structurally the main difference between the third phase and the earlier phases was that the latter had very substantial corner posts which supported most of the weight of the roof, whereas in the third phase the weight was distributed more evenly along the length of the, possibly more substantial, walls with added supported given by the buttresses.

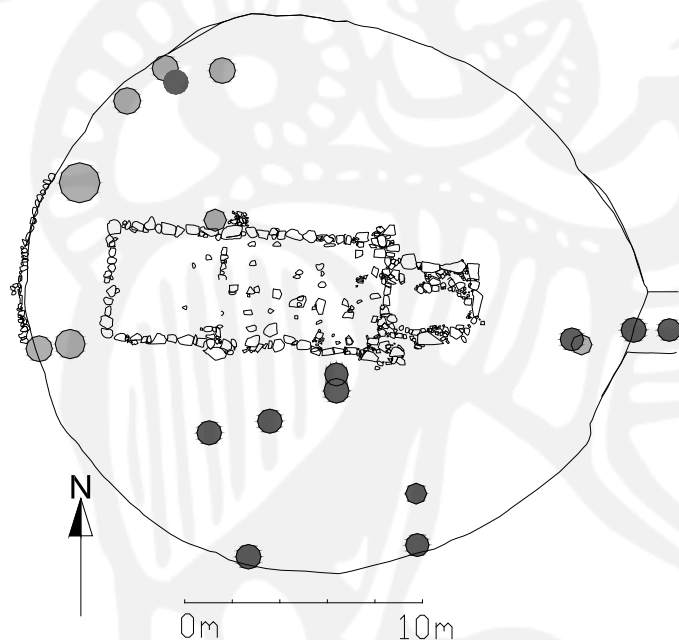
*Location of metal objects (dark-grey) and slag (light-grey) in the churchyard at Gásir. Finds from topsoil [5001] not included.*

any plausible iron-working features ([5096] might be the exception), its concentration in the northwestern part of the churchyard suggests that small-scale iron-working took place in this area, possibly using the church as shelter from the prevailing southerlies. The iron slag from top soil [5001] is probably from disturbed earlier layers (due to early 20<sup>th</sup> century excavation at site) rather than later activity. The slag awaits further specialists analysis.

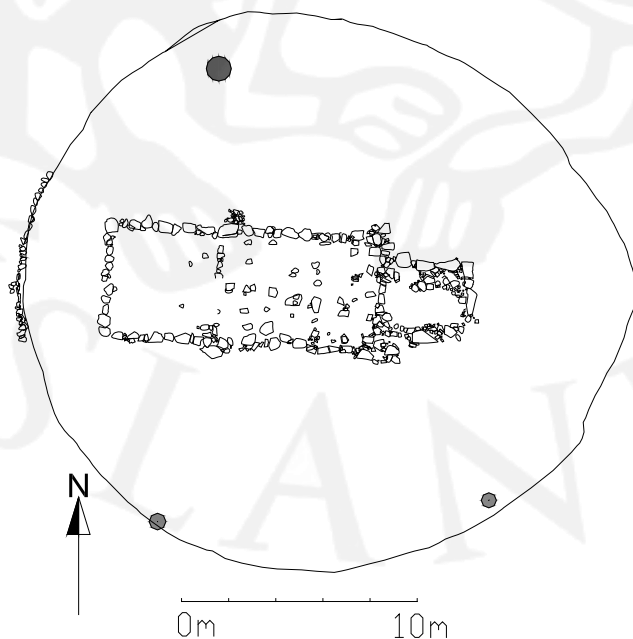
*Location of glass (dark-grey) finds (finds from top soil 5001 not included) and ceramic finds (light –grey).*

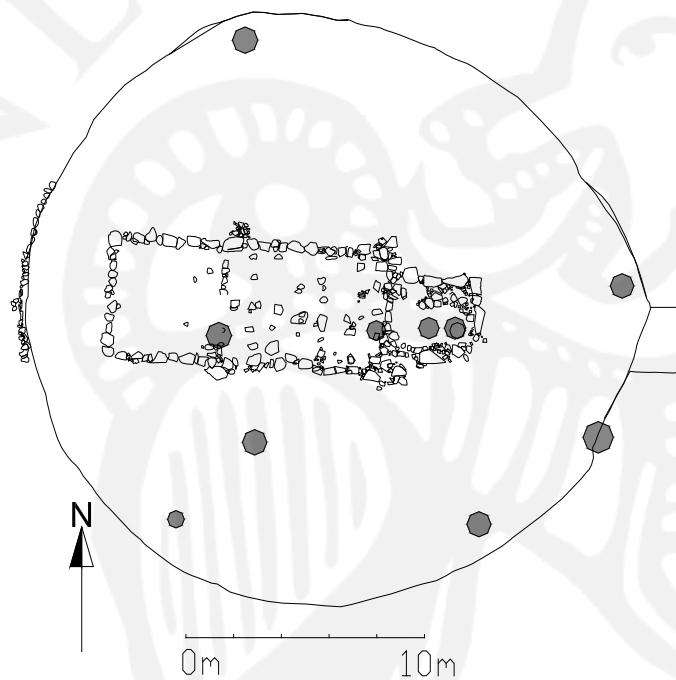
*Location of stone finds in the churchyard at Gásir.*

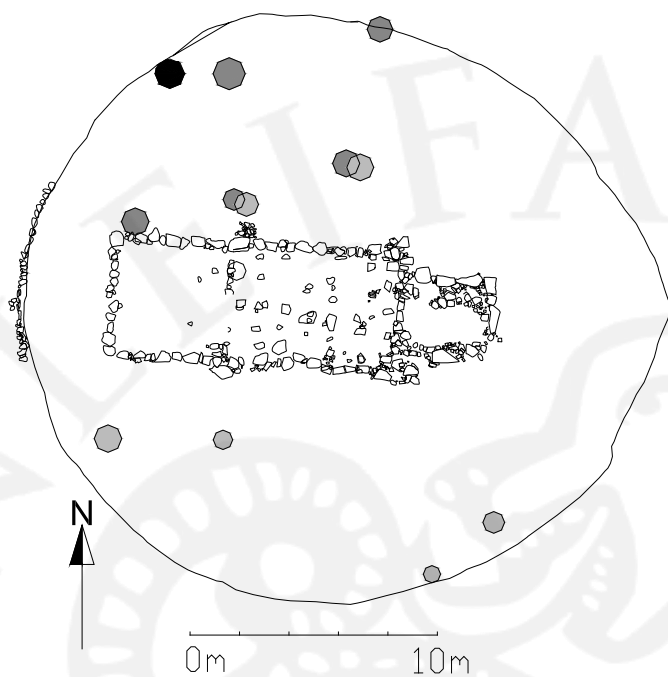
*Location of bone (black), textiles (mid-grey) and wood (light-grey) finds in the churchyard at Gásir.*

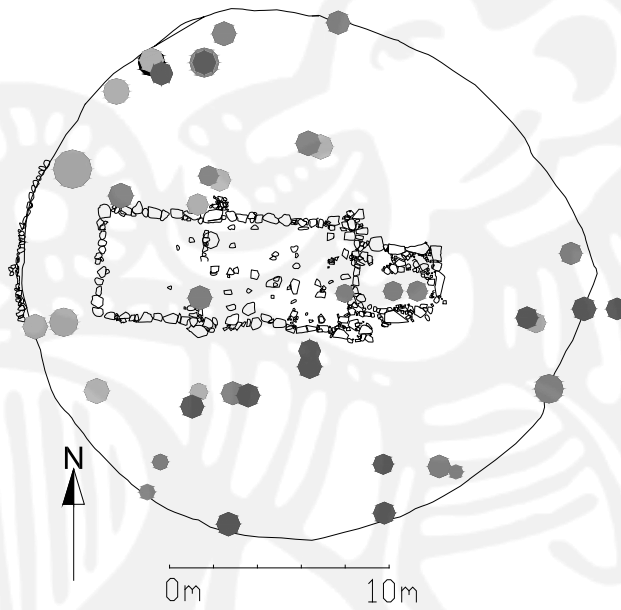
*Location of all finds within the excavation area.*

As can be seen from Fig. X most of the artefacts were found in the churchyard. Only four come from within the church (probable whetstone fragment, baking plate fragments and manuports) most of which relate to the construction rather than the use of the building. The finds in the church are remarkable mainly for their small number, supporting both the notion that the church had a wooden floor and that it was in quite limited use, possibly only for several times a year for little more than a century. The finds assemblage as a whole suggests interesting and multiple actions within the churchyard none of which can be directly connected to the religious function of the church. Interestingly there are not either any finds of a personal nature, accessories or other small objects people are likely to loose and which would be expected in a place of frequent gathering of large groups of people. On the other

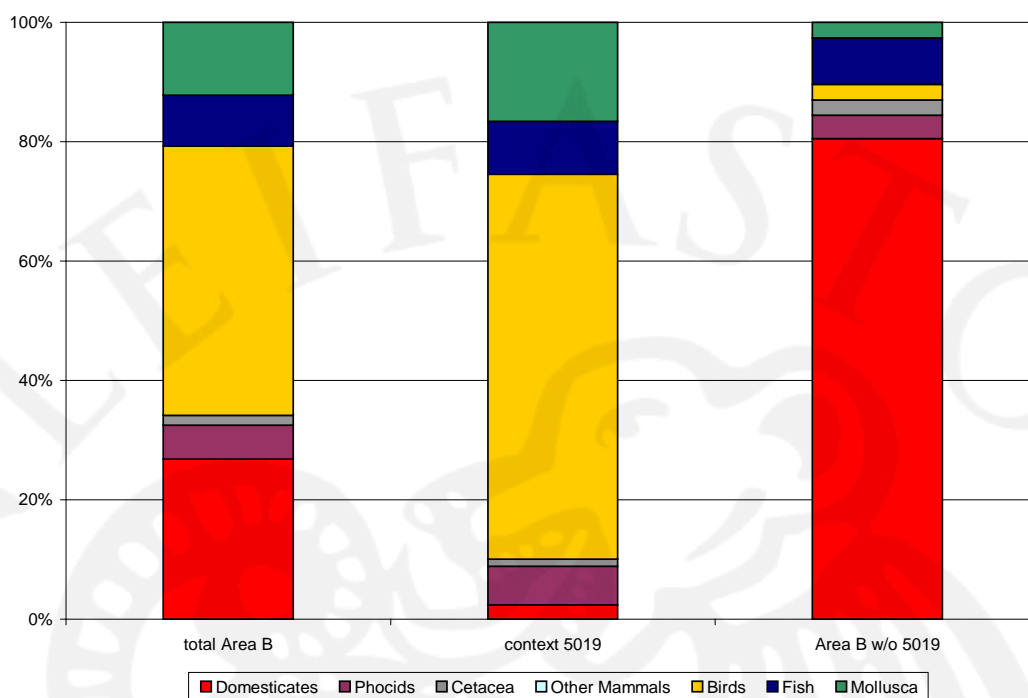
Figure 1: Area B - Major Taxes comparatives (% NISP)

Figure 1 demonstrates that the Domesticates are prevalent everywhere, but for context 5019. The profile of taxa distribution in that one context is strikingly different from the overall site distribution. The context contained a far lower number of domesticates than the other site contexts.

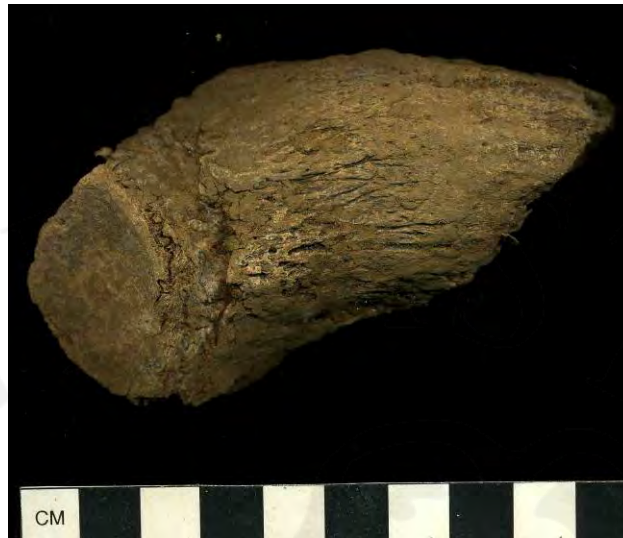
**Figure 2: Cattle Horn Core, posterior view (context 5227)**

*Cattle* bone is present, and the caprine/cattle ratio is about 1.17 caprine bone for every cattle bone. The total number of *Bos taurus* remains is 29, including three cattle horn cores, found in contexts 5078, 5207, 5227 (fig. 2). These horn cores are potential indicators for horn craft working. Four of the long-bone remains showed chop marks and at least half of all the elements exhibited signs of heavy erosion or exfoliation.

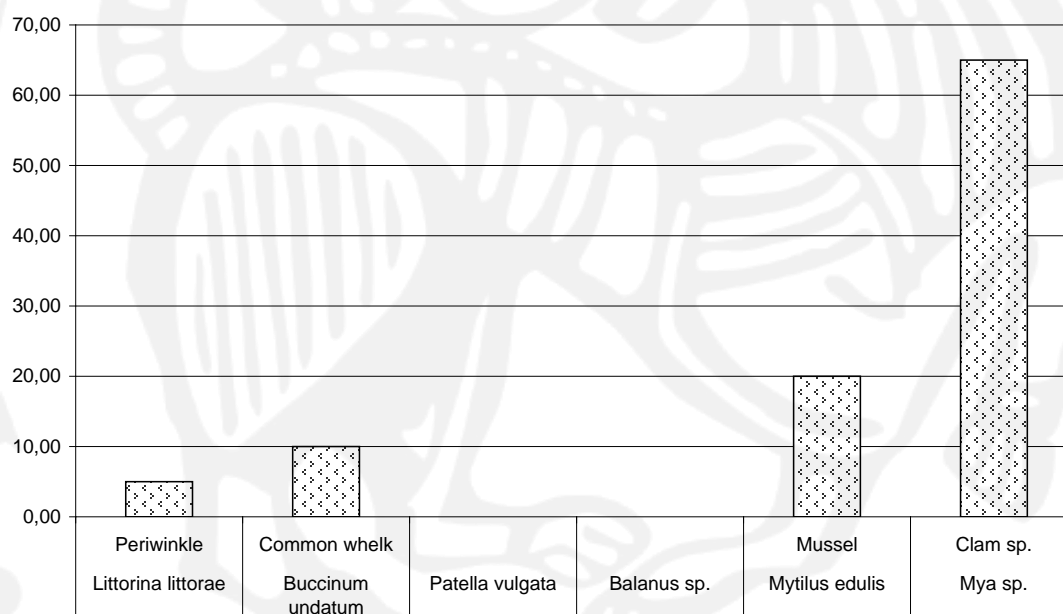
**Figure 3: Gásir Area B  
Mollusca Sp ID %**

*Mollusks.* Mollusk remains made up roughly 12% of the total bone assemblage, and 17% of the [5019] assemblage. Clam fragments were the most abundant, and mussels the second highest in number. Midden [5019] contained 28 of the 30 elements of mollusks and two of them were speciated to *Buccinum undatum* or common whelk that lives in the waters of the North Atlantic. Figure 3 presents the various identified Mollusk species.

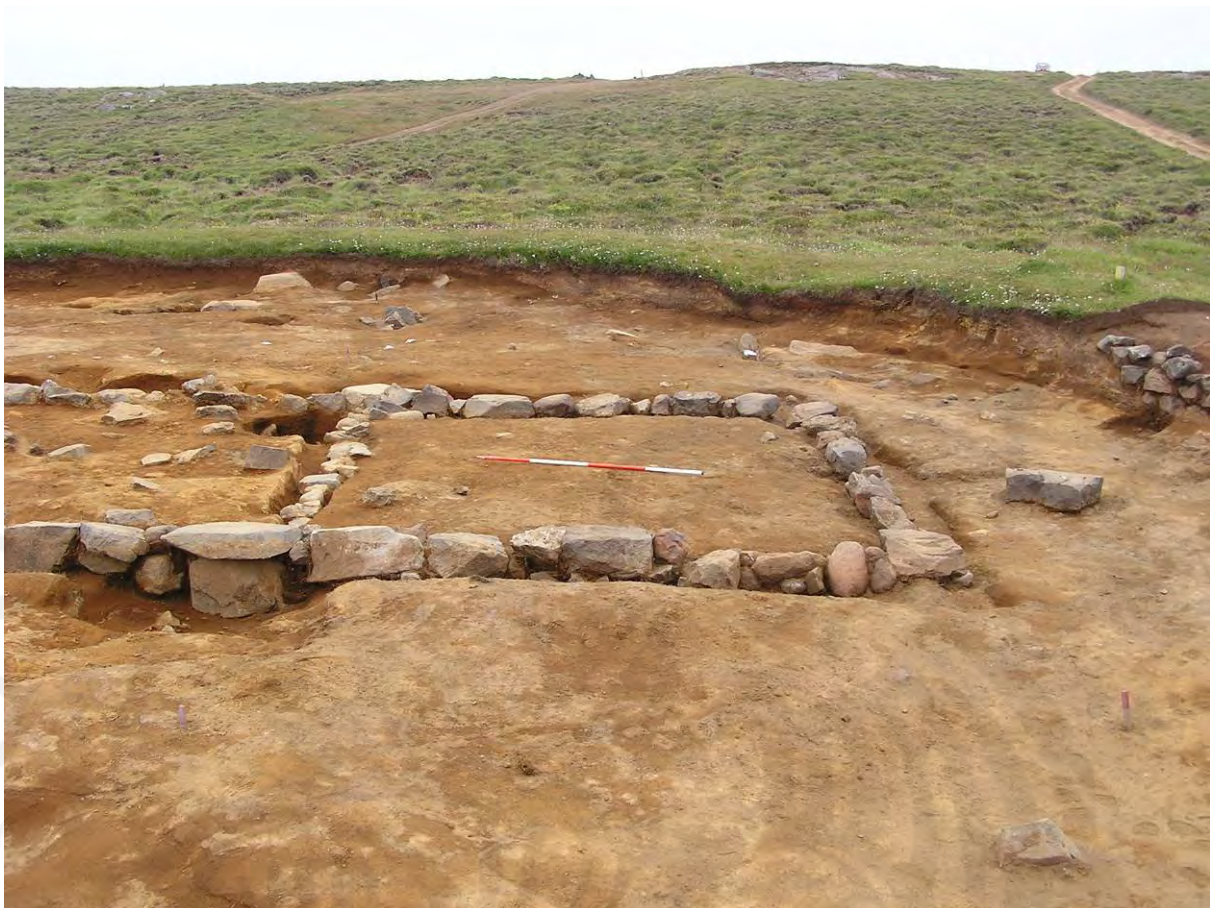
**Vesturendi yngsta byggingarstigsins, horft í suður. Undirstaða undir vesturgafli miðstigsins sést til vinstri sem og gryfjurnar undir hornstafi elsta stigsins.**

Yngstu kirkjuundirstöðurnar eru gerðar úr samfelldri röð steina í grunnum skurðum. Aurstokkar kirkjunnar hafa hvílt á þessum undirstöðum og þyngd þaksins hefur alfarið hvílt á

útveggjunum. Til að hindra að kirkjan gliðnaði undan þunganum hafa verið skástífur við horn kirkjuskipsins og fundust þrjár af fjórum undirstöðum undir þær. Skipið er 11,6 x 5,0 m en kórinn er undir minna formi, 3,8 x 3,1 m að stærð. Alls hefur þessi yngsta kirkja því verið 15,4 m að lengd. Timburgólf hefur verið í henni allri og virðist gólfíð í kórnum hafa verið um feti hærra en í kirkjuskipinu, en undirstöður kórsins eru gerðar úr mun stærri steinum sem hafa staðið hærra upp úr jörðinni en steinarnir í undirstöðum skipsins. Dyr hafa verið á vesturenda norðurveggjar og hugsanlega einnig á suðurvegg kórsins.

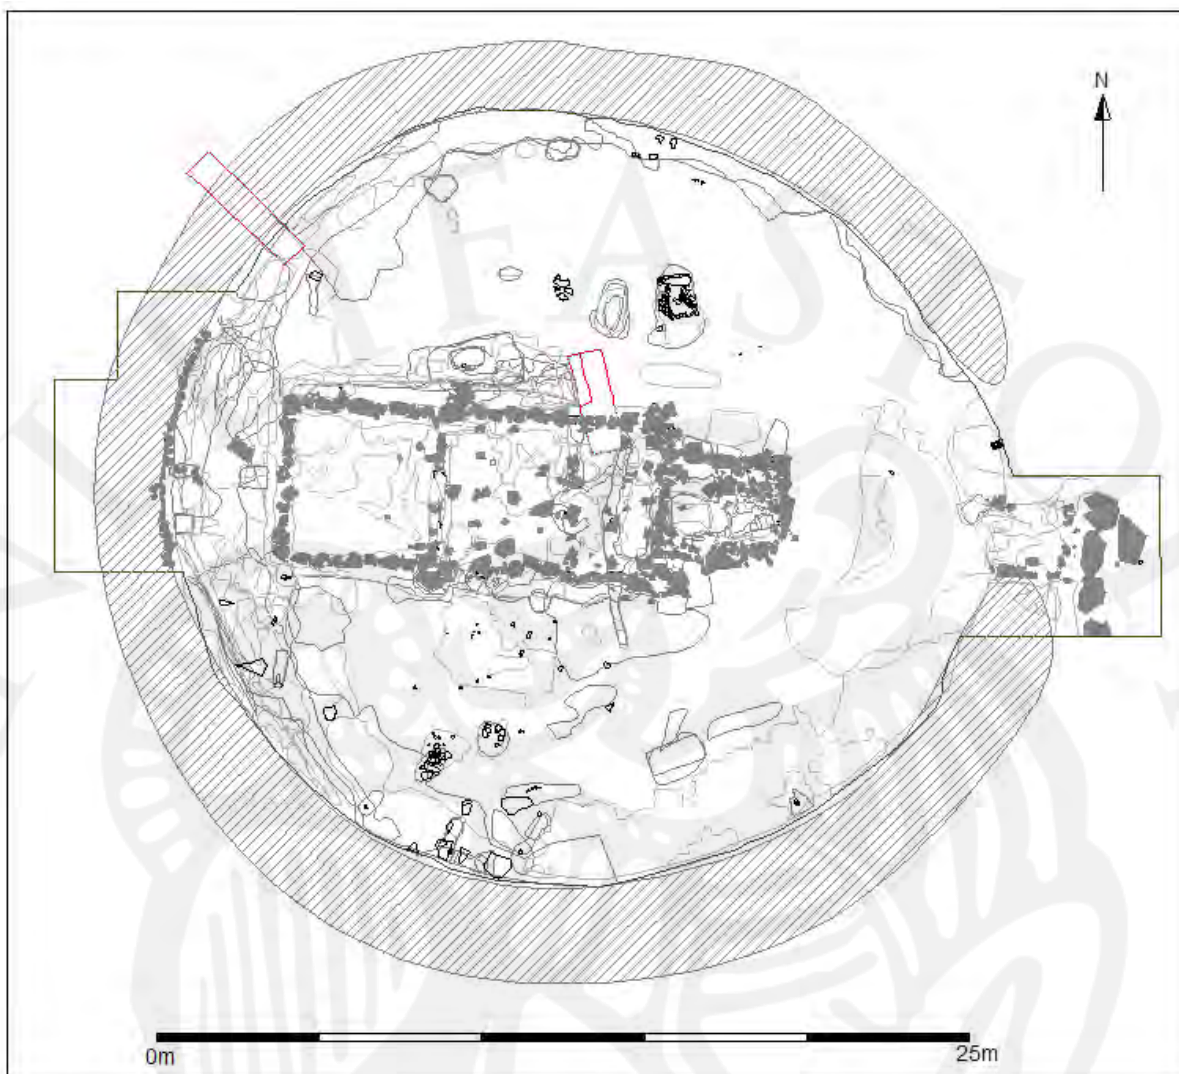
**Kirkja og kirkjugarður á Gásam. Myndin sýnir öll uppgrafin lög.**

Ennþá minna verður sagt um eldri kirkjurnar en fara má nokkuð nærri um stærðir þeirra og grundvallargerð. Miðkirkjan hefur eins og arftaki hennar haft steinaraðir í grunnnum skurðum sem héldu uppi aurstokkunum, og slík ummerki hafa varðveist undir vesturvegg hennar, en hornstafir hennar hvíldu á stórum steinum steinum sem voru rammlega niðurgrafnir. Sá umbúnaður bendir til að í þessari kirkju hafi þyngd þaksins hvílt fyrst og fremst á hornstöfunum, en ekki dreift á veggina eins í þeirri yngstu. Skip miðkirkjunnar var 7,7x4,8 m en meiri vafi leikur á um kórinn. Ef tilgáta um að niðurgröftur undir kór yngstu kirkjunnar sé undan norðausturhorni miðkórsins þá hefur hann verið 2,4x2,2 m, og hefur þá

heildarlengd miðkirkjunnar verið 10,1 m. Miðkirkjan hefur haft sýnu suðaustlægri stefnu en hinar tvær.
