# VATNSFJÖRÐUR 2011

## FRAMVINDUSKÝRSLUR/INTERIM REPORTS

**FS492-030911**

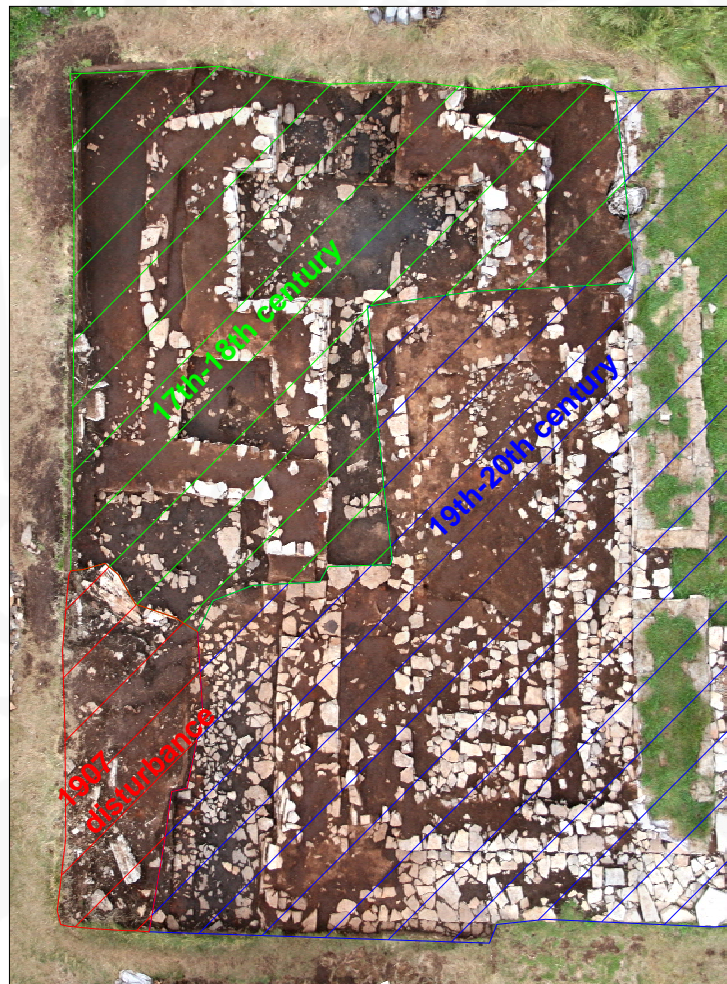
**Figure 2: An overview over the phasing of the farm mound research area at the end of the 2010 season.**

phases. Room (10662) and the corridor (10590) had remained in use into the 20<sup>th</sup> century and formed a part of the farm as rebuilt in 1884. Areas (8590), (10671), and (9560) were on the other hand still covered with 19<sup>th</sup>-20<sup>th</sup> century deposits belonging to the 1884 farm as well as a vegetable garden built into its ruins in the early 20<sup>th</sup> century (see figure 2 below, see also Isaksen in Milek 2011, 58-59, and Gísladóttir in Milek 2010, 72-73).

the south-western corner of the site containing the remains of a farm house built in 1907 (see figure 2).

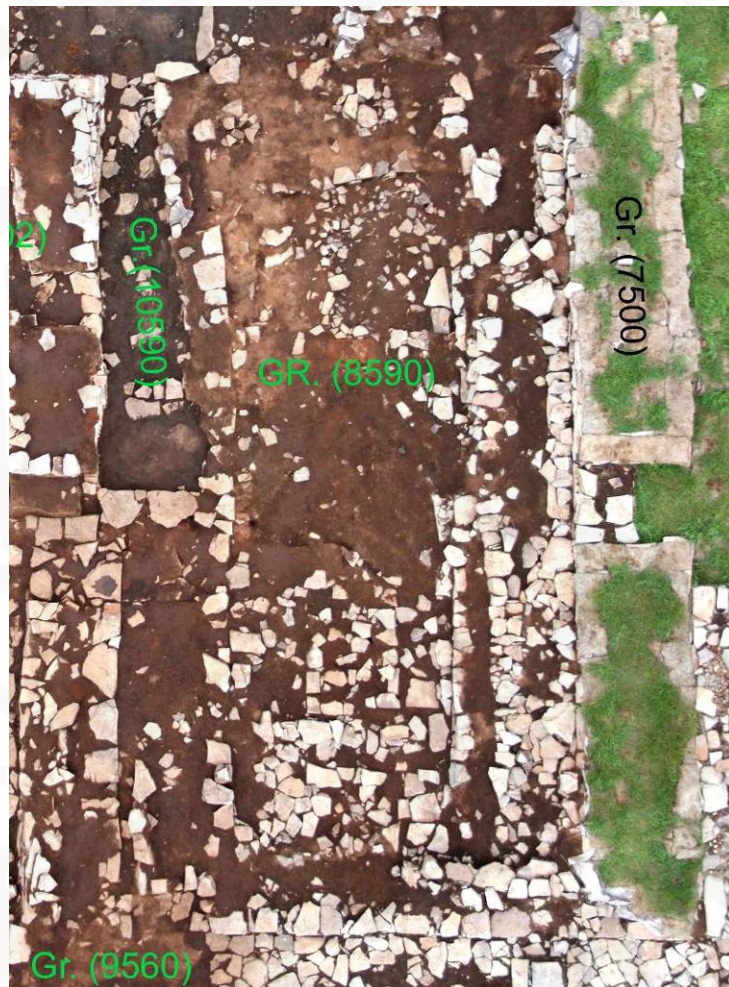
**Figure 3: An overview of the area covered by vegetable garden (8590) at the end of the 2010 field season.**

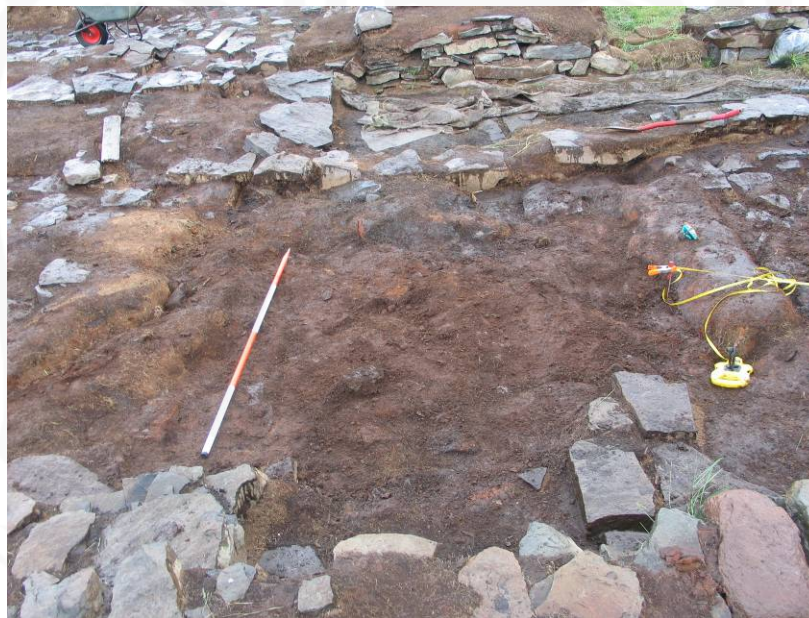
**Figure 4: An overview over pit [11571] before excavation, camera facing west.**

Quite early on in the season, most of the post abandonment deposits had been removed and the form of the vegetable garden was starting to take shape, with earlier structures also becoming more visible beneath. In the center of the garden a large pit [11571] started to appear. This feature was filled with a mix of turf and stones (in chronological order, latest to earliest, [11520], [11522], [11527] and [11562].)

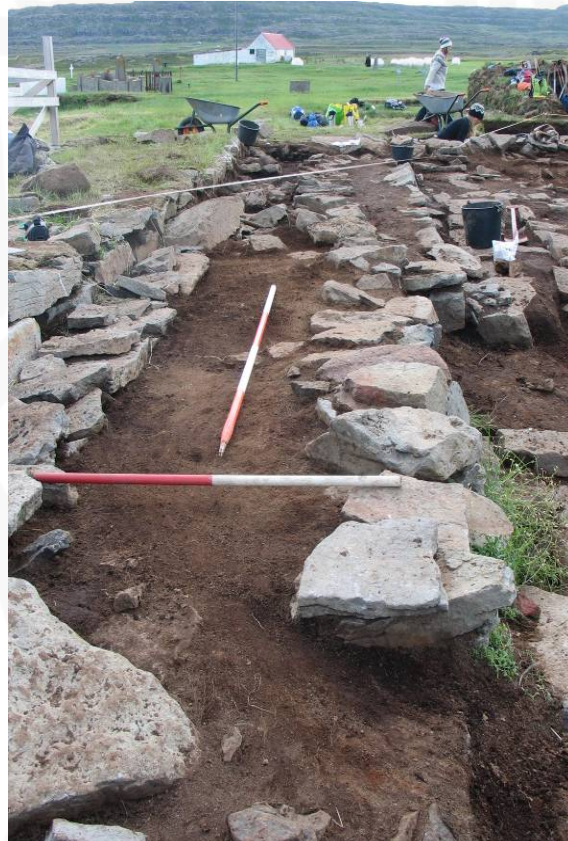
**Figure 5: The eastern wall, camera facing south.**

The eastern wall measured about 14m in length and 1.70m in width. The northern half of the wall was about 0.45 high, but at the southern edge only about 10-15 cm high. The northern half of the wall was composed of a stone facing made of rocks of irregular shape and a fill made of turf rich soil. This soil was probably taken from the farm mound,

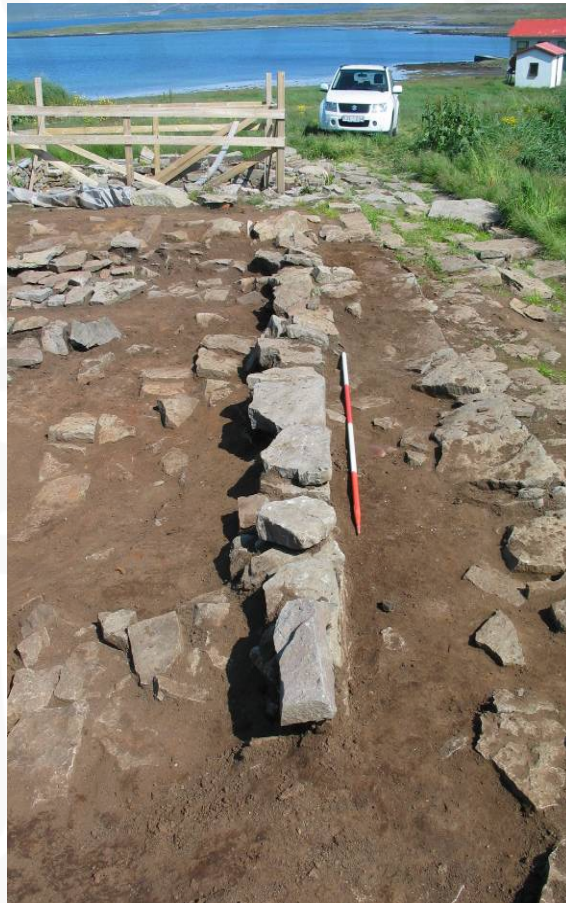
**Figure 6: The southern wall (gr.11624) of the vegetable garden, camera facing east.**

mixed with turf rich soil (also containing 19<sup>th</sup>-20<sup>th</sup> century pottery). The southern half of the wall was in much poorer condition than the northern part, likely due to the late 20<sup>th</sup> century leveling of the farm mound. The southern wall, group (11624), was in a very poor state of preservation and had collapsed into the garden - in all likelihood when the home field was flattened in the late 20<sup>th</sup> century. It was composed of 6 deposits (units, [9578], [9590], [9621], [9640], [11504] and [11535]). The latter deposits chiefly contained stone and turf rich soil, including some charcoal and a small assemblage of late 19<sup>th</sup>- 20<sup>th</sup> century pottery, vessel glass and window glass. Due to the poor condition

of the wall, it is difficult to be confident of its dimensions. However, it appears to have been about 1 m wide, about 6.5m long and between 0.4 and 0.5m in height.

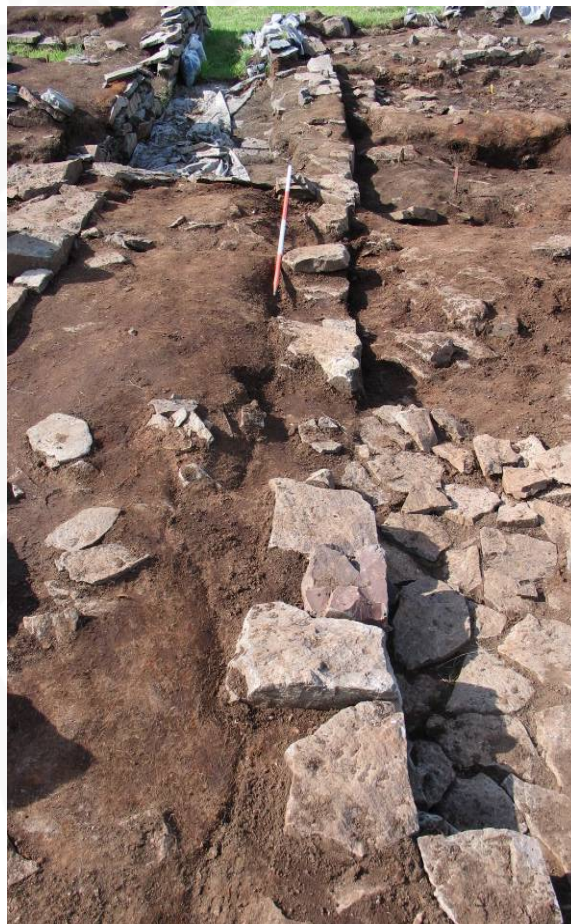
**Figure 7: The western wall (gr. 11541) of the vegetable garden, camera facing north.**

The western wall (unit 11541), was about 11m long, 0.4-0.7m in width and survived to circa 0.3m in height at most. It was composed of an interior stone facing of large flat stones and a fill of strips of turf (*strengur*). The southern half of the wall was built up against a wall (units [11549] and [11609]) that is believed to be a part of the 1884 farm house. The northern half of the western wall sat on top of an earlier wall, believed to date back to the 17<sup>th</sup> century.

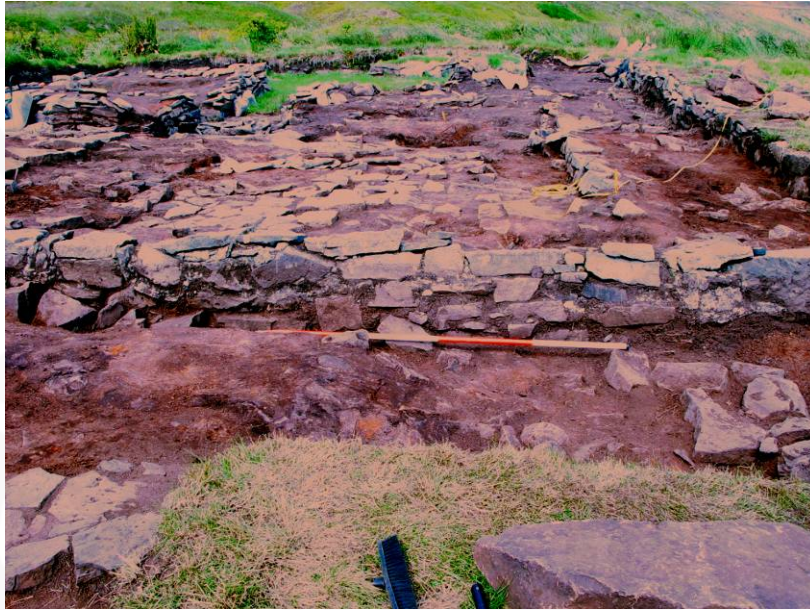
**Figure 10: The south facing of the southern wall of gr. (9560), camera facing north.**

above). The southern facing of the wall (unit [11608]) was however in a much better condition.

It was made of massive stones partially bonded with concrete, that were sitting in a foundation trench (unit [11620]), filled with turf rich soil mixed with rocks (unit [11613]), up to 0.5 m deep. The foundation trench clearly truncated earlier remains.

The wall was about 6m long and survived to circa 30cm above ground, seen from the outside. From the surviving remains of the inner facing of the wall, it appears to have been 1.3m wide. The wall was truncated by a pipe trench at its eastern end, where it adjoins a large wall of turf and stone, running north to south that belongs to the 1884 farm buildings revealed and partly excavated in 2007 (group 7500)

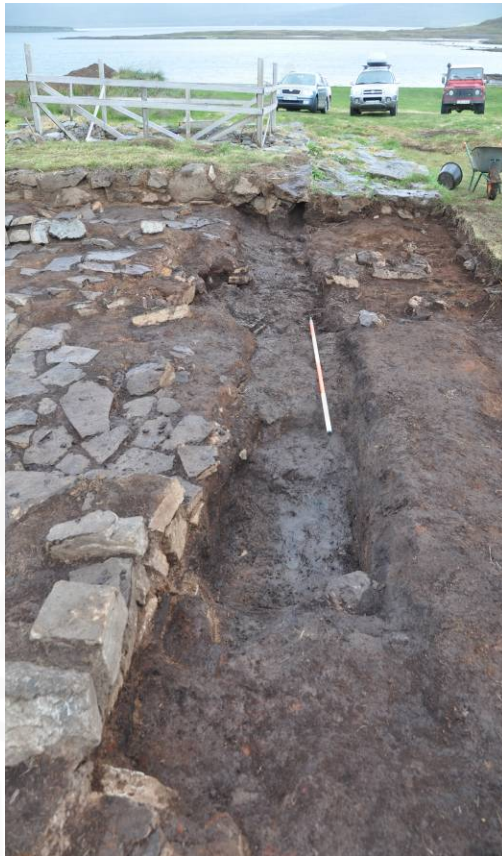
**Figure 11: Foundation trench [11620] for the southern wall of gr. (9560).**

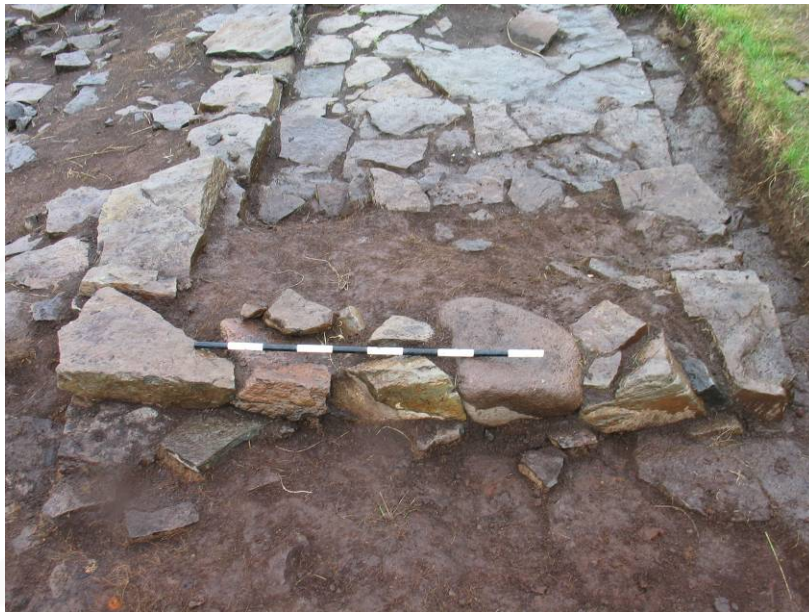
**Figure 12: Platform (11628), camera facing east.**

At the junction of the southern and western walls was a platform of turf and stone, about 2.5m long (north-south), 2m wide and about 0.3m high. This platform is thought to be the remains of a front porch. It was badly disturbed and therefore had to be excavated in a number of parts (units [9584], [10623], [10626], [10629], [10631], [10644], [10636], [10637], [10658], [10642], [10656], [10657], [10630], [11530][11533] and [11551]). The latter units were given the collective group number (11628) (see figure 12).

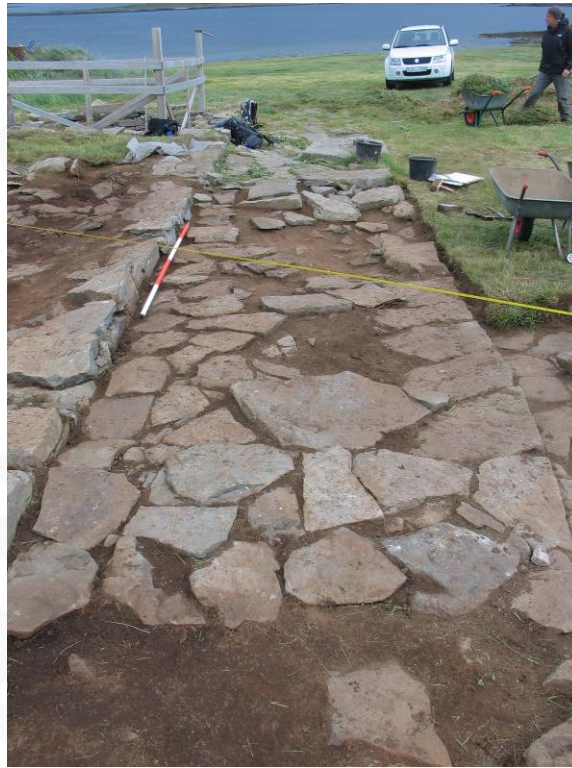
**Figure 13: Pavement [7541], camera facing east.**

On the south side of wall (11621) an external pavement (unit [7541]) had been uncovered in 2007 and 2008, also belonging to the 1884 farmhouse. The pavement had been left unexcavated as a part of the structures (gr. 7500) that were intended to be preserved as a monument of the 1884 farm (see here above). The pavement was composed of large flat stones, was about 2m wide and extended about 15m to the east and then about 7m to the north, around the remains belonging to the 1884 farm house (gr. 7500 and 9560).

The pavement was partially excavated in 2011, up until the western wall of the buildings belonging to gr. (7500). Its removal revealed number of leveling deposits (units [11513], [11565], [11567] [11519] [11593], [11576] [11597] and [11599],) composed of turf rich soil mixed with other anthropogenic materials such as peat ash, wood ash and charcoal, some containing 18-19<sup>th</sup> century pottery. These latter deposits were seen to cover an earlier pavement (gr. 11629), running along the southern edge of the excavation area (see gr. 10671 below).

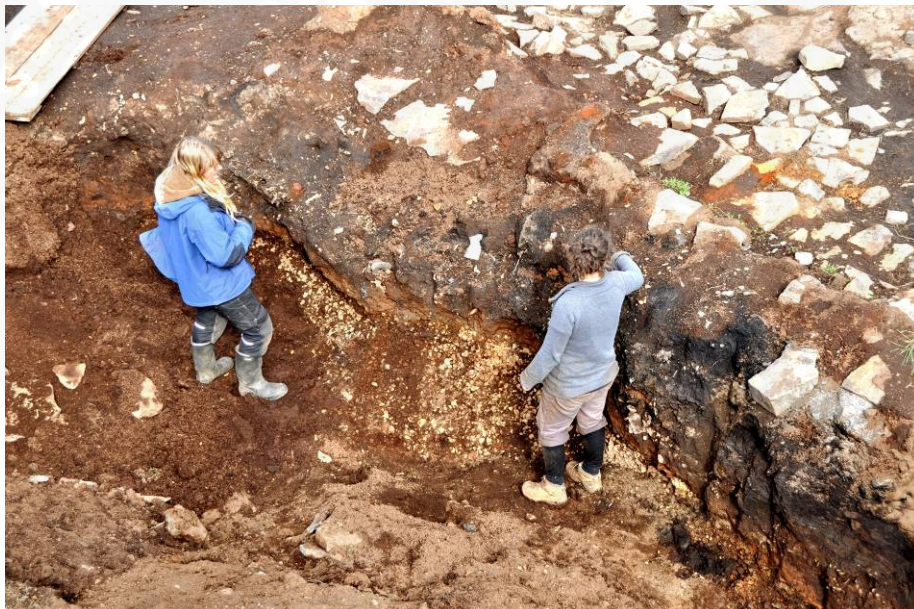
**Figure 17: Archaeologists Guðrún A. Gísladóttir and Céline Dupont-Hébert cleaning the west facing section of midden (11545), shortly after it was revealed.**

After the removal of the remains of the 190 farmhouse, a midden (gr. 11545) was discovered in section, beneath deposits in gr. (10671) on the east side and gr. (8562) on the north side of the cut.

The total dimensions of this midden are as yet unclear, as its extent is obscured by later remains. The removal of the remaining deposits of gr. (11627), along the eastern edge of the foundation cut, did however uncover about 0.5m wide portion of the midden that was excavated for the recovery of dating evidence. It is however known to predate building (8562), a structure built prior to 1693 AD (see Isaksen, in Milek 2011, 52-53).

As excavated to date, the midden is about 0.5m thick and about 5m long, and is sitting directly on top of natural gravels. The midden is composed of a series of peat ash and wood ash deposits, mixed with charcoal, along with occasional clean charcoal deposits separated by layers of turf. The latter turf deposits may represent consolidation between dumping events. This part of the midden produced a large collection of bones (pending

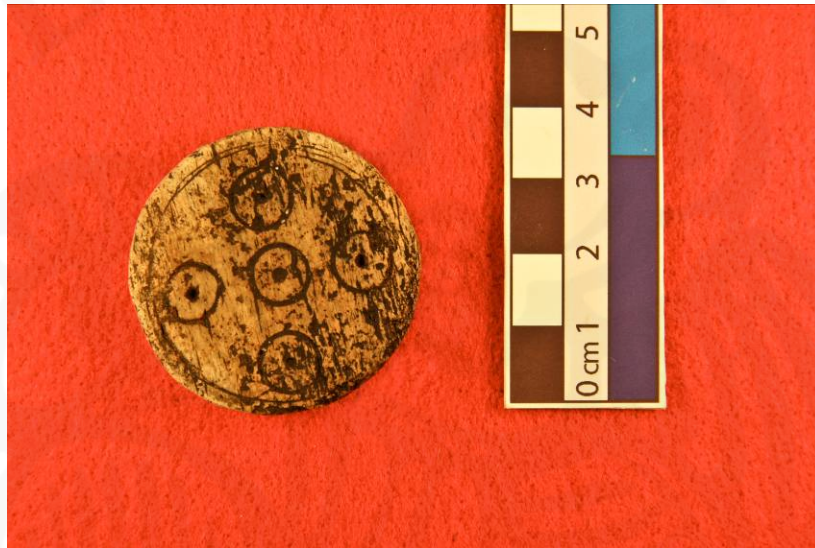
**Figure 18: The 12<sup>th</sup>-13<sup>th</sup> century gaming piece found in midden (11545).**

analysis) indicating good potential for further study. Altogether the midden did not produce many finds (mostly nails and other non-diagnostic iron objects), but one datable artifact was found, a 12<sup>th</sup>-13<sup>th</sup> century gaming piece from layer [11596] (see figure 18.).

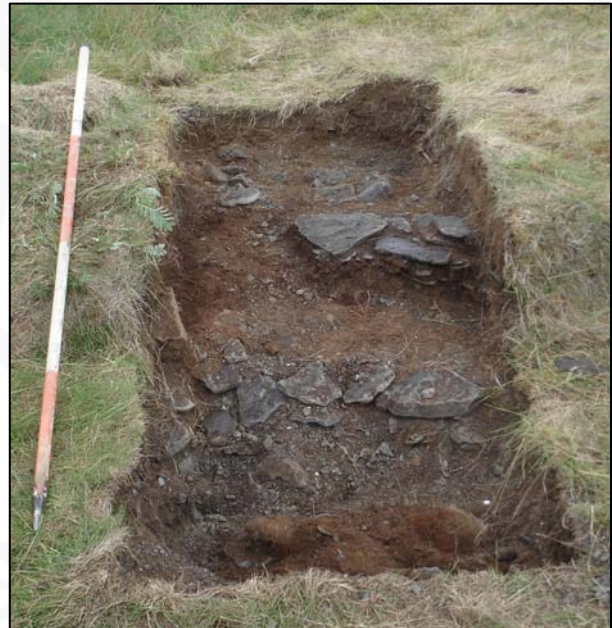
**Figure 3: Evaluation trench 5, looking south**

structural or cultural deposits. Excavations in Trench 5, which measured 1 x 2.8 m across the southern 'wall', were more productive. As figure 3 shows, this trench uncovered a low linear turf wall approximately 1 m in width, which was edged by flat stones. The alignment of these was clear on the southern edge of the wall, although the stones had slumped downwards on the northern side. The turf core of this wall was overlain by the Hekla 1693 tephra and aeolian soil deposits, indicating that the wall had

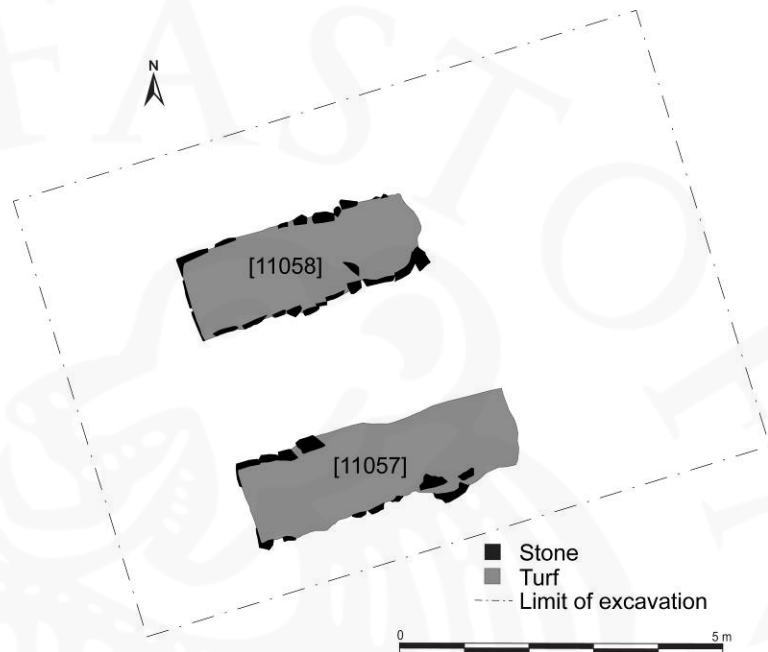
**Figure 7: The minimum extent of the post-1693 walls of the structure**

After the removal of this small internal division, collapse and slump layers continued to be excavated to the outer edges of the structure. Between the two walls, a layer of mid-yellowish brown sandy silt [11048] was found confined to the inside of the structure, between the two parallel walls. Like previous collapse layers, this too contained numerous iron nails and rivets. The limits of the walls of the structure were defined, revealing two parallel walls approximately 1 m wide (see figure 7). The northern wall displayed a stone lining on the

outer and inner edges, while on the southern wall edging stones were found to the outside of the wall and to the western end of the inner edge of the wall. During excavation, the walls were recorded as being just over 4 m long, with extensions to the eastern end, of approximately 1.5 m. However, it seems likely that these 'extensions,' [11068] and [11069], are more likely to have been parts of the main wall and have been more subject to erosion and slumping than the western ends of the walls. The northern wall [11056] was also unfortunately truncated somewhat during deturfing of the site. The turf core of both walls consisted of a mottled dark reddish brown and light brown sandy silt, which like the later internal division showed a tephra layer, presumed to be Hekla 1693, included within the individual turves, which seemed to be of the *strengur* type. The inclusion of this tephra indicates that this phase of the walls was built some time after the Hekla 1693 eruption, giving the structure a clear post-medieval date. Below the collapse layer [11048], the floor of the building was mostly clear apart from a small compacted organic deposit up against the northern wall at the eastern end of the
